SVL SINGAPORE SERVICES

M.T.-----

Thermal Imaging

Steering, Deck Hyd & Emergency Fire pump

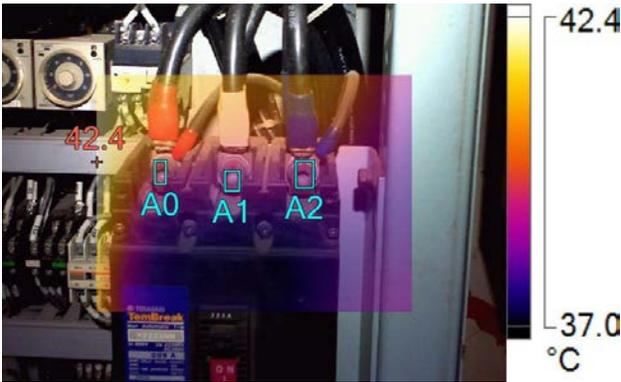
IR005253.IS2-No1 Steering Gear
12/3/2016 4:36:11 PM

We did not find any abnormality with respect to Thermal Imaging under this section. All the Mooring Hydraulic pumps were run under no load. Predictive findings are restricted under this section

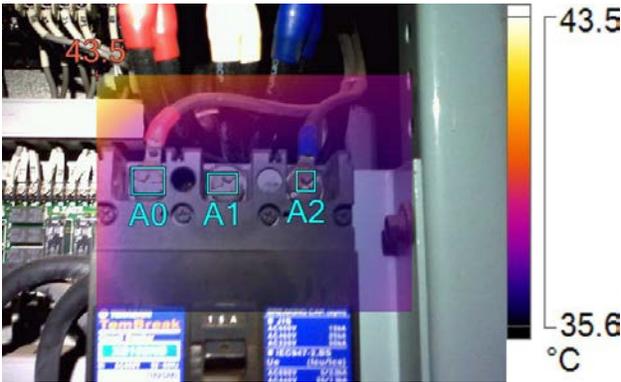
IR005255.IS2-No1 Steering Gear panel

We did not find any abnormality with respect to Thermal Imaging under this section. All the Mooring Hydraulic pumps were run under no load. Predictive findings are restricted under this condition

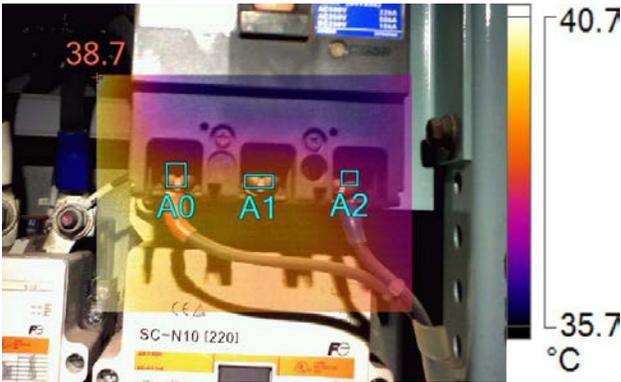
IR005256.IS2-No1 Steering Gear panel

We did not find any abnormality with respect to Thermal Imaging under this section. All the Mooring Hydraulic pumps were run under no load. Predictive findings are restricted under this section

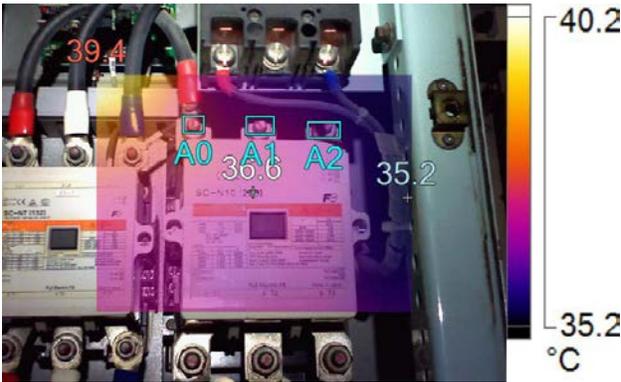
IR005257.IS2-No1 Steering Gear panel

We did not find any abnormality with respect to Thermal Imaging under this section. All the Mooring Hydraulic pumps were run under no load. Predictive findings are restricted under this section

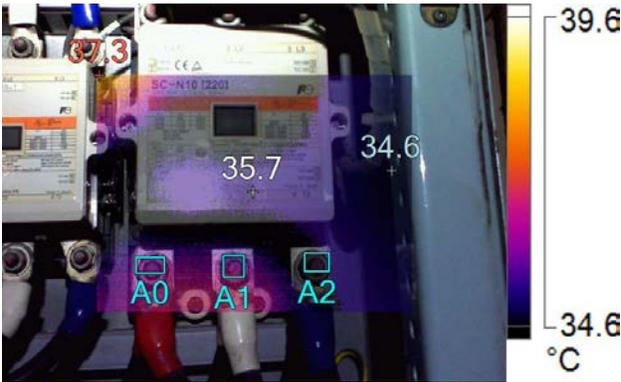
IR005258.IS2-No1 Steering Gear panel

We did not find any abnormality with respect to Thermal Imaging under this section. All the Mooring Hydraulic pumps were run under no load. Predictive findings are restricted under this section

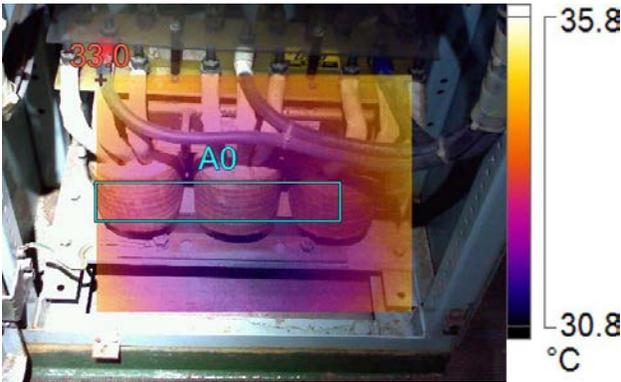
IR005260.IS2-No1 Steering Gear panel

We did not find any abnormality with respect to Thermal Imaging under this section. All the Mooring Hydraulic pumps were run under no load. Predictive findings are restricted under this section

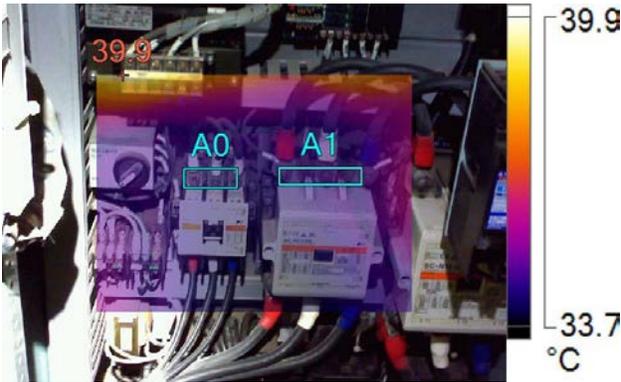
IR005261.IS2-No1 Steering Gear panel

We did not find any abnormality with respect to Thermal Imaging under this section. All the Mooring Hydraulic pumps were run under no load. Predictive findings are restricted under this section

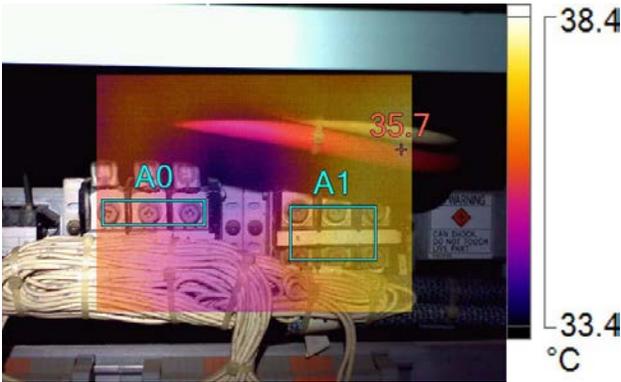
IR005264.IS2-No1 Steering Gear panel

We did not find any abnormality with respect to Thermal Imaging under this section. All the Mooring Hydraulic pumps were run under no load. Predictive findings are restricted under this section

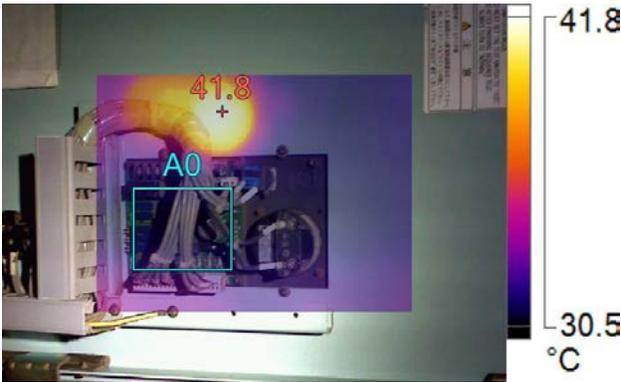
IR005265.IS2-No1 Steering Gear panel

We did not find any abnormality with respect to Thermal Imaging under this section. All the Mooring Hydraulic pumps were run under no load. Predictive findings are restricted under this section

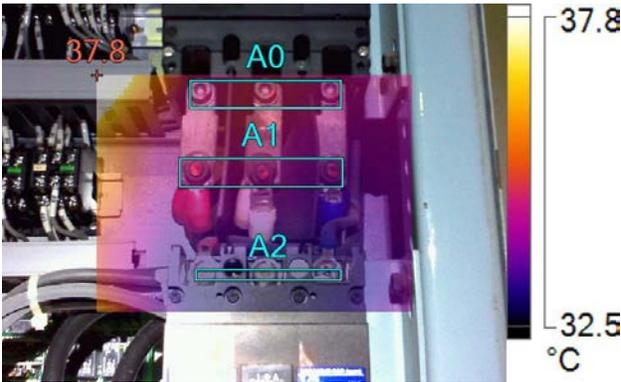
IR005270.IS2-No2 Steering Gear panel
12/3/2016 4:42:45 PM

We did not find any abnormality with respect to Thermal Imaging under this section. All the Mooring Hydraulic pumps were run under no load. Predictive findings are restricted under this section

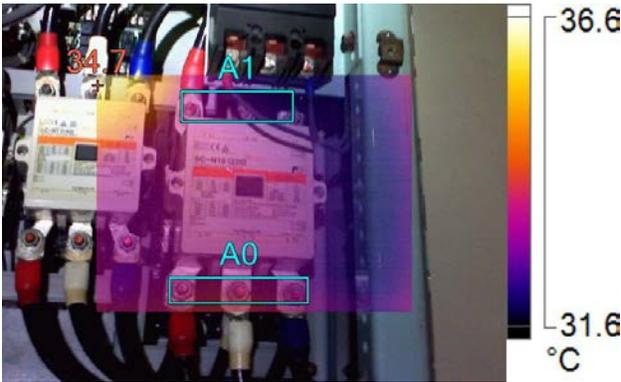
IR005272.IS2-No2 Steering Gear panel
12/3/2016 4:44:19 PM

We did not find any abnormality with respect to Thermal Imaging under this section. All the Mooring Hydraulic pumps were run under no load. Predictive findings are restricted under this section

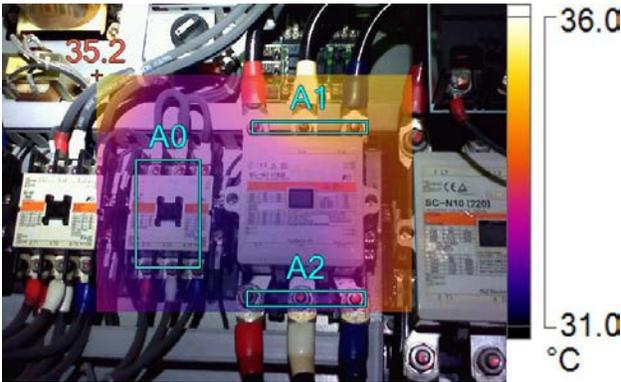
IR005273.IS2-No2 Steering Gear panel
12/3/2016 4:45:23 PM

We did not find any abnormality with respect to Thermal Imaging under this section. All the Mooring Hydraulic pumps were run under no load. Predictive findings are restricted under this section

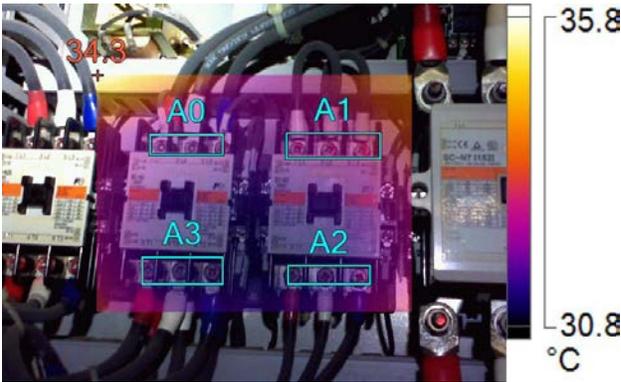
IR005274.IS2-No2 Steering Gear panel
12/3/2016 4:45:33 PM

We did not find any abnormality with respect to Thermal Imaging under this section. All the Mooring Hydraulic pumps were run under no load. Predictive findings are restricted under this section

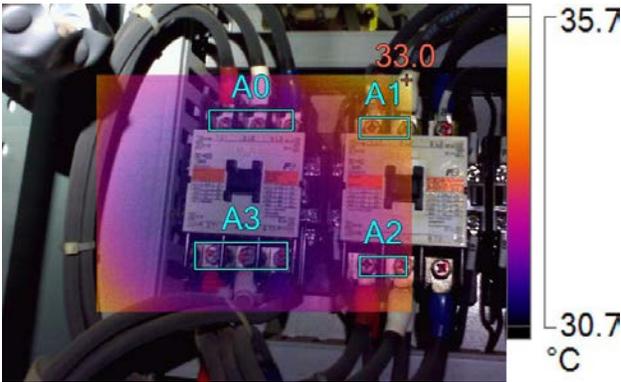
IR005275.IS2-No2 Steering Gear panel
12/3/2016 4:45:49 PM

We did not find any abnormality with respect to Thermal Imaging under this section. All the Mooring Hydraulic pumps were run under no load. Predictive findings are restricted under this section

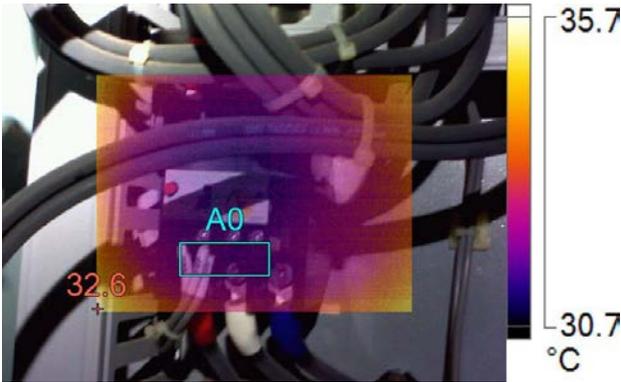
IR005276.IS2-No2 Steering Gear panel
12/3/2016 4:45:55 PM

We did not find any abnormality with respect to Thermal Imaging under this section. All the Mooring Hydraulic pumps were run under no load. Predictive findings are restricted under this section

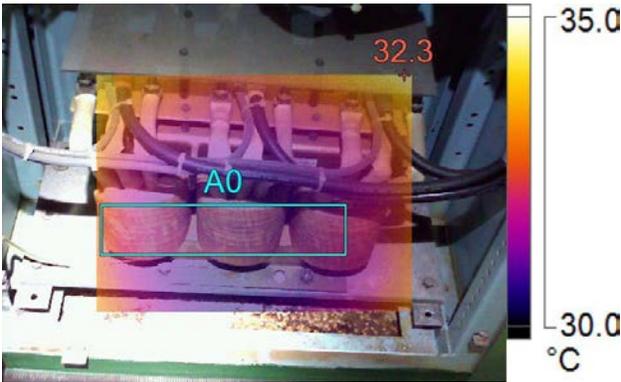
IR005277.IS2-No2 Steering Gear panel
12/3/2016 4:46:12 PM

We did not find any abnormality with respect to Thermal Imaging under this section. All the Mooring Hydraulic pumps were run under no load. Predictive findings are restricted under this section

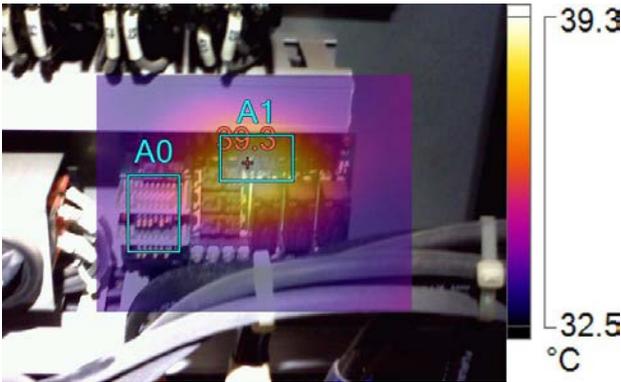
IR005278.IS2-No2 Steering Gear panel
12/3/2016 4:46:30 PM

We did not find any abnormality with respect to Thermal Imaging under this section. All the Mooring Hydraulic pumps were run under no load. Predictive findings are restricted under this section

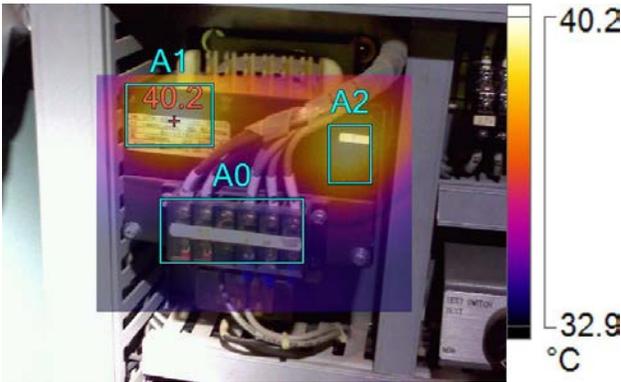
IR005279.IS2-No2 Steering Gear panel
12/3/2016 4:46:44 PM

We did not find any abnormality with respect to Thermal Imaging under this section. All the Mooring Hydraulic pumps were run under no load. Predictive findings are restricted under this section

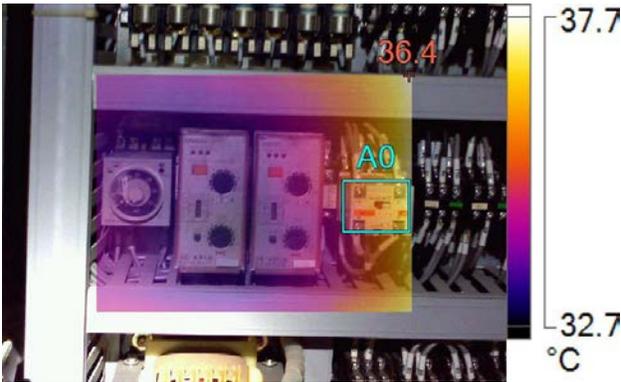
IR005280.IS2-No2 Steering Gear panel
12/3/2016 4:46:54 PM

We did not find any abnormality with respect to Thermal Imaging under this section. All the Mooring Hydraulic pumps were run under no load. Predictive findings are restricted under this section

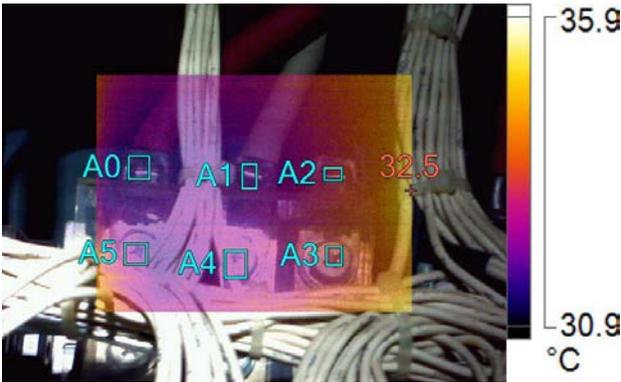
IR005285.IS2-No2 Steering Gear panel
12/3/2016 4:47:37 PM

We did not find any abnormality with respect to Thermal Imaging under this section. All the Mooring Hydraulic pumps were run under no load. Predictive findings are restricted under this section

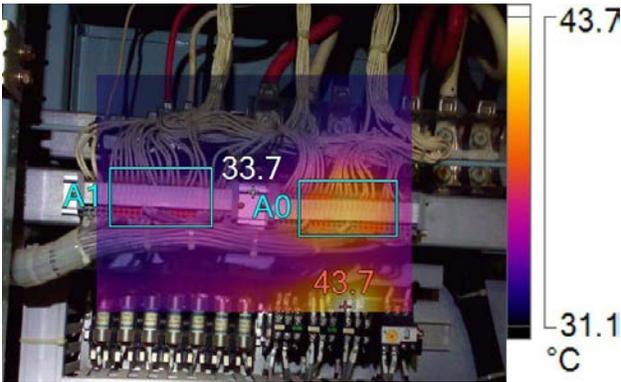
IR005286.IS2-No2 Steering Gear panel
12/3/2016 4:48:11 PM

We did not find any abnormality with respect to Thermal Imaging under this section. All the Mooring Hydraulic pumps were run under no load. Predictive findings are restricted under this section

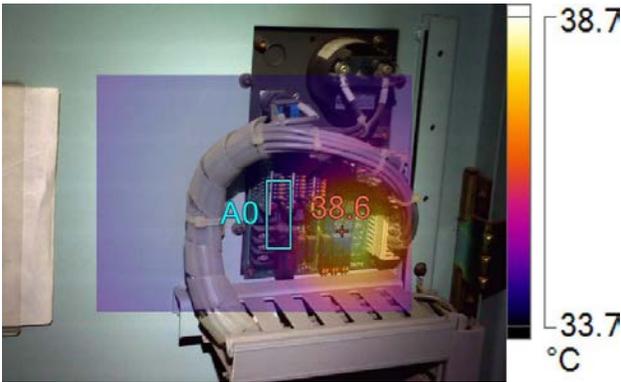
IR005287.IS2-No2 Steering Gear panel
12/3/2016 4:48:18 PM

We did not find any abnormality with respect to Thermal Imaging under this section. All the Mooring Hydraulic pumps were run under no load. Predictive findings are restricted under this section

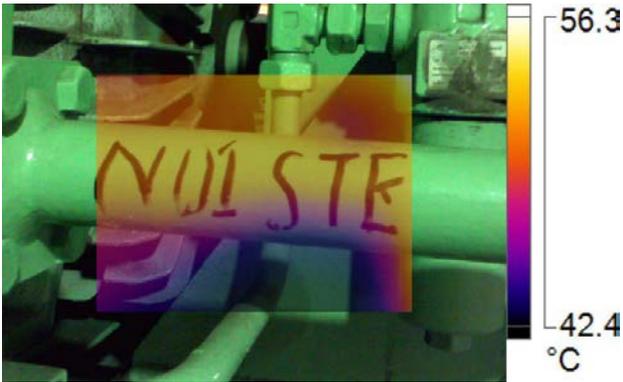
IR005288.IS2-No2 Steering Gear panel
12/3/2016 4:48:42 PM

We did not find any abnormality with respect to Thermal Imaging under this section. All the Mooring Hydraulic pumps were run under no load. Predictive findings are restricted under this section
