**UNIFIED INTERPRETATIONS TO SOLAS CHAPTER II-2, THE FSS CODE
AND RELATED FIRE TEST PROCEDURES**

Guidelines on insulation of high temperature surfaces

Submitted by the Republic of Korea

ONBOARD INVESTIGATION RESULT

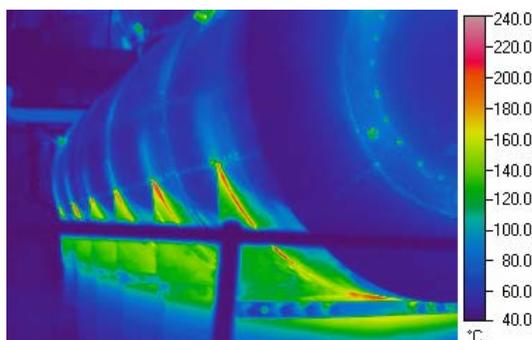
Figure 1. Exh. gas manifold of M/E

Generally, exhaust gas manifold are insulated with glass fabric encased in steel sheathing or equivalent material to prevent the oil penetration. If insulated properly, the temperature of surfaces is in the 100 °C (plus/minus 5) range in engine full load condition as shown Figure 1. Around exhaust gas manifold supporting stay, however, the points over 220 °C were observed due to misplaced insulation in those parts as shown in Figure 2.

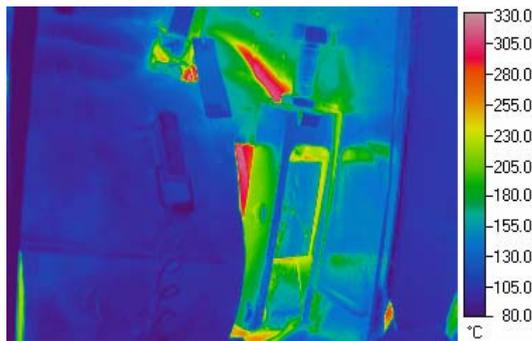
Figure 3. Exhaust gas outlet compensator to manifold(M/E)

The areas around exhaust gas piping between turbo charger and exhaust gas manifold, and exhaust gas piping before and after turbo charger was mostly found to be hot surfaces. In these cases, the problem stemmed from the poor workmanship on that area caused by complicated shape. This in turn has caused discontinuity of insulation making the exhaust gas pipe exposed to high temperature surfaces. Figures 3 and 4 show the typical temperature of these areas.

In order to avoid the discontinuity of insulation of the exhaust gas piping (i.e. the exhaust gas piping before and after turbo charger and the exhaust gas piping between cylinder and exhaust gas manifold), special finishing material (e.g. pot rivet or finish insulation mat) should be used as shown in figure A2-3.

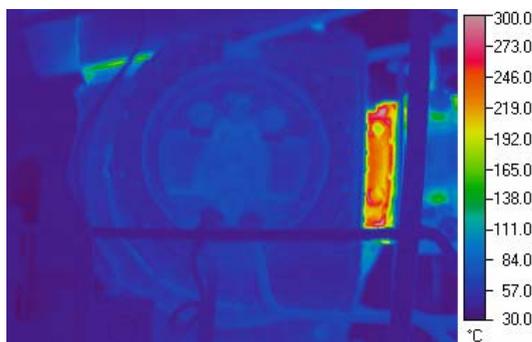
Figure 5. Turbo charge turbine side of M/E

Turbo-chargers of main engine are normally water-cooled type. By this reason, their surface temperature is in the 80 °C range. Therefore, the non-insulation of the turbo charger is a normal practice. The temperature range of turbine side is shown in Fig 5. However, turbo chargers used in small diesel engines with less than 1000 kW output such as diesel generating engine, etc. have hot surfaces due to some parts not being insulated. As shown in Figure 6, the temperature at inlet and outlet of turbine side were measured to be around 400 °C.

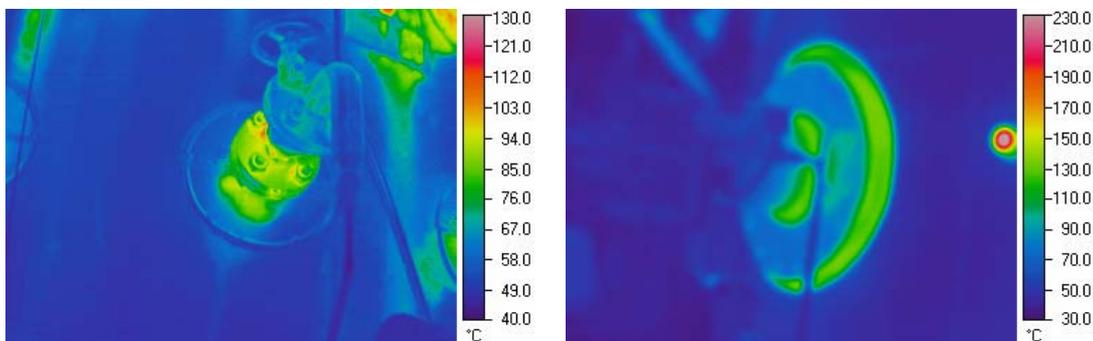
Figure 7. Boiler feed water valve close-up **Figure 8. Boiler burning point**

Boilers were found to be well insulated as shown in figures 7 and 8 and the only hot surfaces over 220 °C found were area around peep hole as shown in figure 8.

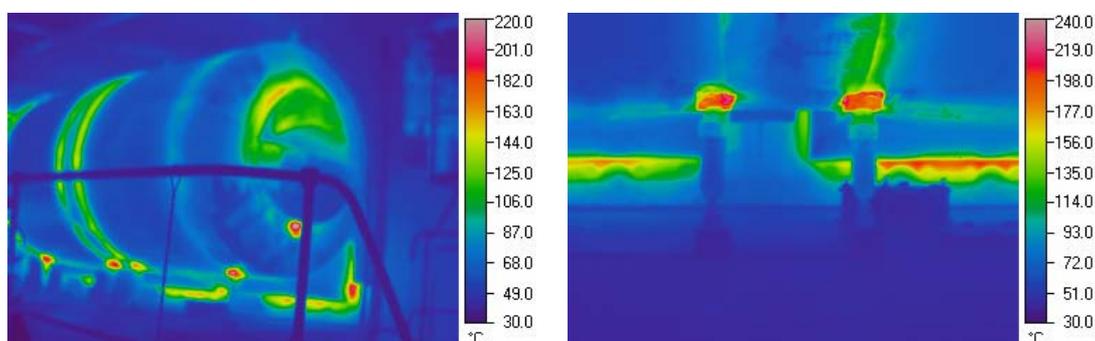
Figure 9 Exhaust gas manifold of M/E **Figure 10 Exh. gas manifold support of M/E**

For main engine as shown in figure 9, joint areas of manifolds were measured as having relatively high temperature due to aging of insulation material. Figure 10 shows the hot surfaces at manifold support of main engine. Figure 11 indicates that the hot surfaces found were around inspection man hole located at both ends of exhaust gas manifold. In this case, the insulation for inspection man hole was properly fitted, but the part of the insulation material was taken off and the gap has become widened due to frequent inspection and maintenance. Figure 12 shows that some parts of exhaust gas piping to manifold were found to have high temperature.

Even though the insulation of exhaust gas manifold is considered sturdy and satisfactory, special attention should be given to insulating supporters of manifold which are susceptible to become hot surfaces due to heat transfer.

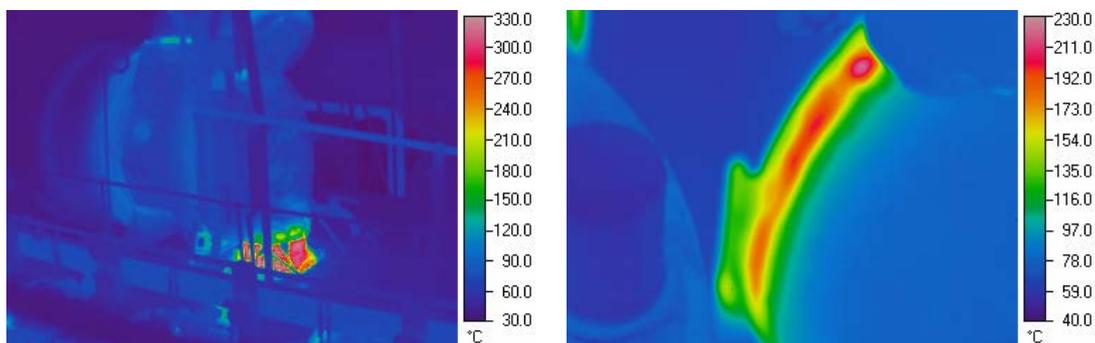
Figure 13 T/C inlet compensator (missing part) Figure 14 M/E outlet compensator to manifold

The measured temperatures around exhaust gas piping on older ships were of similar in pattern to that of new ships. Like new ships, areas around exhaust gas piping before and after turbo charger and exhaust gas piping between cylinder and exhaust gas manifold were found as hot surfaces. Figure 13 shows that an inappropriate replacement of insulation has resulted in hot surface after maintenance work of exhaust gas compensator (expansion joint). In general, when the insulation is arranged in horizontal direction there is no problem, but when installed in vertical direction, the insulation materials tend to compress down resulting in hot surfaces.

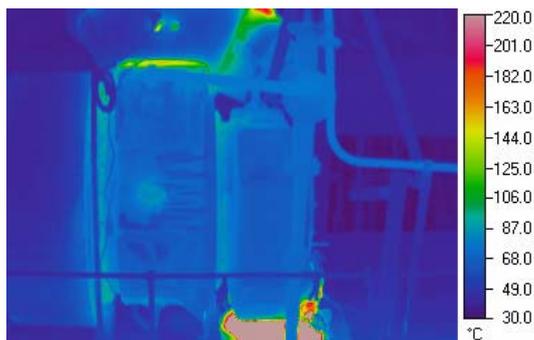
Figure15 M/E turbo charger

In case of M/E turbo charger, normally being of wet type, the surface temperature was in 90 °C range. Figure 15, however, shows the high temperature area around compensator when the insulation was removed after maintenance. In case of G/E turbo charger, normally being of dry type, many parts of surfaces were revealed as areas having high temperature as shown in figure 16.

4.1 A regular check of equipment or material should be made to confirm that the insulation is in place as installed. When maintenance or repair to equipment has been carried out, checks should be made to ensure that the insulation covering the heated surfaces has been properly replaced. Especially, special attention should be paid on the following:

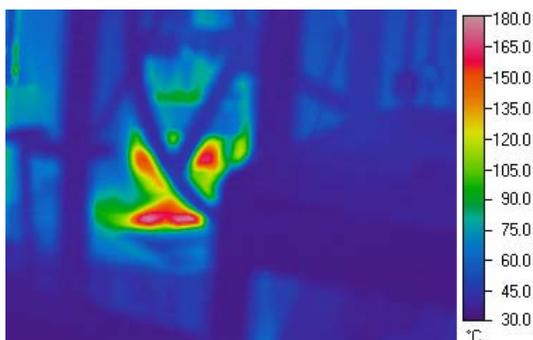
Figure 17 Superheated steam pipe and globe V/V

As shown in Figure17, superheated steam pipe and globe stop valve were found not to exceed 220 °C and over. However, superheated steam pipe and angle valve were found to have relatively high temperature - around 360 °C. In this case, the problem was found to stemming from the discontinuity of insulation because the direction of insulation changed at the valve.

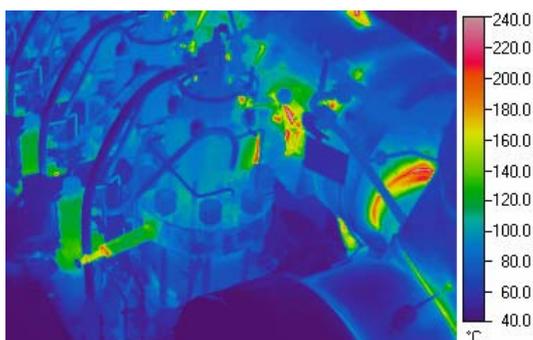
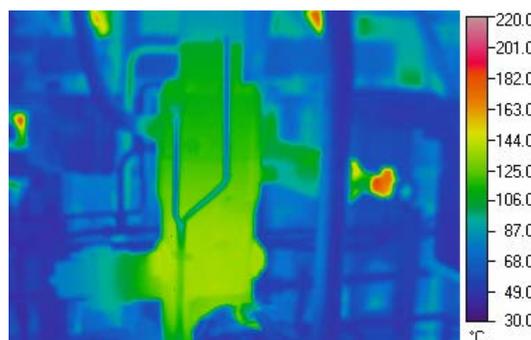
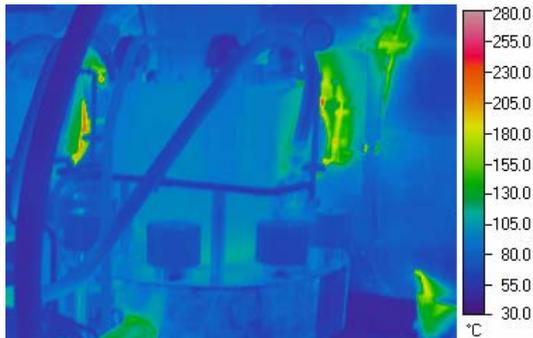
As shown in figures 19, 20, 21 and 22, there was no significant sign of hot surfaces around main engine, indicator cock and cylinder head. Whereas the temperature of fuel injection nozzle was found to be around 140 °C like the temperature of fuel oil, the temperature around cylinder was found to be similar to engine cooling temperature. Even the area of M/E indicator cock was found to indicate lower temperature than expected. The step area of the indicator was found to have relatively high temperature - around 160 °C.
