TECHNICAL PAPER

HOT SURFACES IN ENGINE ROOMS

PAPER SERIES No. 2000-P025
November 2000

DET NORSKE VERITAS

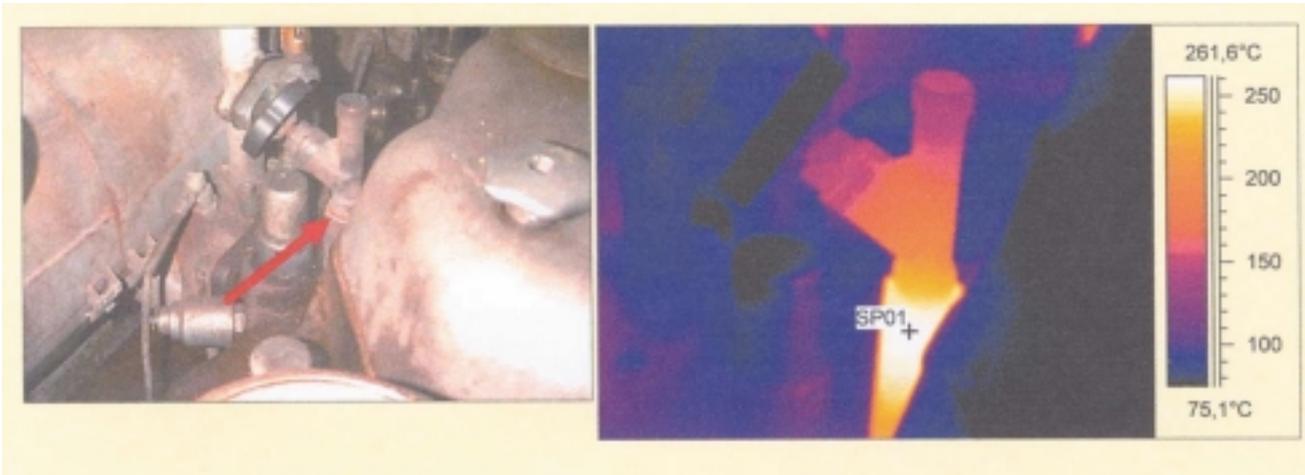
Detail 1. Hot indicator valve. Area is only a few cm² and difficult to detect. It is advised to examine area around one chosen cylinder thoroughly, as many items will be identical on all other cylinders on that engine. Hot spot as indicated by arrow is 260°C.

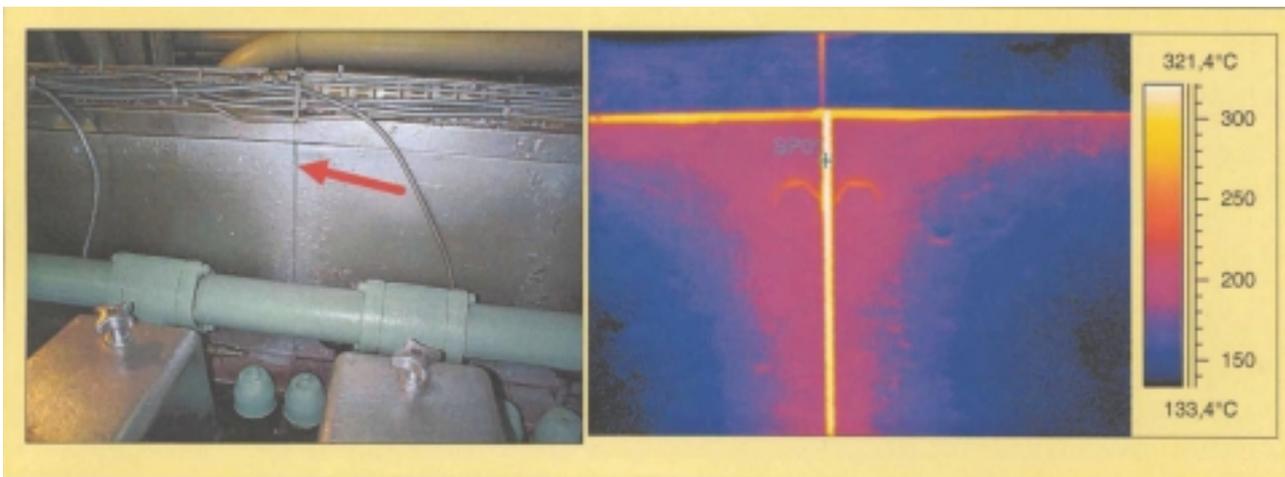
Detail 2: No overlap between steel sheeting covering exhaust manifold. Same problem often found on "insulation pad" type insulation. Larger gaps in insulation than shown on above picture can often be found. New steel sheeting with proper overlap to be provided or additional protection to be applied in way of joints. Hot spot = 320°C.

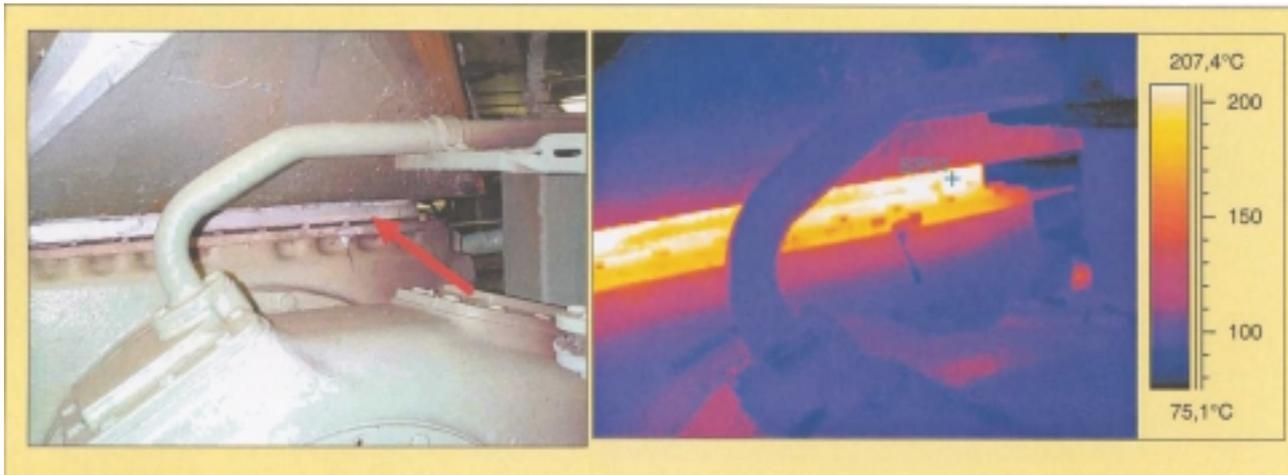
Detail 3: No insulation of flanges between exhaust manifold and exhaust duct. Hot spot = 230°C.

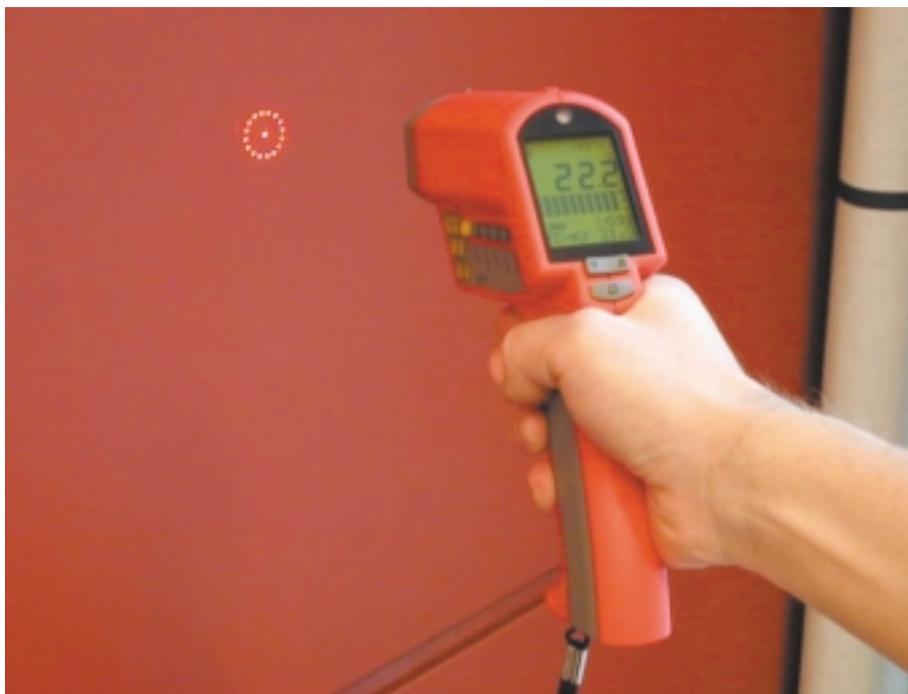
Lasertracer with field of vision 1:60. Average temperature within shown circle is returned.

All lasertracers will measure the average temperature in an area, which is dependent upon the distance from lasertracer to object. In most cases this will be a different temperature than for the spot indicated by the laser! For conventional lasertracers with a field of view on 1:8, this average area will be 200 mm in diameter at 1.5 m. Considering the notable temperature variation shown in picture 1, chapter 2, we can conclude that it is difficult to detect these details without knowing the effect of average areas. Some advanced models have a much more narrow field of view and will, in addition, indicate the field of view by a circle of lasers-points outside the centre laser (see picture).
