SVL SINGAPORE SERVICES

M.T.-----

Thermal Imaging

Steering, Deck Hyd & Emergency Fire pump

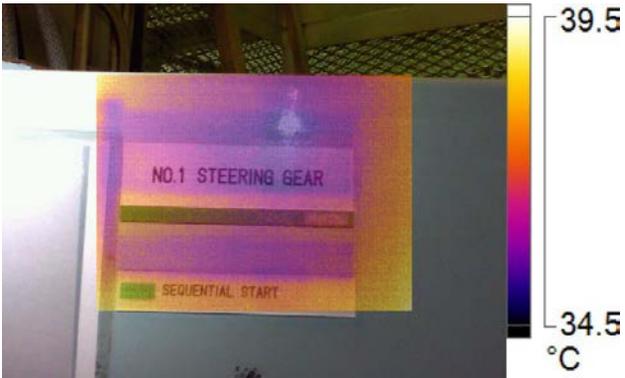
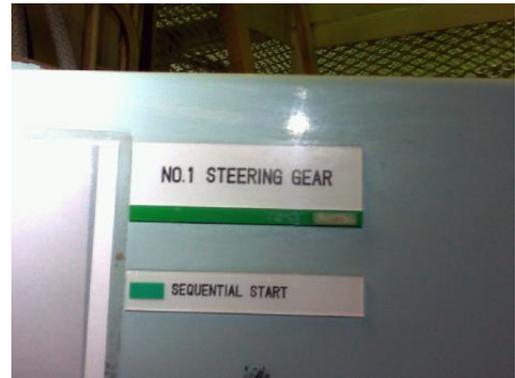
IR005253.IS2-No1 Steering Gear
12/3/2016 4:36:11 PM

We did not find any abnormality with respect to Thermal Imaging under this section. All the Mooring Hydraulic pumps were run under no load. Predictive findings are restricted under this section

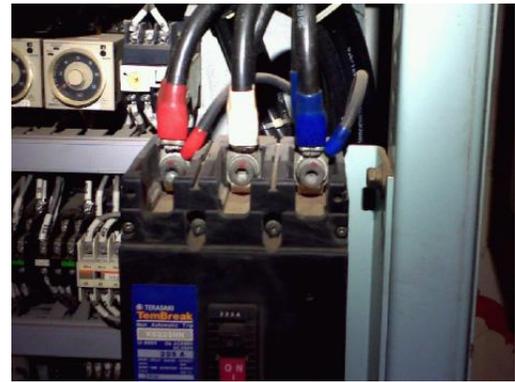
IR005254.IS2-No1 Steering Gear panel
12/3/2016 4:36:45 PM

We did not find any abnormality with respect to Thermal Imaging under this section. All the Mooring Hydraulic pumps were run under no load. Predictive findings are restricted under this section

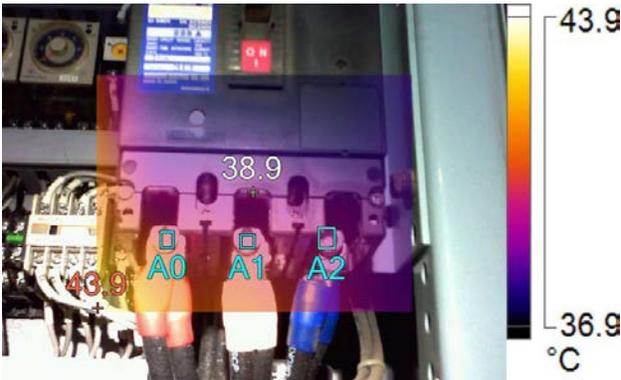
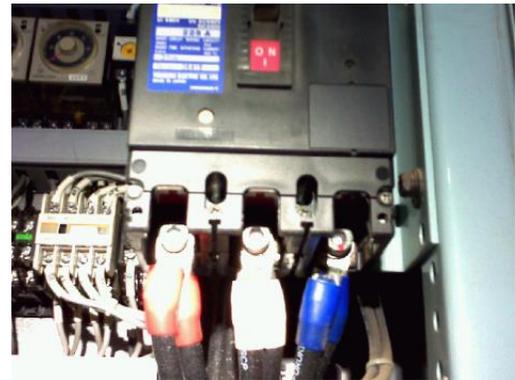
IR005255.IS2-No1 Steering Gear panel

We did not find any abnormality with respect to Thermal Imaging under this section. All the Mooring Hydraulic pumps were run under no load. Predictive findings are restricted under this condition

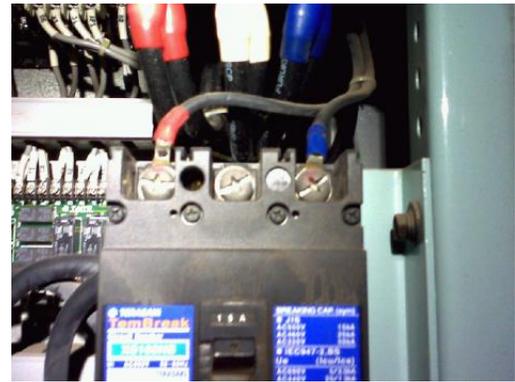
IR005256.IS2-No1 Steering Gear panel

We did not find any abnormality with respect to Thermal Imaging under this section. All the Mooring Hydraulic pumps were run under no load. Predictive findings are restricted under this section

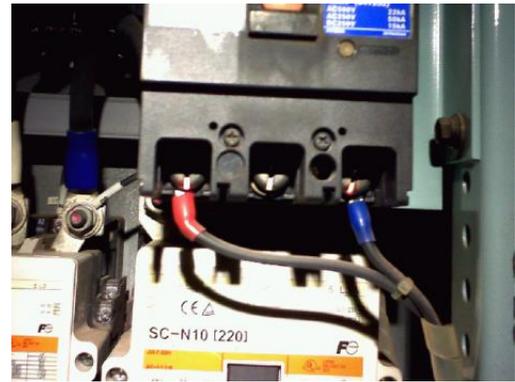
IR005257.IS2-No1 Steering Gear panel

We did not find any abnormality with respect to Thermal Imaging under this section. All the Mooring Hydraulic pumps were run under no load. Predictive findings are restricted under this section

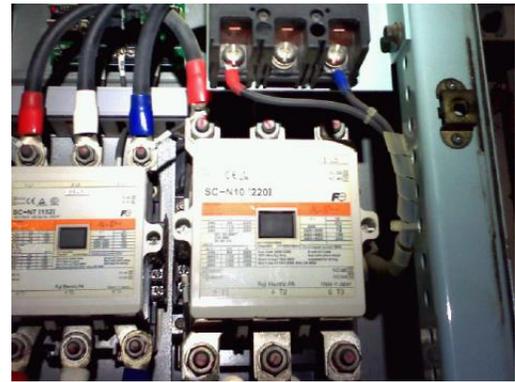
IR005258.IS2-No1 Steering Gear panel

We did not find any abnormality with respect to Thermal Imaging under this section. All the Mooring Hydraulic pumps were run under no load. Predictive findings are restricted under this section

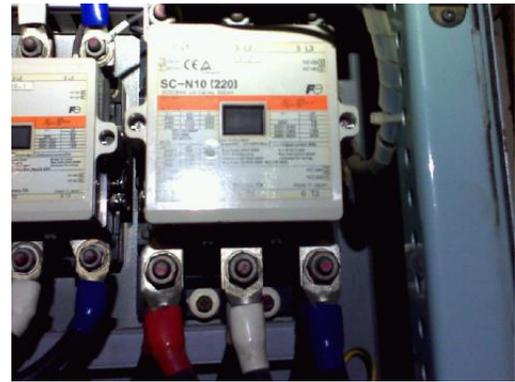
IR005259.IS2-No1 Steering Gear panel

We did not find any abnormality with respect to Thermal Imaging under this section. All the Mooring Hydraulic pumps were run under no load. Predictive findings are restricted under this section

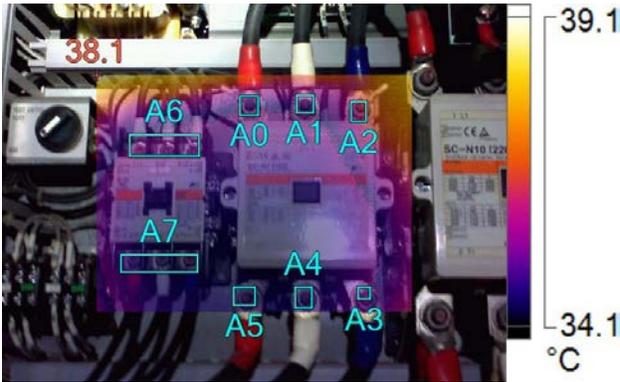
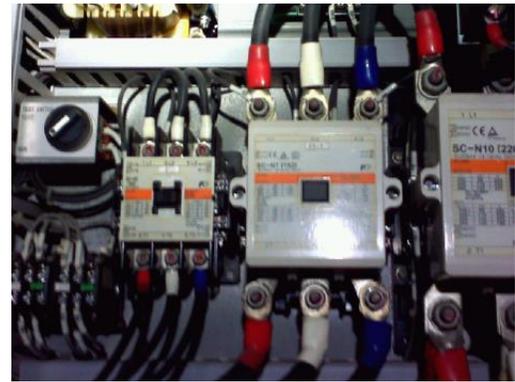
IR005260.IS2-No1 Steering Gear panel

We did not find any abnormality with respect to Thermal Imaging under this section. All the Mooring Hydraulic pumps were run under no load. Predictive findings are restricted under this section

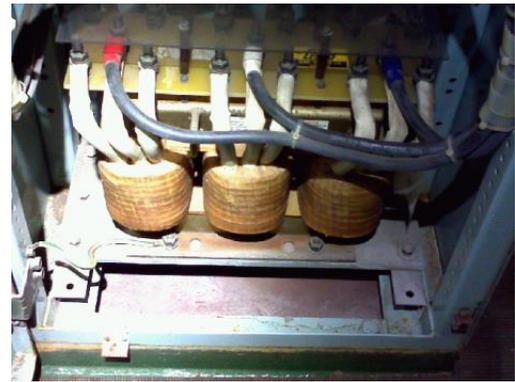
IR005261.IS2-No1 Steering Gear panel

We did not find any abnormality with respect to Thermal Imaging under this section. All the Mooring Hydraulic pumps were run under no load. Predictive findings are restricted under this section

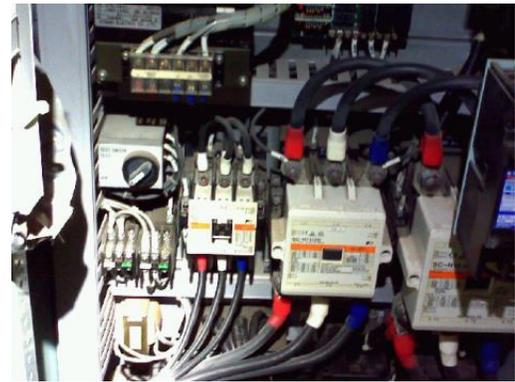
IR005262.IS2-No1 Steering Gear panel

We did not find any abnormality with respect to Thermal Imaging under this section. All the Mooring Hydraulic pumps were run under no load. Predictive findings are restricted under this section

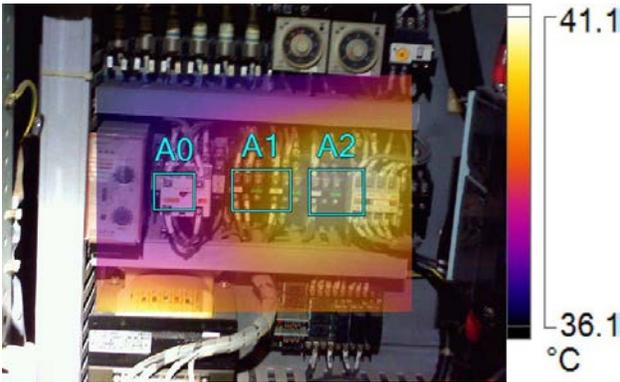
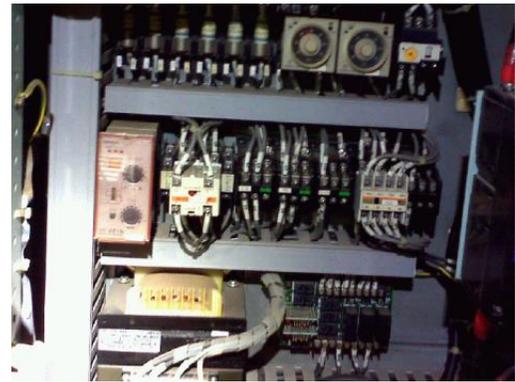
IR005263.IS2-No1 Steering Gear panel

We did not find any abnormality with respect to Thermal Imaging under this section. All the Mooring Hydraulic pumps were run under no load. Predictive findings are restricted under this section

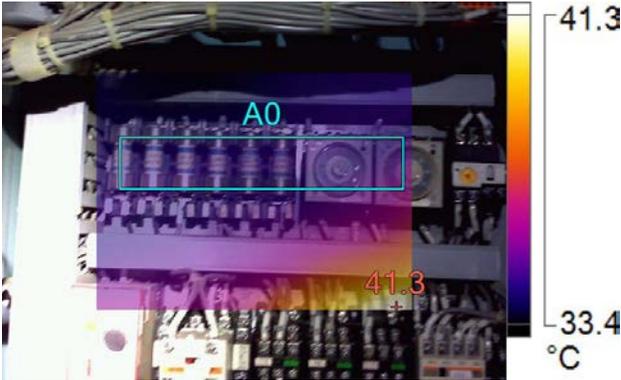
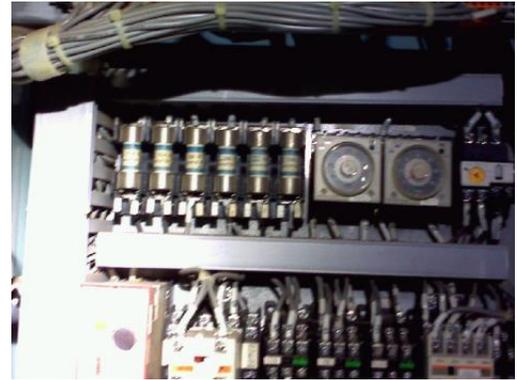
IR005264.IS2-No1 Steering Gear panel

We did not find any abnormality with respect to Thermal Imaging under this section. All the Mooring Hydraulic pumps were run under no load. Predictive findings are restricted under this section

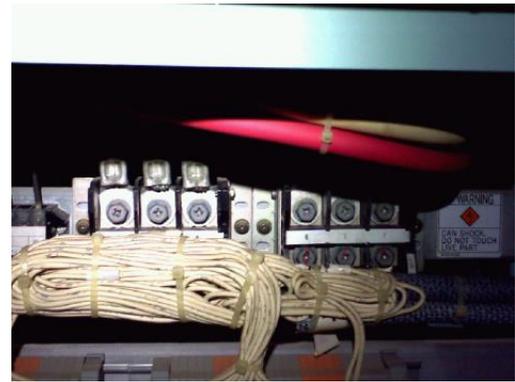
IR005265.IS2-No1 Steering Gear panel

We did not find any abnormality with respect to Thermal Imaging under this section. All the Mooring Hydraulic pumps were run under no load. Predictive findings are restricted under this section

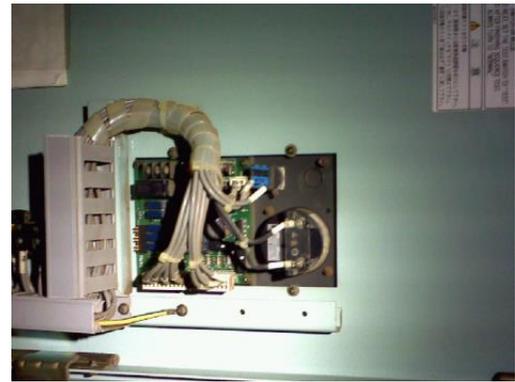
IR005266.IS2-No1 Steering Gear panel

We did not find any abnormality with respect to Thermal Imaging under this section. All the Mooring Hydraulic pumps were run under no load. Predictive findings are restricted under this section

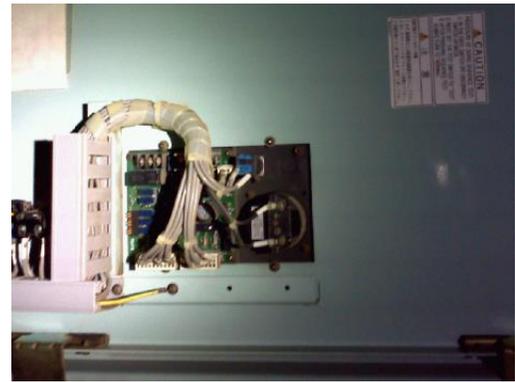
IR005267.IS2-No1 Steering Gear panel

We did not find any abnormality with respect to Thermal Imaging under this section. All the Mooring Hydraulic pumps were run under no load. Predictive findings are restricted under this section

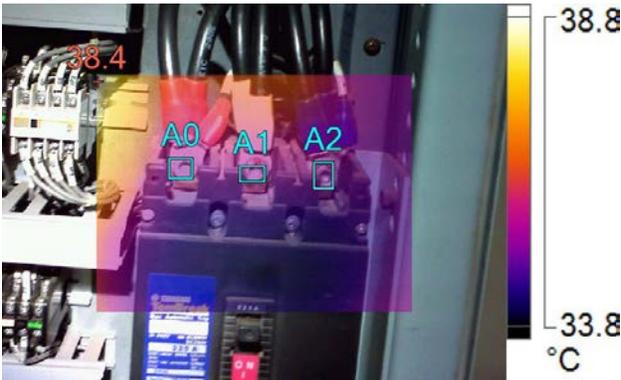
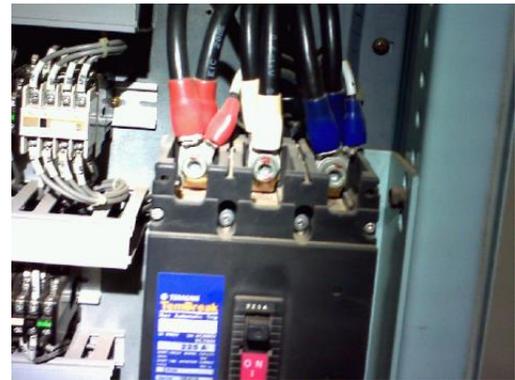
IR005269.IS2-No2 Steering Gear panel
12/3/2016 4:42:29 PM

We did not find any abnormality with respect to Thermal Imaging under this section. All the Mooring Hydraulic pumps were run under no load. Predictive findings are restricted under this section

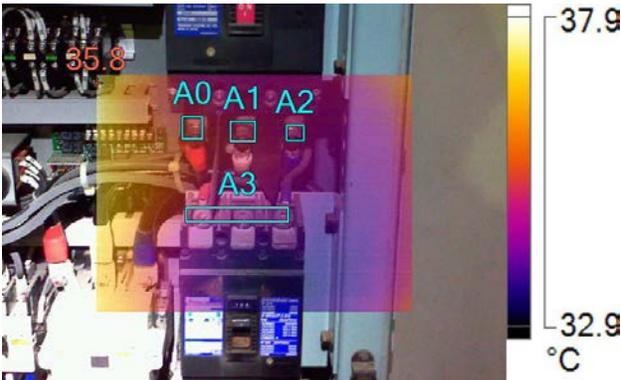
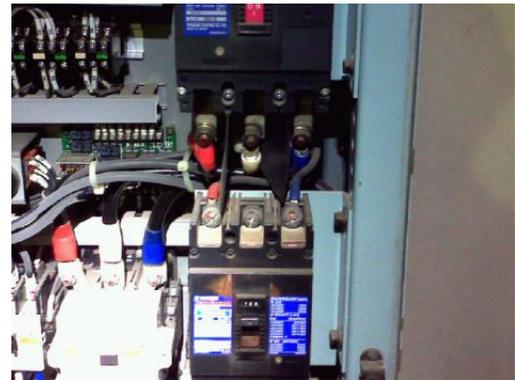
IR005270.IS2-No2 Steering Gear panel
12/3/2016 4:42:45 PM

We did not find any abnormality with respect to Thermal Imaging under this section. All the Mooring Hydraulic pumps were run under no load. Predictive findings are restricted under this section

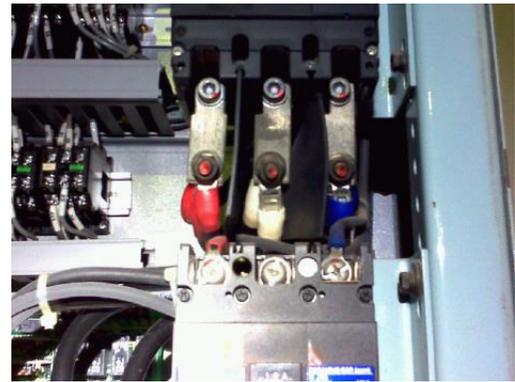
IR005271.IS2-No2 Steering Gear panel
12/3/2016 4:44:03 PM

We did not find any abnormality with respect to Thermal Imaging under this section. All the Mooring Hydraulic pumps were run under no load. Predictive findings are restricted under this section

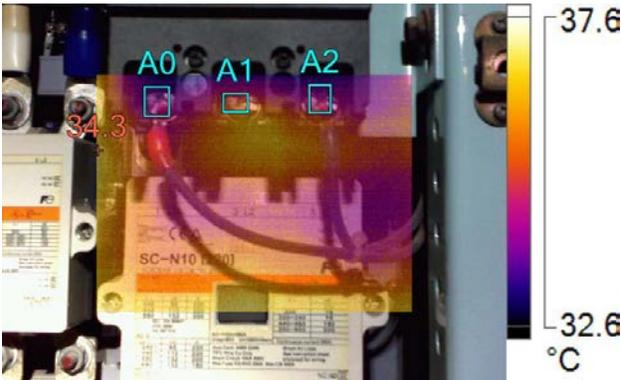
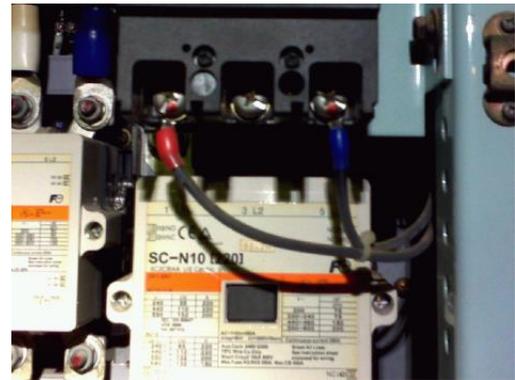
IR005272.IS2-No2 Steering Gear panel
12/3/2016 4:44:19 PM

We did not find any abnormality with respect to Thermal Imaging under this section. All the Mooring Hydraulic pumps were run under no load. Predictive findings are restricted under this section

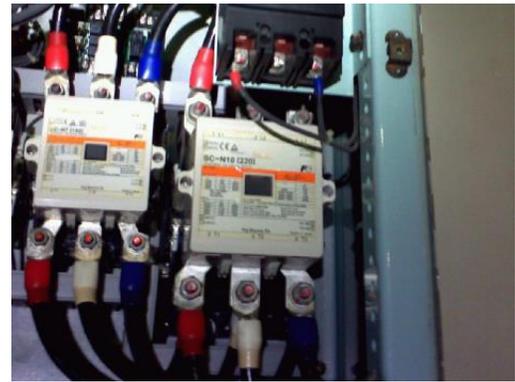
IR005273.IS2-No2 Steering Gear panel
12/3/2016 4:45:23 PM

We did not find any abnormality with respect to Thermal Imaging under this section. All the Mooring Hydraulic pumps were run under no load. Predictive findings are restricted under this section

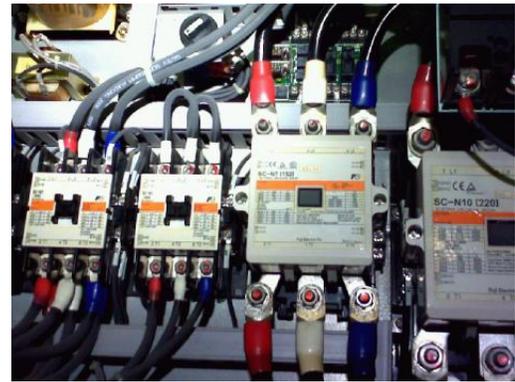
IR005274.IS2-No2 Steering Gear panel
12/3/2016 4:45:33 PM

We did not find any abnormality with respect to Thermal Imaging under this section. All the Mooring Hydraulic pumps were run under no load. Predictive findings are restricted under this section

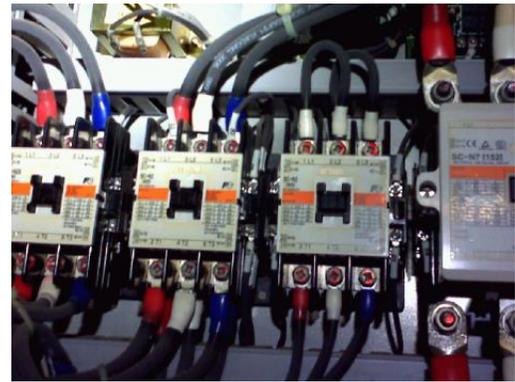
IR005275.IS2-No2 Steering Gear panel
12/3/2016 4:45:49 PM

We did not find any abnormality with respect to Thermal Imaging under this section. All the Mooring Hydraulic pumps were run under no load. Predictive findings are restricted under this section

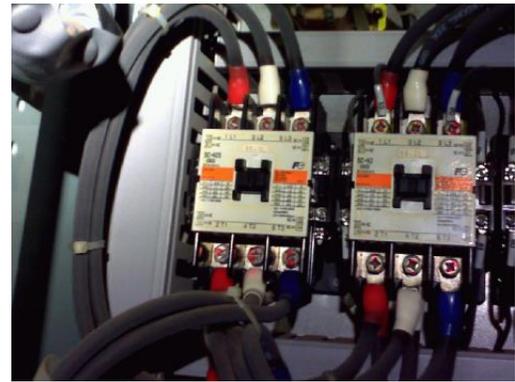
IR005276.IS2-No2 Steering Gear panel
12/3/2016 4:45:55 PM

We did not find any abnormality with respect to Thermal Imaging under this section. All the Mooring Hydraulic pumps were run under no load. Predictive findings are restricted under this section

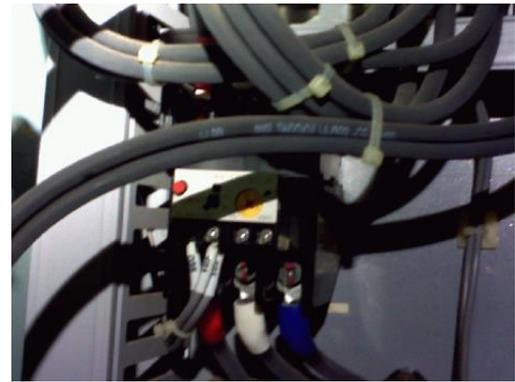
IR005277.IS2-No2 Steering Gear panel
12/3/2016 4:46:12 PM

We did not find any abnormality with respect to Thermal Imaging under this section. All the Mooring Hydraulic pumps were run under no load. Predictive findings are restricted under this section

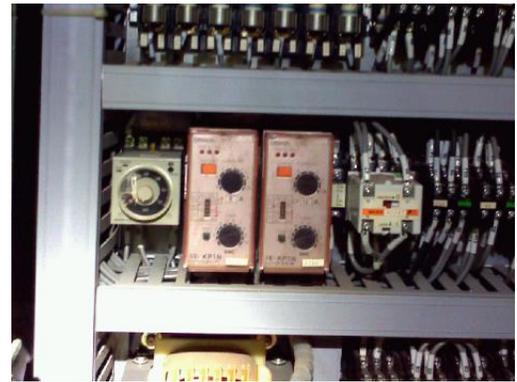
IR005281.IS2-No2 Steering Gear panel
12/3/2016 4:47:06 PM

We did not find any abnormality with respect to Thermal Imaging under this section. All the Mooring Hydraulic pumps were run under no load. Predictive findings are restricted under this section

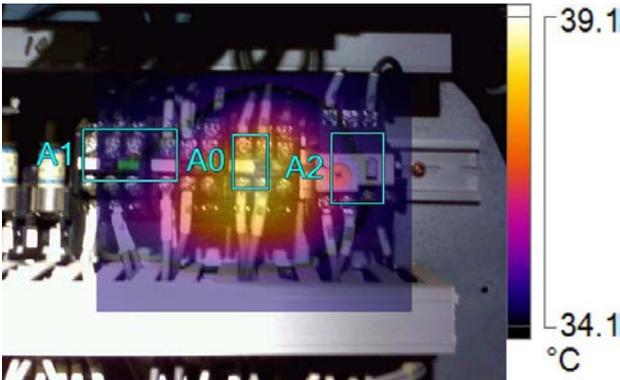
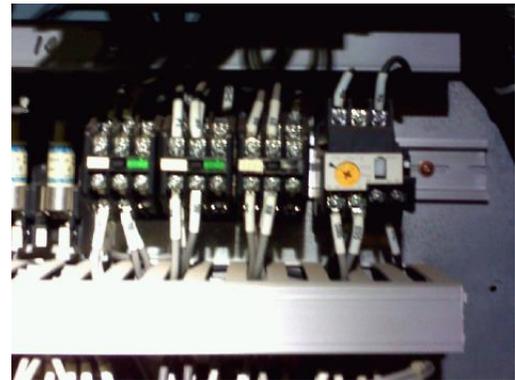
IR005283.IS2-No2 Steering Gear panel
12/3/2016 4:47:18 PM

Name	Avg	Min	Max	Emissivity
A0	38.4°C	37.2°C	39.1°C	0.95
A1	35.9°C	34.9°C	37.3°C	0.95
A2	36.1°C	35.0°C	37.3°C	0.95

We did not find any abnormality with respect to Thermal Imaging under this section. All the Mooring Hydraulic pumps were run under no load. Predictive findings are restricted under this section

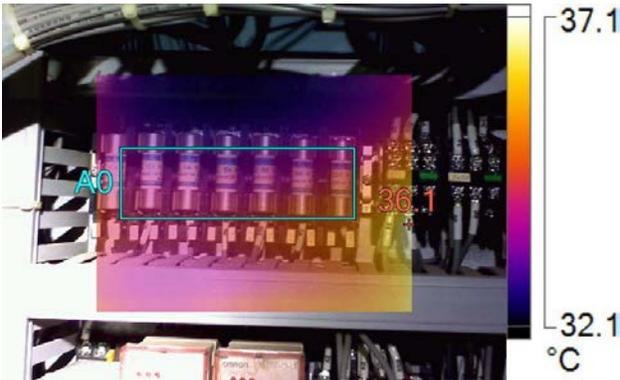
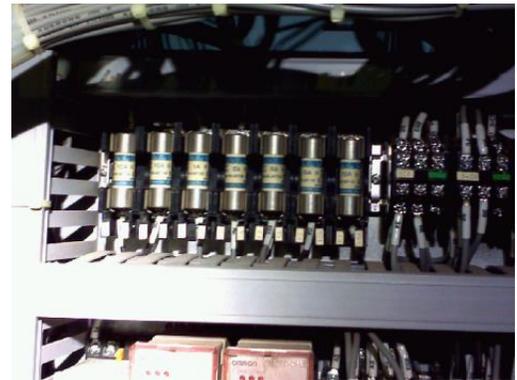
IR005284.IS2-No2 Steering Gear panel
12/3/2016 4:47:26 PM

Name	Avg	Min	Max	Emissivity
A0	33.6°C	32.8°C	34.8°C	0.95

Name	Temperature	Emissivity
Hot	36.1°C	0.95

We did not find any abnormality with respect to Thermal Imaging under this section. All the Mooring Hydraulic pumps were run under no load. Predictive findings are restricted under this section

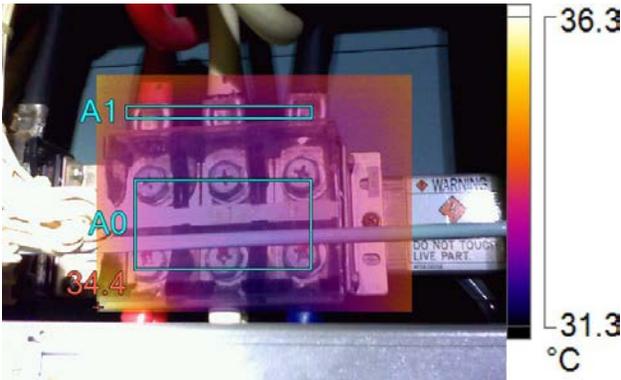
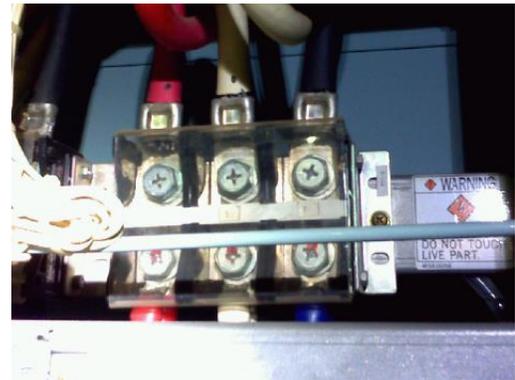
IR005285.IS2-No2 Steering Gear panel
12/3/2016 4:47:37 PM

Name	Avg	Min	Max	Emissivity
A0	32.1°C	31.6°C	32.8°C	0.95
A1	32.4°C	32.1°C	33.0°C	0.95

Name	Temperature	Emissivity
Hot	34.4°C	0.95

We did not find any abnormality with respect to Thermal Imaging under this section. All the Mooring Hydraulic pumps were run under no load. Predictive findings are restricted under this section

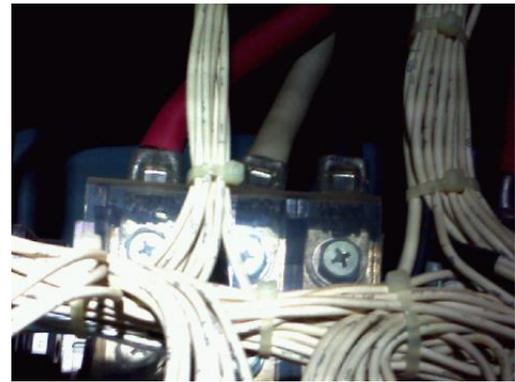
IR005286.IS2-No2 Steering Gear panel
12/3/2016 4:48:11 PM

Name	Avg	Min	Max	Emissivity
A0	31.2°C	30.9°C	31.3°C	0.95
A1	31.3°C	31.1°C	31.4°C	0.95
A2	31.6°C	31.5°C	31.8°C	0.95
A3	31.7°C	31.5°C	31.9°C	0.95
A4	31.4°C	31.2°C	31.6°C	0.95
A5	31.3°C	31.1°C	31.6°C	0.95

Name	Temperature	Emissivity
Hot	32.5°C	0.95

We did not find any abnormality with respect to Thermal Imaging under this section. All the Mooring Hydraulic pumps were run under no load. Predictive findings are restricted under this section

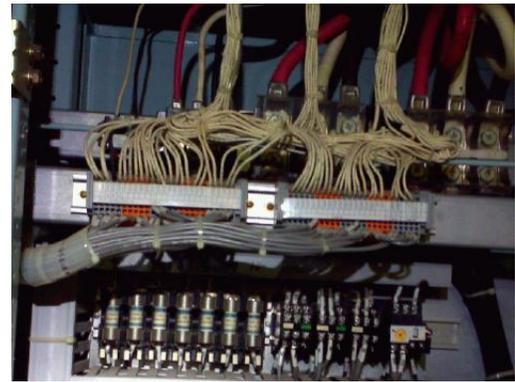
IR005287.IS2-No2 Steering Gear panel
12/3/2016 4:48:18 PM

Name	Avg	Min	Max	Emissivity
A0	37.3°C	34.1°C	39.4°C	0.95
A1	33.5°C	32.4°C	34.6°C	0.95

Name	Temperature	Emissivity
Centerpoint	33.7°C	0.95
Hot	43.7°C	0.95

We did not find any abnormality with respect to Thermal Imaging under this section. All the Mooring Hydraulic pumps were run under no load. Predictive findings are restricted under this section

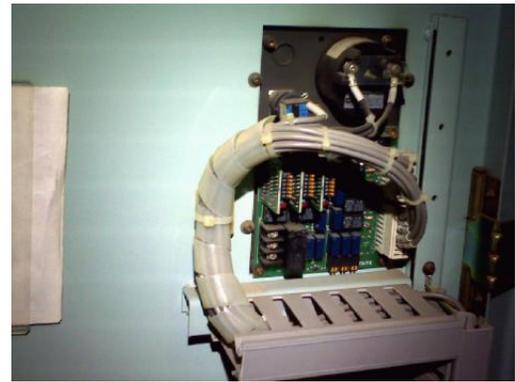
IR005288.IS2-No2 Steering Gear panel
12/3/2016 4:48:42 PM

Name	Avg	Min	Max	Emissivity
A0	35.4°C	34.4°C	36.6°C	0.95

Name	Temperature	Emissivity
Hot	38.6°C	0.95

We did not find any abnormality with respect to Thermal Imaging under this section. All the Mooring Hydraulic pumps were run under no load. Predictive findings are restricted under this section

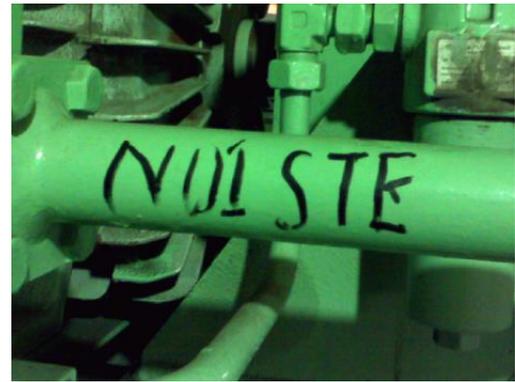
IR005289.IS2-No1 Steering gear
12/3/2016 5:02:51 PM

We did not find any abnormality with respect to Thermal Imaging under this section. All the Mooring Hydraulic pumps were run under no load. Predictive findings are restricted under this section

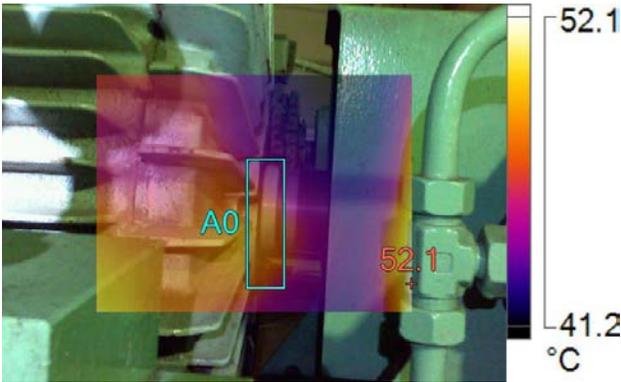
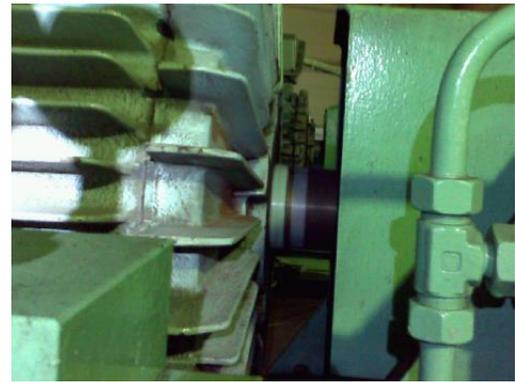
IR005290.IS2-No1 Steering gear

Name	Avg	Min	Max	Emissivity
A0	48.5°C	45.4°C	50.0°C	0.95

Name	Temperature	Emissivity
Hot	52.1°C	0.95

We did not find any abnormality with respect to Thermal Imaging under this section. All the Mooring Hydraulic pumps were run under no load. Predictive findings are restricted under this section

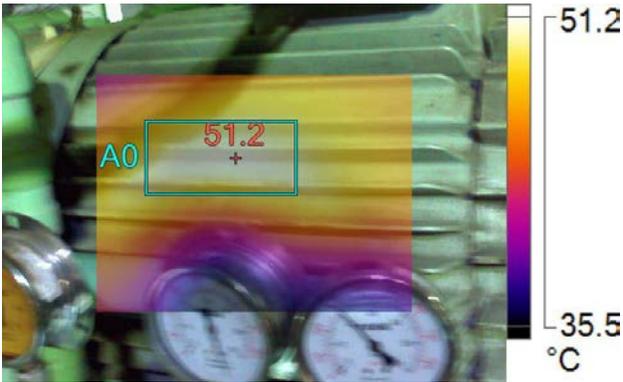
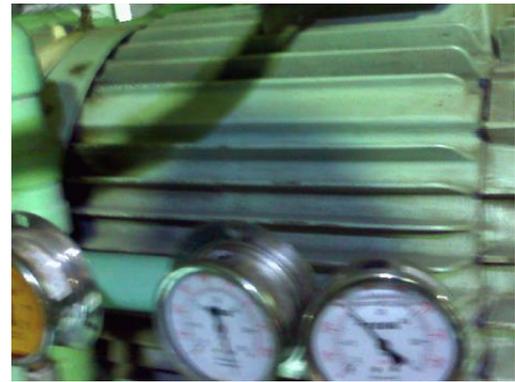
IR005291.IS2-No1 Steering gear

Name	Avg	Min	Max	Emissivity
A0	50.3°C	48.1°C	51.2°C	0.95

Name	Temperature	Emissivity
Hot	51.2°C	0.95

We did not find any abnormality with respect to Thermal Imaging under this section. All the Mooring Hydraulic pumps were run under no load. Predictive findings are restricted under this section

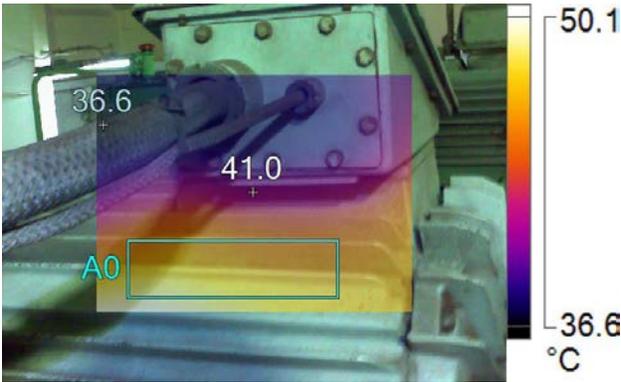
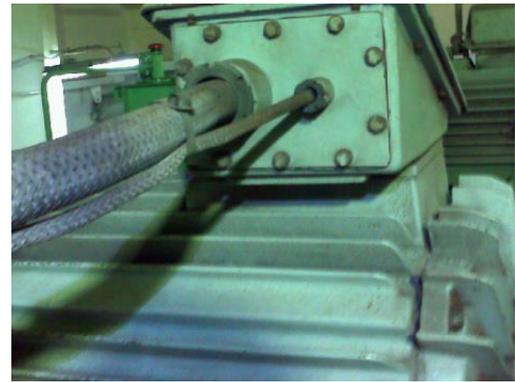
IR005292.IS2-No1 Steering gear

Name	Avg	Min	Max	Emissivity
A0	46.7°C	44.5°C	49.4°C	0.95

Name	Temperature	Emissivity
Centerpoint	41.0°C	0.95
Cold	36.6°C	0.95

We did not find any abnormality with respect to Thermal Imaging under this section. All the Mooring Hydraulic pumps were run under no load. Predictive findings are restricted under this section

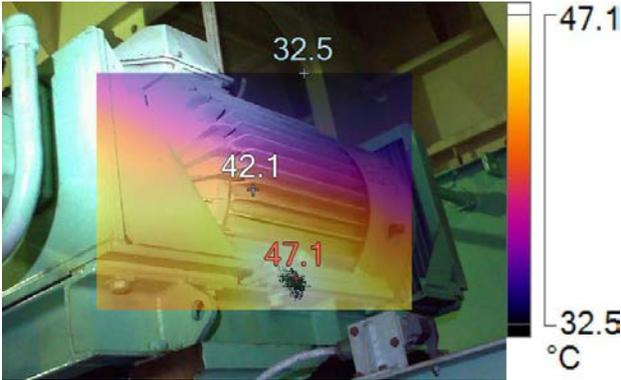
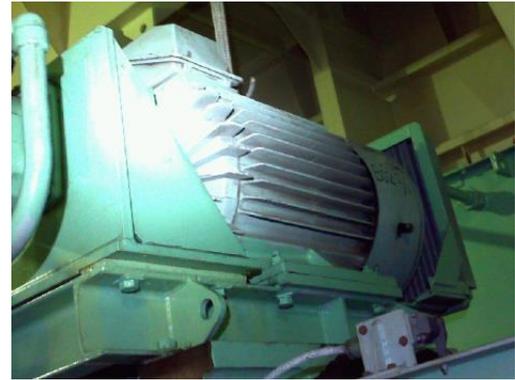
IR005293.IS2-No1 Steering gear

Name	Temperature	Emissivity
Centerpoint	42.1°C	0.95
Hot	47.1°C	0.95
Cold	32.5°C	0.95

We did not find any abnormality with respect to Thermal Imaging under this section. All the Mooring Hydraulic pumps were run under no load. Predictive findings are restricted under this section

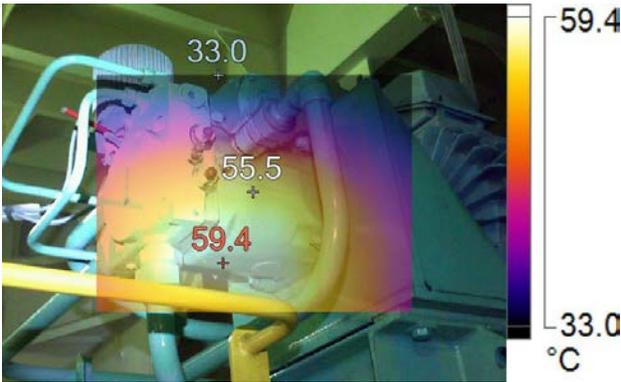
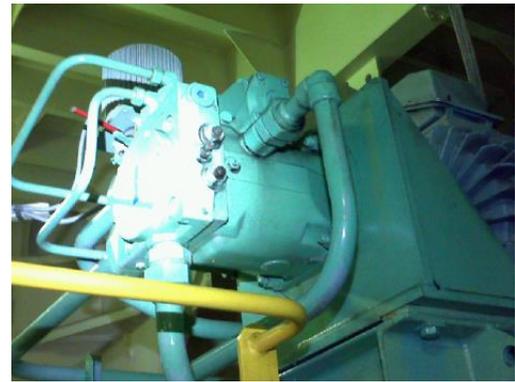
IR005294.IS2-No1 Steering gear

Name	Temperature	Emissivity
Centerpoint	55.5°C	0.95
Hot	59.4°C	0.95
Cold	33.0°C	0.95

We did not find any abnormality with respect to Thermal Imaging under this section. All the Mooring Hydraulic pumps were run under no load. Predictive findings are restricted under this section

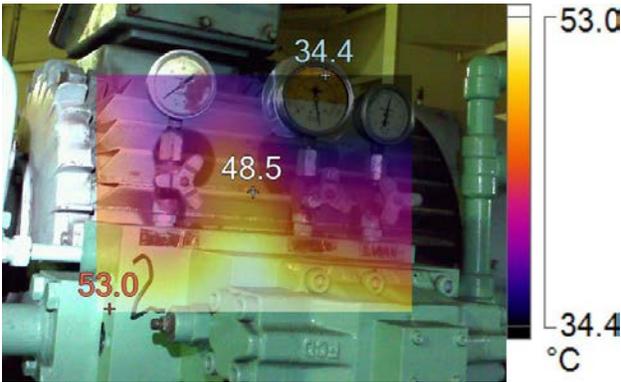
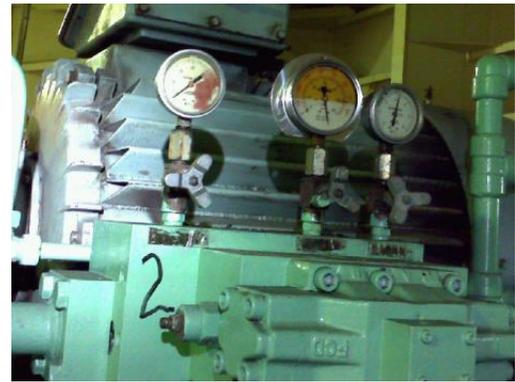
IR005295.IS2-No1 Steering gear

Name	Temperature	Emissivity
Centerpoint	48.5°C	0.95
Hot	53.0°C	0.95
Cold	34.4°C	0.95

We did not find any abnormality with respect to Thermal Imaging under this section. All the Mooring Hydraulic pumps were run under no load. Predictive findings are restricted under this section

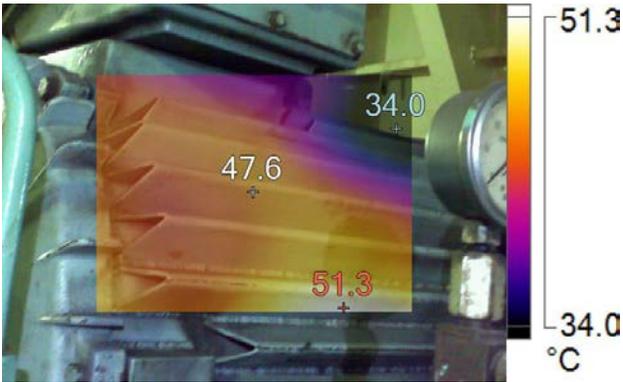
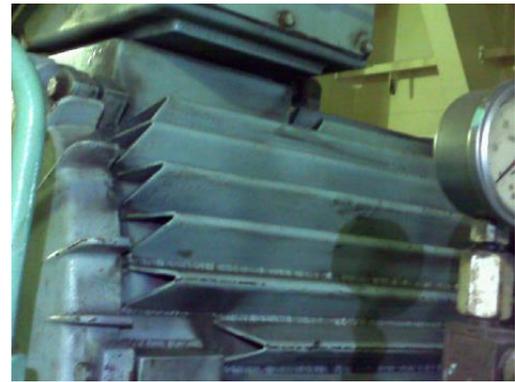
IR005296.IS2-No1 Steering gear

Name	Temperature	Emissivity
Centerpoint	47.6°C	0.95
Hot	51.3°C	0.95
Cold	34.0°C	0.95

We did not find any abnormality with respect to Thermal Imaging under this section. All the Mooring Hydraulic pumps were run under no load. Predictive findings are restricted under this section

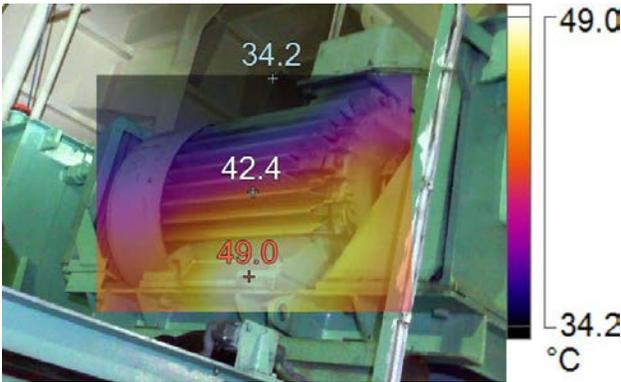
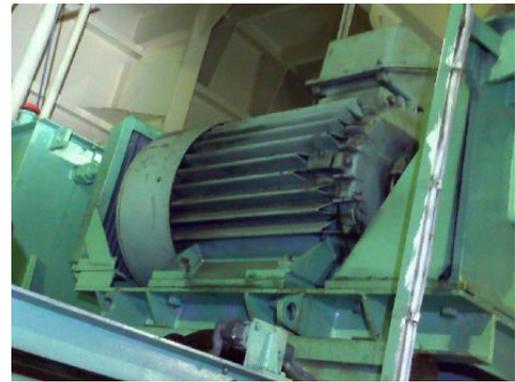
IR005297.IS2-No1 Steering gear

Name	Temperature	Emissivity
Centerpoint	42.4°C	0.95
Hot	49.0°C	0.95
Cold	34.2°C	0.95

We did not find any abnormality with respect to Thermal Imaging under this section. All the Mooring Hydraulic pumps were run under no load. Predictive findings are restricted under this section

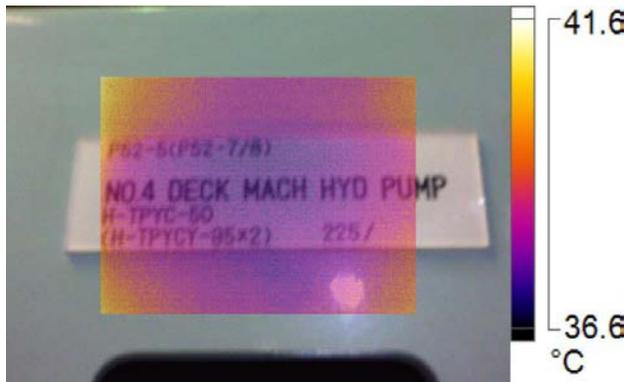
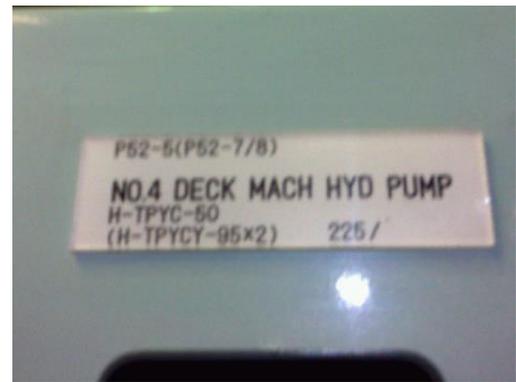
IR005298.IS2-No4 Deck Hyd Pump
12/3/2016 5:55:14 PM

We did not find any abnormality with respect to Thermal Imaging under this section. All the Mooring Hydraulic pumps were run under no load. Predictive findings are restricted under this section

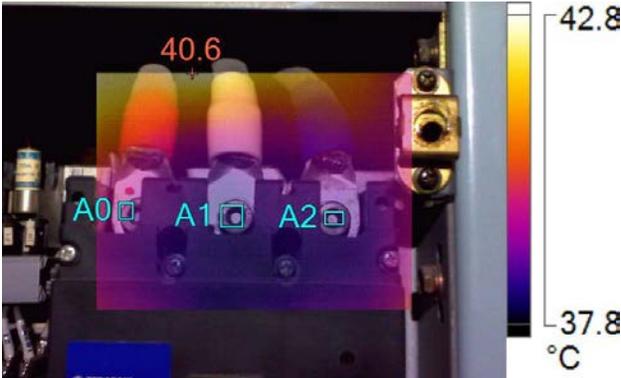
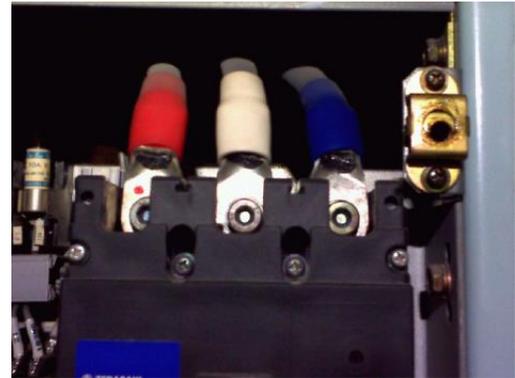
IR005299.IS2-No4 Deck Hyd Pump

Name	Avg	Min	Max	Emissivity
A0	38.5°C	38.4°C	38.7°C	0.95
A1	38.1°C	37.9°C	38.2°C	0.95
A2	38.2°C	38.1°C	38.4°C	0.95

Name	Temperature	Emissivity
Hot	40.6°C	0.95

We did not find any abnormality with respect to Thermal Imaging under this section. All the Mooring Hydraulic pumps were run under no load. Predictive findings are restricted under this section

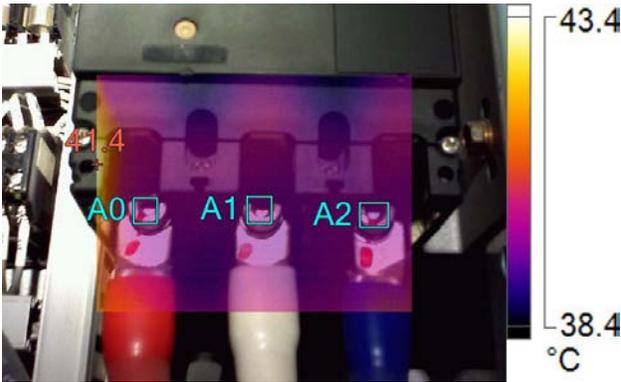
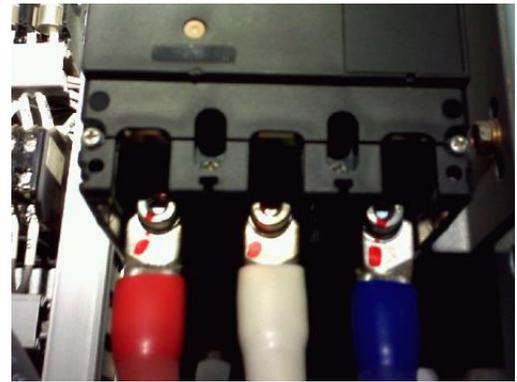
IR005300.IS2-No4 Deck Hyd Pump

Name	Avg	Min	Max	Emissivity
A0	39.4°C	39.2°C	39.6°C	0.95
A2	39.3°C	39.1°C	39.4°C	0.95
A1	39.2°C	39.0°C	39.3°C	0.95

Name	Temperature	Emissivity
Hot	41.4°C	0.95

We did not find any abnormality with respect to Thermal Imaging under this section. All the Mooring Hydraulic pumps were run under no load. Predictive findings are restricted under this section

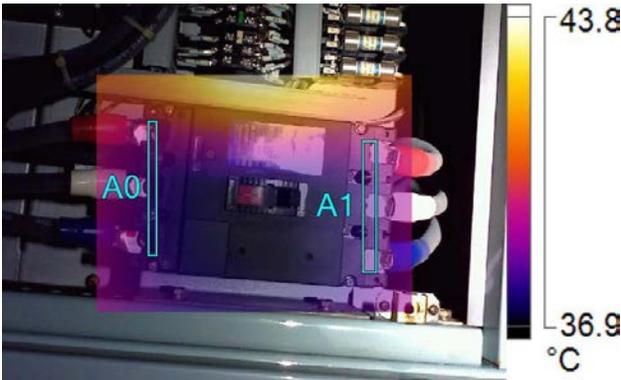
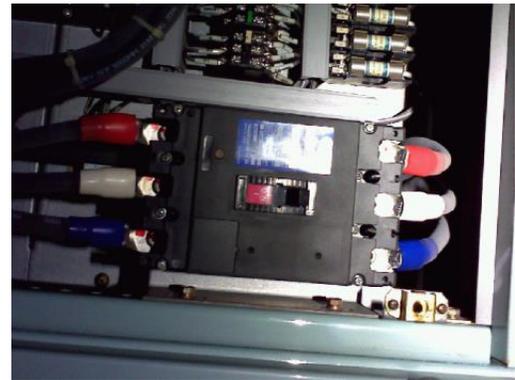
IR005301.IS2-No4 Deck Hyd Pump

Name	Avg	Min	Max	Emissivity
A0	38.4°C	37.8°C	40.0°C	0.95
A1	38.4°C	37.9°C	39.7°C	0.95

We did not find any abnormality with respect to Thermal Imaging under this section. All the Mooring Hydraulic pumps were run under no load. Predictive findings are restricted under this section

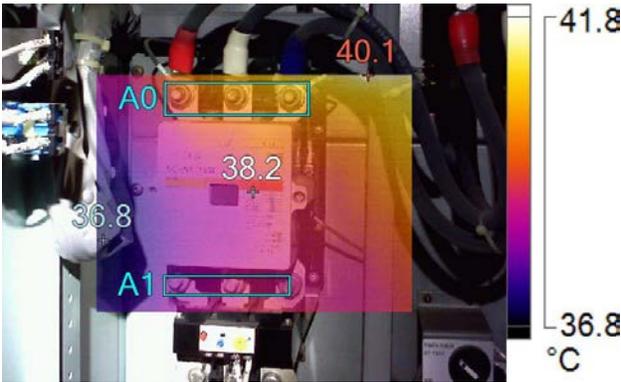
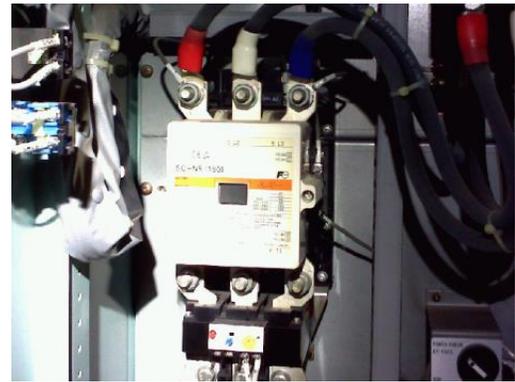
IR005302.IS2-No4 Deck Hyd Pump

Name	Avg	Min	Max	Emissivity
A0	38.9°C	38.1°C	39.6°C	0.95
A1	38.0°C	37.4°C	38.3°C	0.95

Name	Temperature	Emissivity
Centerpoint	38.2°C	0.95
Hot	40.1°C	0.95
Cold	36.8°C	0.95

We did not find any abnormality with respect to Thermal Imaging under this section. All the Mooring Hydraulic pumps were run under no load. Predictive findings are restricted under this section

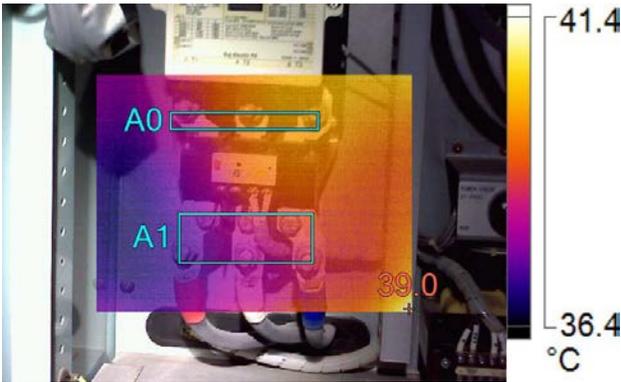
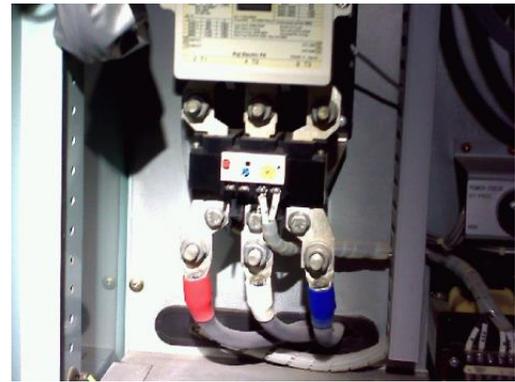
IR005303.IS2-No4 Deck Hyd Pump

Name	Avg	Min	Max	Emissivity
A0	37.9°C	37.1°C	38.5°C	0.95
A1	37.3°C	36.7°C	37.9°C	0.95

Name	Temperature	Emissivity
Hot	39.0°C	0.95

We did not find any abnormality with respect to Thermal Imaging under this section. All the Mooring Hydraulic pumps were run under no load. Predictive findings are restricted under this section

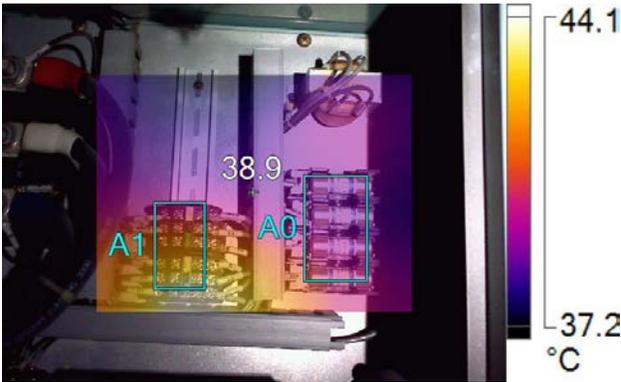
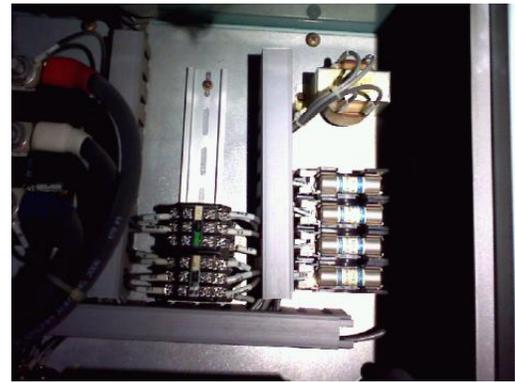
IR005305.IS2-No4 Deck Hyd Pump

Name	Avg	Min	Max	Emissivity
A0	39.2°C	38.6°C	40.7°C	0.95
A1	41.6°C	39.4°C	43.7°C	0.95

We did not find any abnormality with respect to Thermal Imaging under this section. All the Mooring Hydraulic pumps were run under no load. Predictive findings are restricted under this section

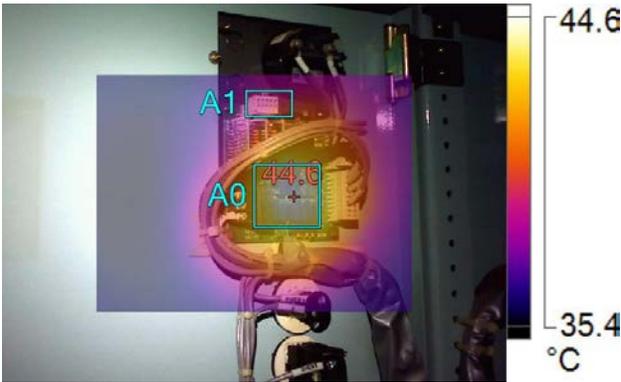
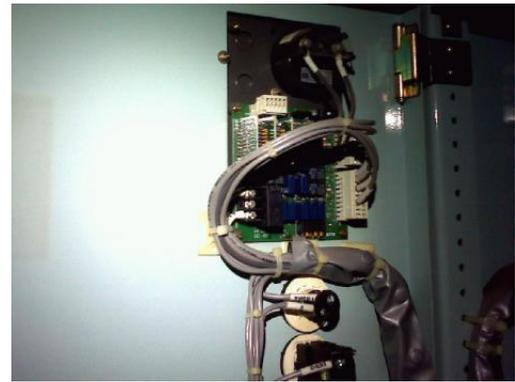
IR005306.IS2-No4 Deck Hyd Pump

Name	Avg	Min	Max	Emissivity
A0	43.7°C	42.0°C	44.6°C	0.95
A1	39.0°C	37.9°C	40.6°C	0.95

Name	Temperature	Emissivity
Hot	44.6°C	0.95

We did not find any abnormality with respect to Thermal Imaging under this section. All the Mooring Hydraulic pumps were run under no load. Predictive findings are restricted under this section

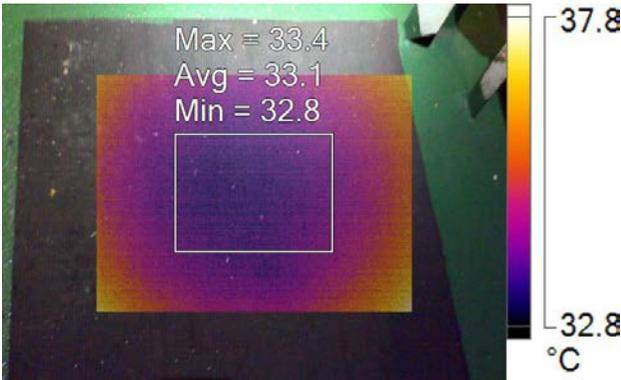
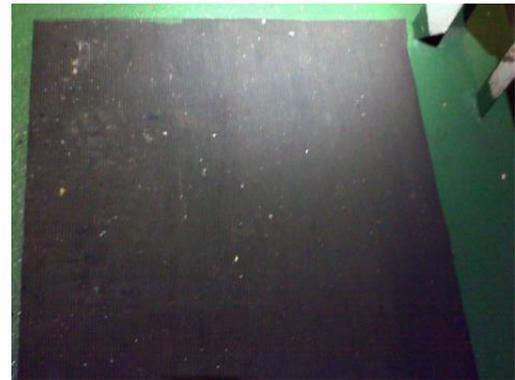
IR005307.IS2-Room Temperature
12/3/2016 5:56:59 PM

Name	Avg	Min	Max	Emissivity
Centerbox	33.1°C	32.8°C	33.4°C	0.95

We did not find any abnormality with respect to Thermal Imaging under this section. All the Mooring Hydraulic pumps were run under no load. Predictive findings are restricted under this section

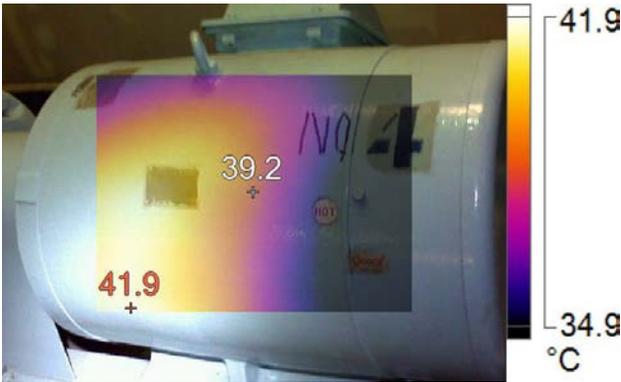
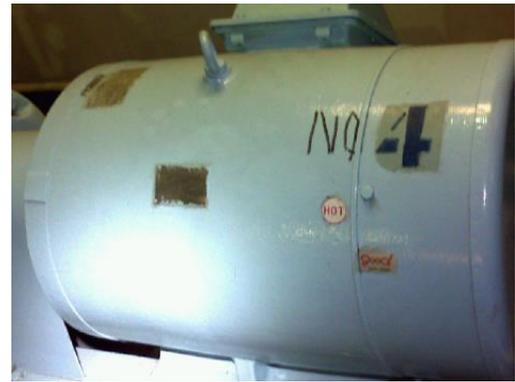
IR005308.IS2-No4 Deck Hyd Pump

Name	Temperature	Emissivity
Centerpoint	39.2°C	0.95
Hot	41.9°C	0.95

We did not find any abnormality with respect to Thermal Imaging under this section. All the Mooring Hydraulic pumps were run under no load. Predictive findings are restricted under this section

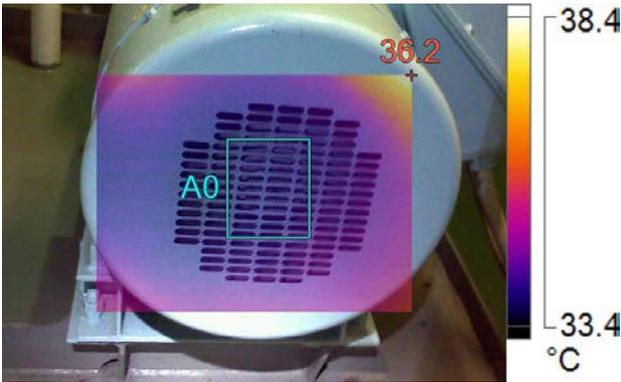
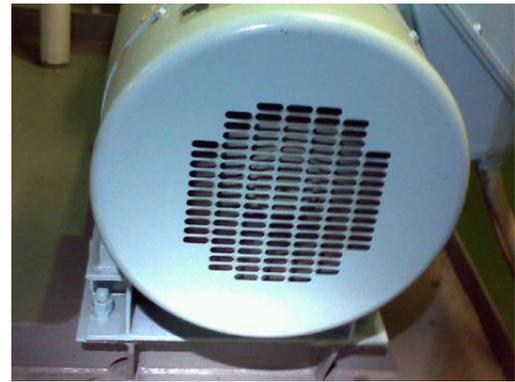
IR005309.IS2-No4 Deck Hyd Pump

Name	Avg	Min	Max	Emissivity
A0	33.7°C	33.4°C	34.1°C	0.95

Name	Temperature	Emissivity
Hot	36.2°C	0.95

We did not find any abnormality with respect to Thermal Imaging under this section. All the Mooring Hydraulic pumps were run under no load. Predictive findings are restricted under this section

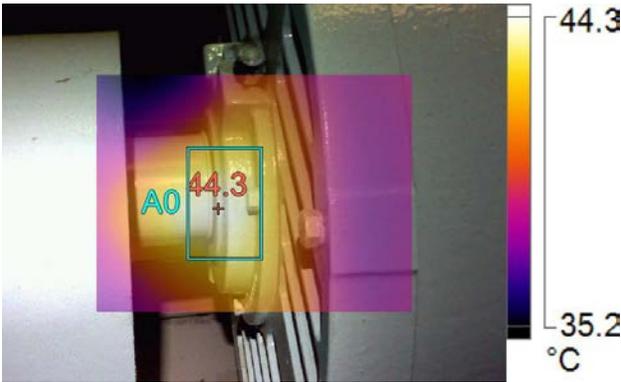
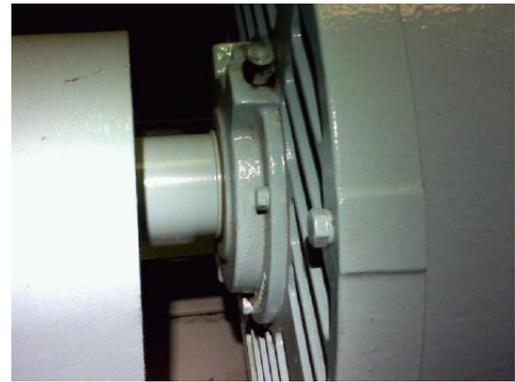
IR005310.IS2-No4 Deck Hyd Pump

Name	Avg	Min	Max	Emissivity
A0	43.3°C	40.9°C	44.3°C	0.95

Name	Temperature	Emissivity
Hot	44.3°C	0.95

We did not find any abnormality with respect to Thermal Imaging under this section. All the Mooring Hydraulic pumps were run under no load. Predictive findings are restricted under this section

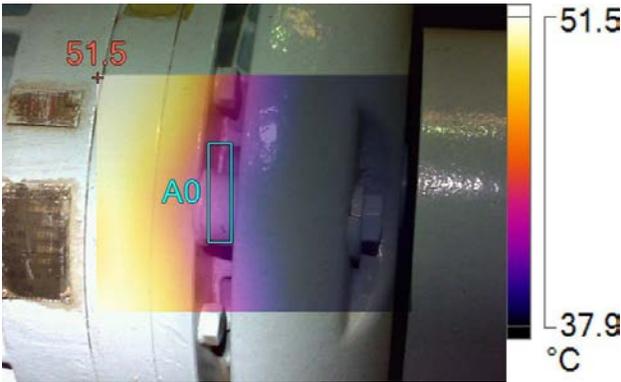
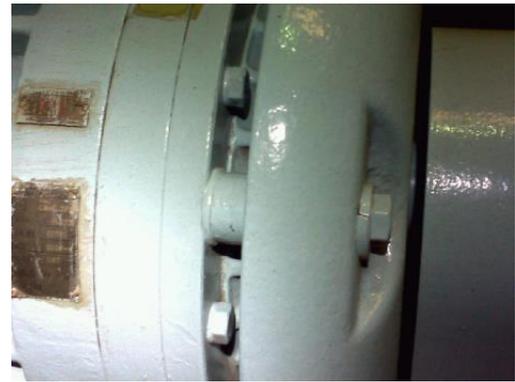
IR005311.IS2-No4 Deck Hyd Pump

Name	Avg	Min	Max	Emissivity
A0	43.4°C	41.7°C	46.0°C	0.95

Name	Temperature	Emissivity
Hot	51.5°C	0.95

We did not find any abnormality with respect to Thermal Imaging under this section. All the Mooring Hydraulic pumps were run under no load. Predictive findings are restricted under this section

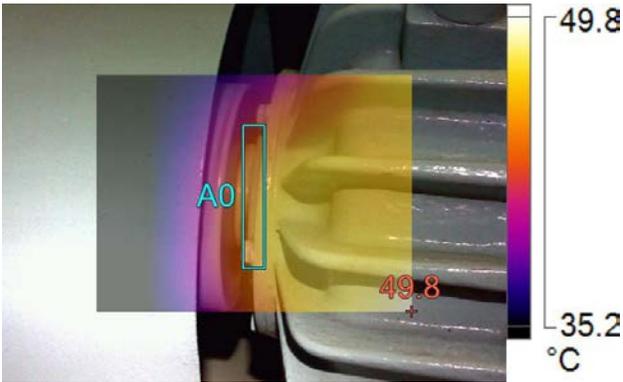
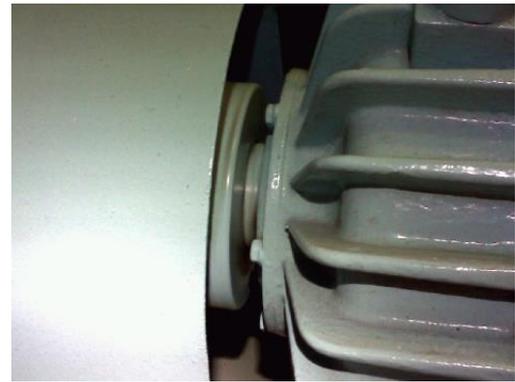
IR005312.IS2-No4 Deck Hyd Pump

Name	Avg	Min	Max	Emissivity
A0	46.7°C	43.5°C	48.2°C	0.95

Name	Temperature	Emissivity
Hot	49.8°C	0.95

We did not find any abnormality with respect to Thermal Imaging under this section. All the Mooring Hydraulic pumps were run under no load. Predictive findings are restricted under this section
