SVL SINGAPORE SERVICES

M.T.-----

Thermal Imaging

Steering, Deck Hyd & Emergency Fire pump

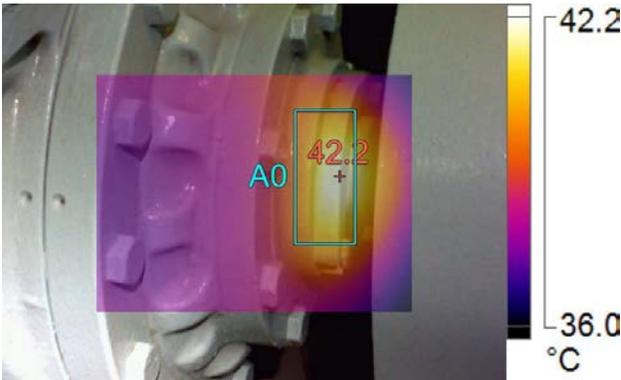
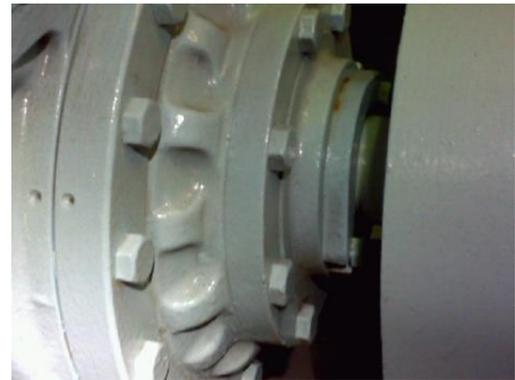
IR005313.IS2-No4 Deck Hyd Pump

Name	Avg	Min	Max	Emissivity
A0	40.9°C	39.2°C	42.2°C	0.95

Name	Temperature	Emissivity
Hot	42.2°C	0.95

We did not find any abnormality with respect to Thermal Imaging under this section. All the Mooring Hydraulic pumps were run under no load. Predictive findings are restricted under this section

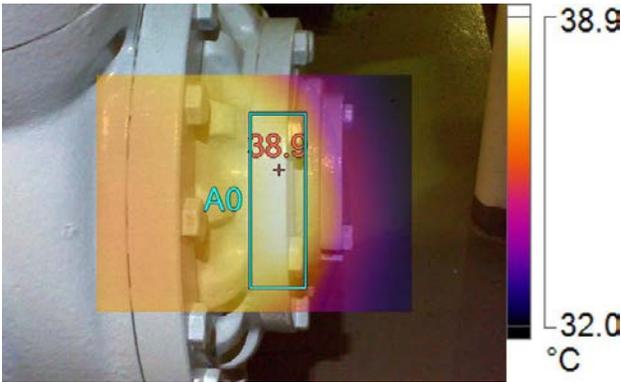
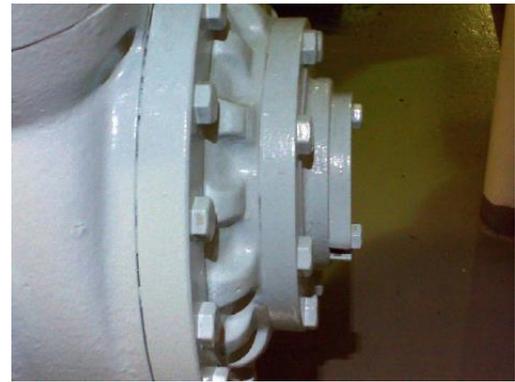
IR005314.IS2-No4 Deck Hyd Pump

Name	Avg	Min	Max	Emissivity
A0	38.4°C	37.0°C	38.9°C	0.95

Name	Temperature	Emissivity
Hot	38.9°C	0.95

We did not find any abnormality with respect to Thermal Imaging under this section. All the Mooring Hydraulic pumps were run under no load. Predictive findings are restricted under this section

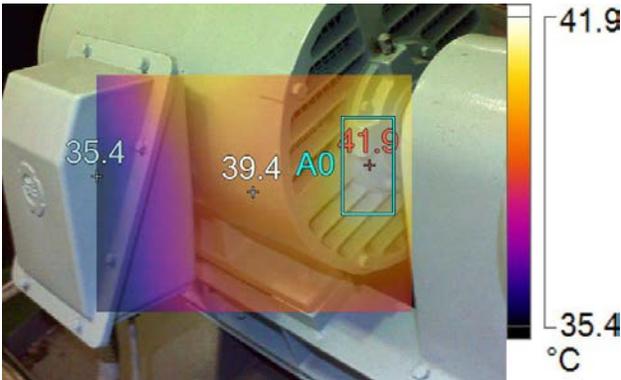
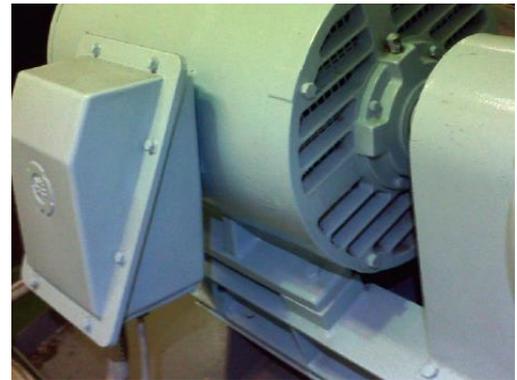
IR005315.IS2-No4 Deck Hyd Pump

Name	Avg	Min	Max	Emissivity
A0	41.5°C	40.5°C	41.9°C	0.95

Name	Temperature	Emissivity
Centerpoint	39.4°C	0.95
Hot	41.9°C	0.95
Cold	35.4°C	0.95

We did not find any abnormality with respect to Thermal Imaging under this section. All the Mooring Hydraulic pumps were run under no load. Predictive findings are restricted under this section

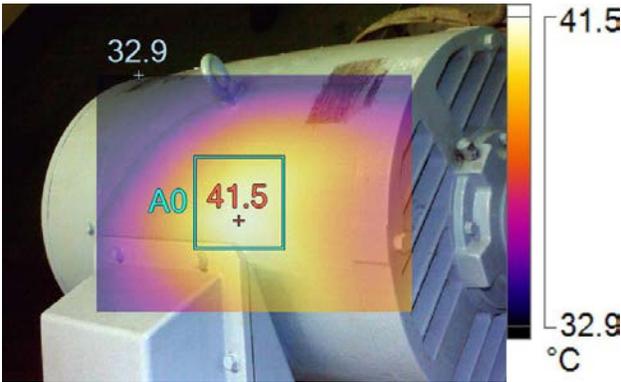
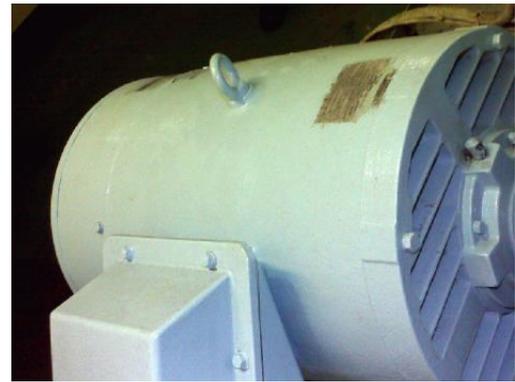
IR005316.IS2-No4 Deck Hyd Pump

Name	Avg	Min	Max	Emissivity
A0	40.7°C	38.5°C	41.5°C	0.95

Name	Temperature	Emissivity
Hot	41.5°C	0.95
Cold	32.9°C	0.95

We did not find any abnormality with respect to Thermal Imaging under this section. All the Mooring Hydraulic pumps were run under no load. Predictive findings are restricted under this section

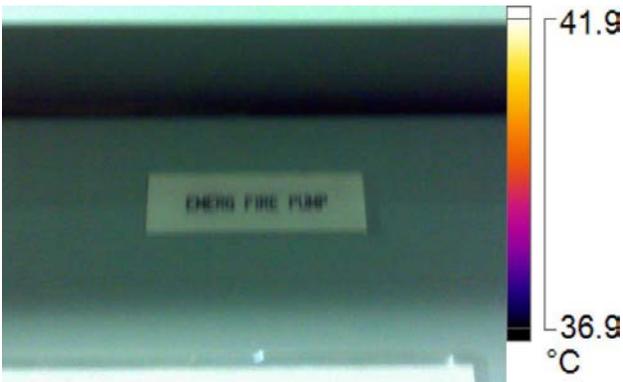
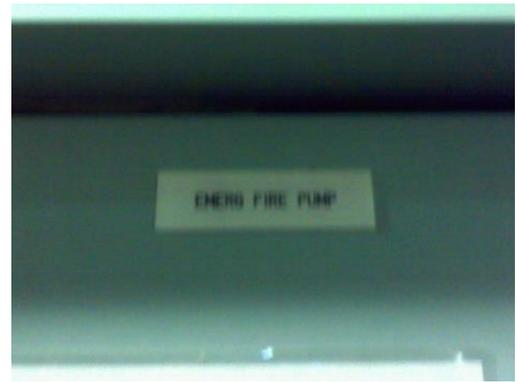
IR005317.IS2-Emergency Fire pump
12/3/2016 7:01:50 PM

We did not find any abnormality with respect to Thermal Imaging under this section. All the Mooring Hydraulic pumps were run under no load. Predictive findings are restricted under this section

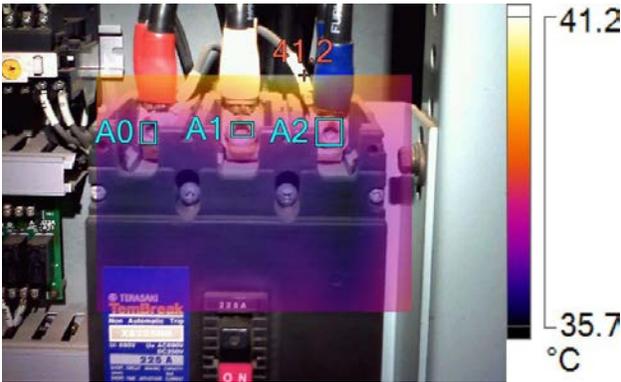
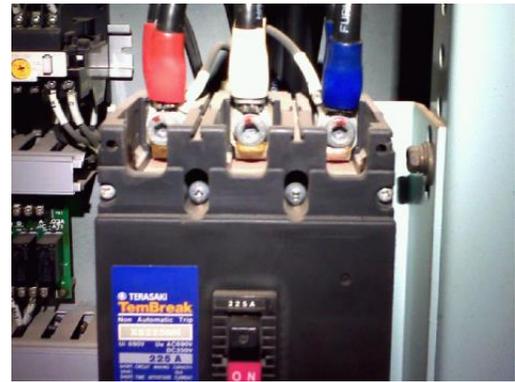
IR005318.IS2-Emergency Fire pump

Name	Avg	Min	Max	Emissivity
A0	37.3°C	36.9°C	37.7°C	0.95
A1	38.0°C	37.6°C	38.3°C	0.95
A2	37.6°C	37.2°C	38.3°C	0.95

Name	Temperature	Emissivity
Hot	41.2°C	0.95

We did not find any abnormality with respect to Thermal Imaging under this section. All the Mooring Hydraulic pumps were run under no load. Predictive findings are restricted under this section

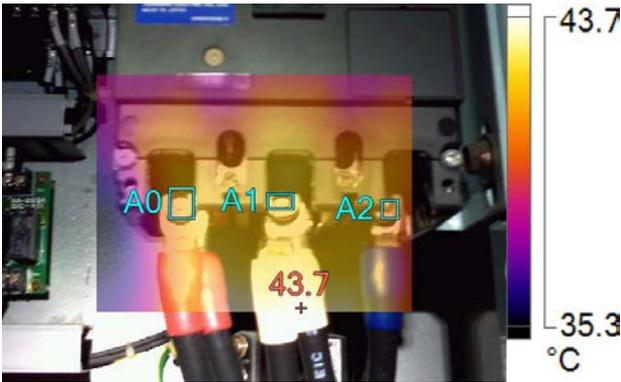
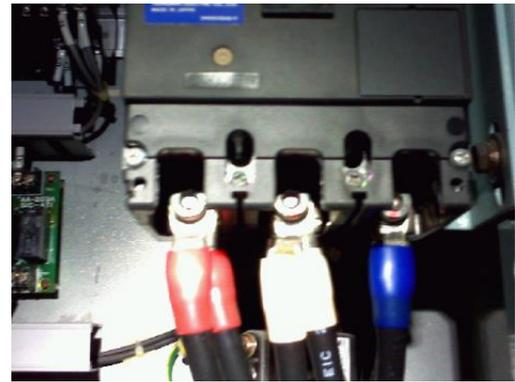
IR005319.IS2-Emergency Fire pump

Name	Avg	Min	Max	Emissivity
A0	41.3°C	40.4°C	41.8°C	0.95
A1	41.9°C	41.7°C	42.1°C	0.95
A2	40.8°C	40.3°C	41.4°C	0.95

Name	Temperature	Emissivity
Hot	43.7°C	0.95

We did not find any abnormality with respect to Thermal Imaging under this section. All the Mooring Hydraulic pumps were run under no load. Predictive findings are restricted under this section

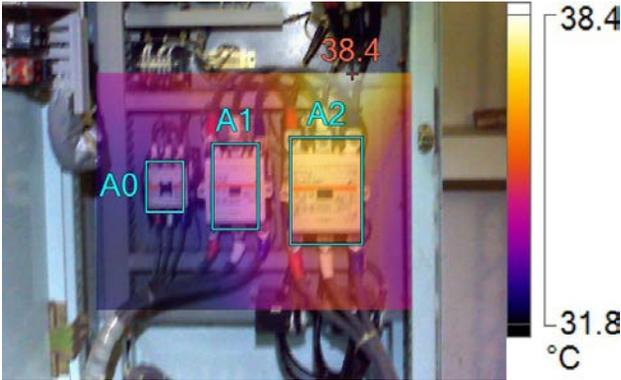
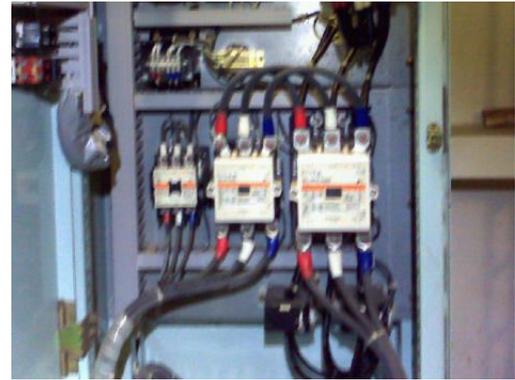
IR005320.IS2-Emergency Fire pump

Name	Avg	Min	Max	Emissivity
A0	33.2°C	32.5°C	34.2°C	0.95
A1	34.7°C	33.2°C	36.2°C	0.95
A2	36.8°C	35.6°C	37.6°C	0.95

Name	Temperature	Emissivity
Hot	38.4°C	0.95

We did not find any abnormality with respect to Thermal Imaging under this section. All the Mooring Hydraulic pumps were run under no load. Predictive findings are restricted under this section

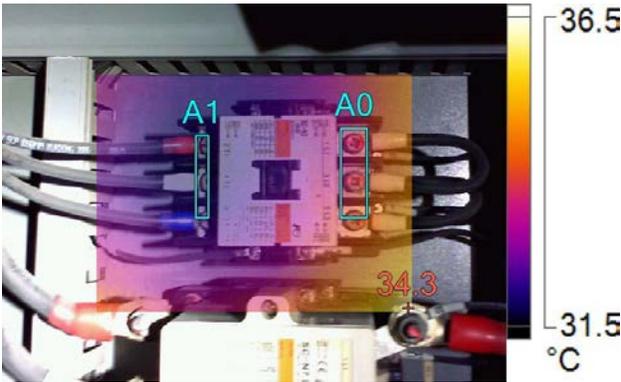
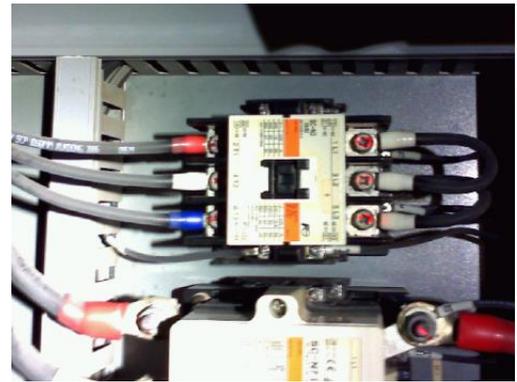
IR005321.IS2-Emergency Fire pump

Name	Avg	Min	Max	Emissivity
A0	32.8°C	32.4°C	33.2°C	0.95
A1	31.8°C	31.5°C	32.1°C	0.95

Name	Temperature	Emissivity
Hot	34.3°C	0.95

We did not find any abnormality with respect to Thermal Imaging under this section. All the Mooring Hydraulic pumps were run under no load. Predictive findings are restricted under this section

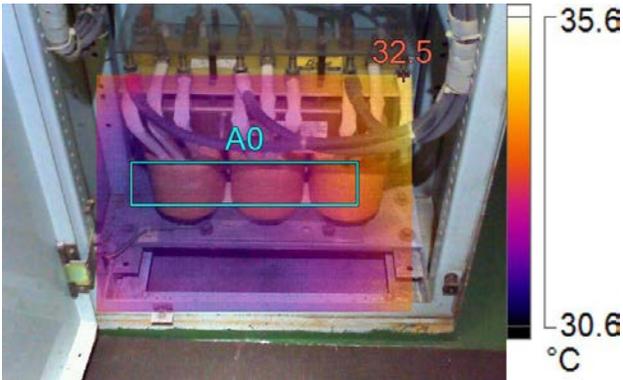
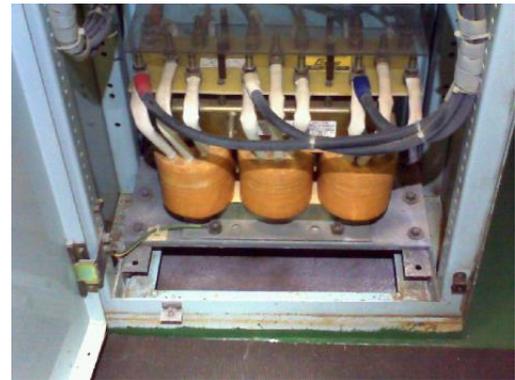
IR005322.IS2-Emergency Fire pump

Name	Avg	Min	Max	Emissivity
A0	31.1°C	30.6°C	31.8°C	0.95

Name	Temperature	Emissivity
Hot	32.5°C	0.95

We did not find any abnormality with respect to Thermal Imaging under this section. All the Mooring Hydraulic pumps were run under no load. Predictive findings are restricted under this section

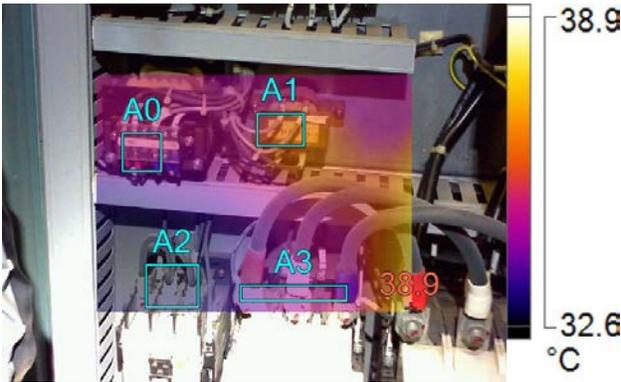
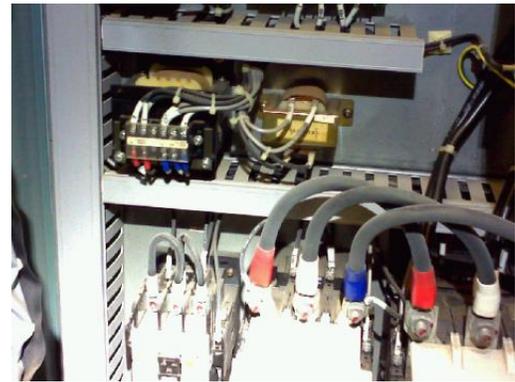
IR005323.IS2-Emergency Fire pump

Name	Avg	Min	Max	Emissivity
A0	35.2°C	34.3°C	36.0°C	0.95
A1	36.6°C	35.9°C	37.1°C	0.95
A2	32.9°C	32.6°C	33.4°C	0.95
A3	34.9°C	33.8°C	35.9°C	0.95

Name	Temperature	Emissivity
Hot	38.9°C	0.95

We did not find any abnormality with respect to Thermal Imaging under this section. All the Mooring Hydraulic pumps were run under no load. Predictive findings are restricted under this section

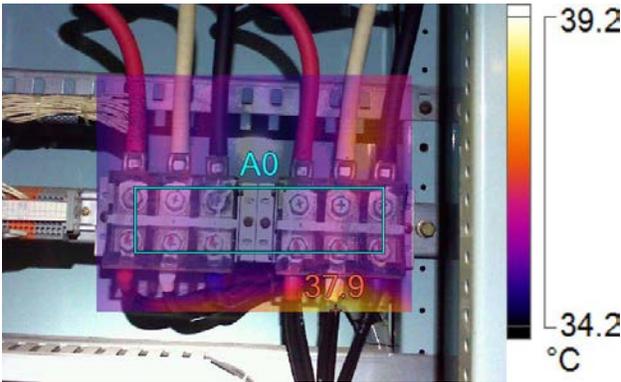
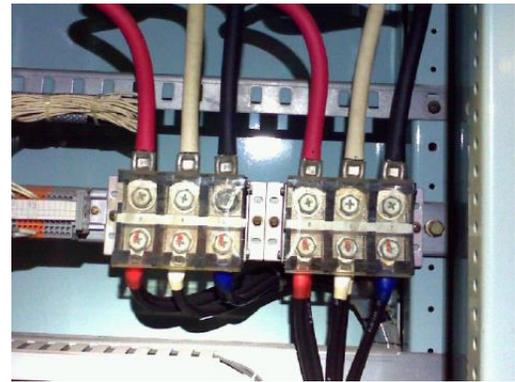
IR005325.IS2-Emergency Fire pump

Name	Avg	Min	Max	Emissivity
A0	35.2°C	34.3°C	36.5°C	0.95

Name	Temperature	Emissivity
Hot	37.9°C	0.95

We did not find any abnormality with respect to Thermal Imaging under this section. All the Mooring Hydraulic pumps were run under no load. Predictive findings are restricted under this section

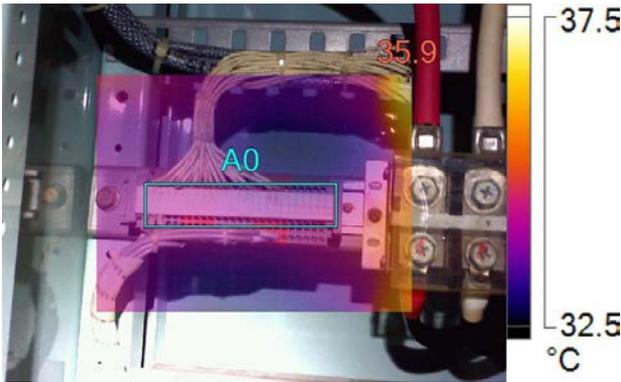
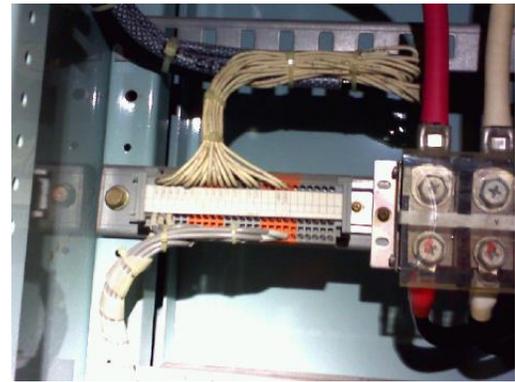
IR005326.IS2-Emergency Fire pump

Name	Avg	Min	Max	Emissivity
A0	33.5°C	32.9°C	33.9°C	0.95

Name	Temperature	Emissivity
Hot	35.9°C	0.95

We did not find any abnormality with respect to Thermal Imaging under this section. All the Mooring Hydraulic pumps were run under no load. Predictive findings are restricted under this section

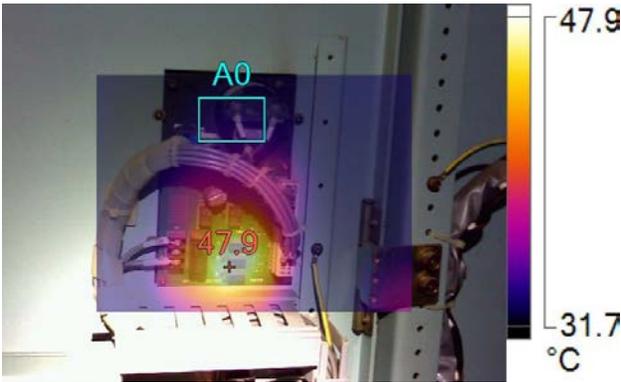
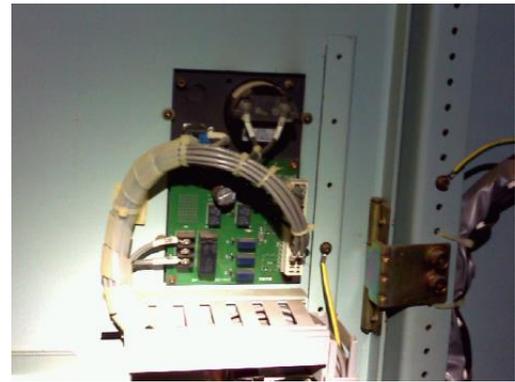
IR005327.IS2-Emergency Fire pump

Name	Avg	Min	Max	Emissivity
A0	33.2°C	32.2°C	34.2°C	0.95

Name	Temperature	Emissivity
Hot	47.9°C	0.95

We did not find any abnormality with respect to Thermal Imaging under this section. All the Mooring Hydraulic pumps were run under no load. Predictive findings are restricted under this section

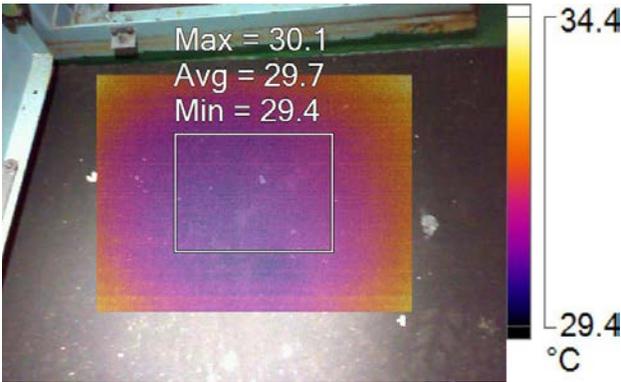
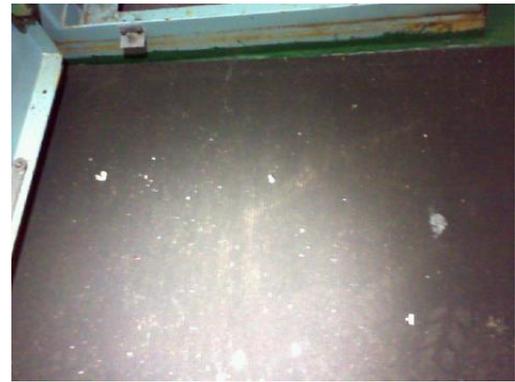
IR005328.IS2-Room temperature
12/3/2016 7:07:58 PM

Name	Avg	Min	Max	Emissivity
Centerbox	29.7°C	29.4°C	30.1°C	0.95

We did not find any abnormality with respect to Thermal Imaging under this section. All the Mooring Hydraulic pumps were run under no load. Predictive findings are restricted under this section

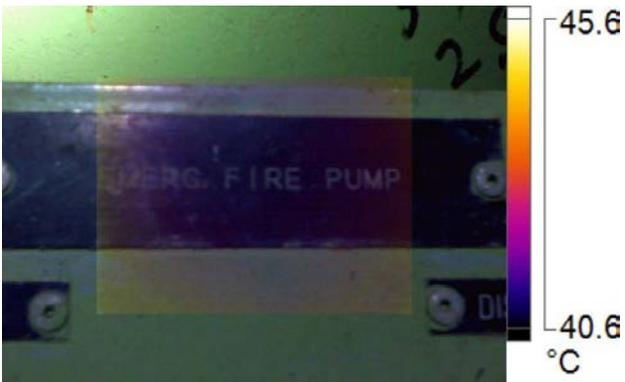
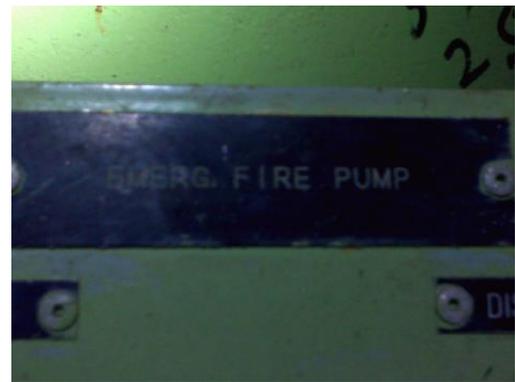
IR005329.IS2-Emergency fire Pump
12/3/2016 7:36:42 PM

We did not find any abnormality with respect to Thermal Imaging under this section. All the Mooring Hydraulic pumps were run under no load. Predictive findings are restricted under this section

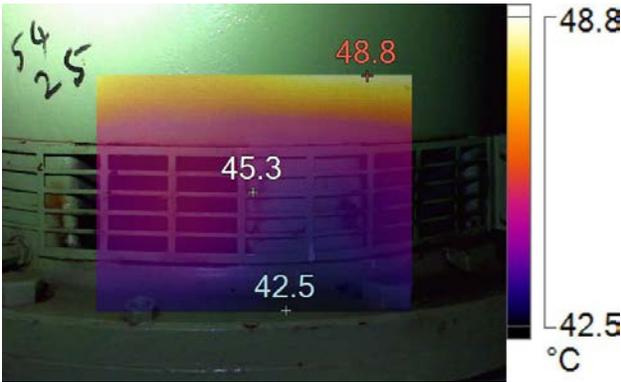
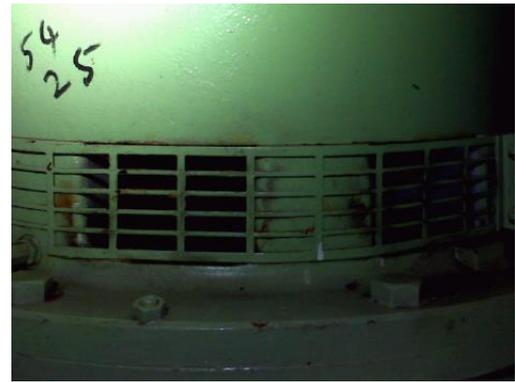
IR005330.IS2-Emergency fire Pump
12/3/2016 7:36:57 PM

Name	Temperature	Emissivity
Centerpoint	45.3°C	0.95
Hot	48.8°C	0.95
Cold	42.5°C	0.95

We did not find any abnormality with respect to Thermal Imaging under this section. All the Mooring Hydraulic pumps were run under no load. Predictive findings are restricted under this section

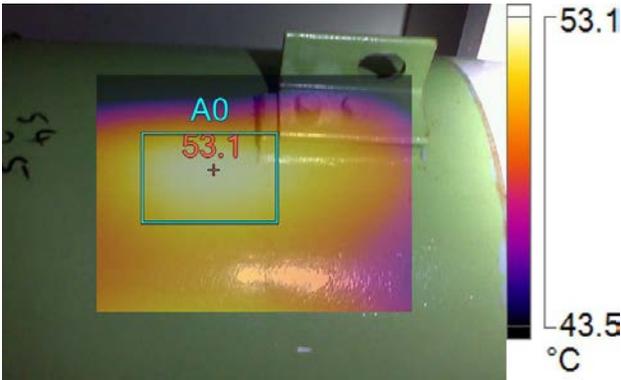
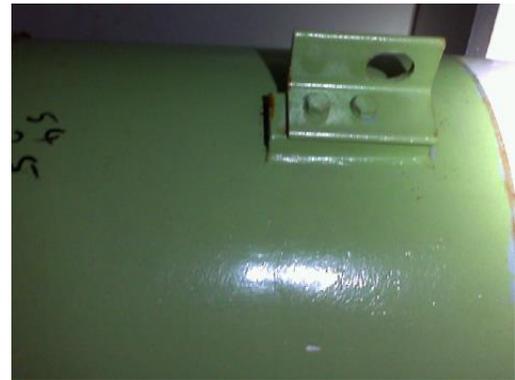
IR005331.IS2-Emergency fire Pump
12/3/2016 7:37:16 PM

Name	Avg	Min	Max	Emissivity
A0	52.4°C	50.9°C	53.1°C	0.95

Name	Temperature	Emissivity
Hot	53.1°C	0.95

We did not find any abnormality with respect to Thermal Imaging under this section. All the Mooring Hydraulic pumps were run under no load. Predictive findings are restricted under this section

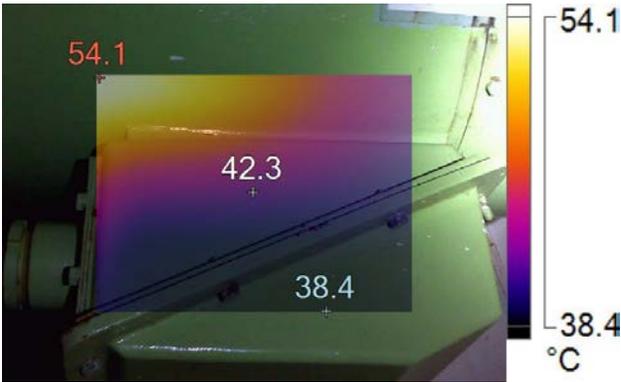
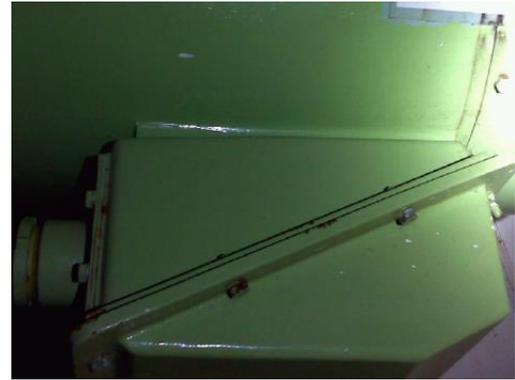
IR005332.IS2-Emergency fire Pump
12/3/2016 7:37:33 PM

Name	Temperature	Emissivity
Centerpoint	42.3°C	0.95
Hot	54.1°C	0.95
Cold	38.4°C	0.95

We did not find any abnormality with respect to Thermal Imaging under this section. All the Mooring Hydraulic pumps were run under no load. Predictive findings are restricted under this section

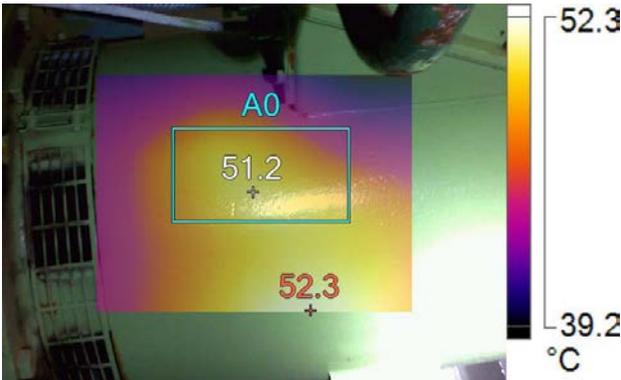
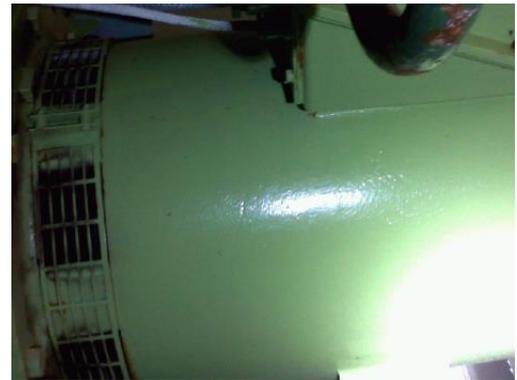
IR005333.IS2-Emergency fire Pump
12/3/2016 7:37:53 PM

Name	Avg	Min	Max	Emissivity
A0	49.8°C	44.7°C	51.3°C	0.95

Name	Temperature	Emissivity
Centerpoint	51.2°C	0.95
Hot	52.3°C	0.95

We did not find any abnormality with respect to Thermal Imaging under this section. All the Mooring Hydraulic pumps were run under no load. Predictive findings are restricted under this section

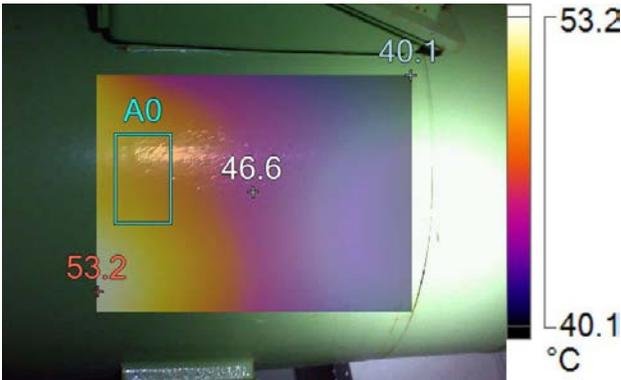
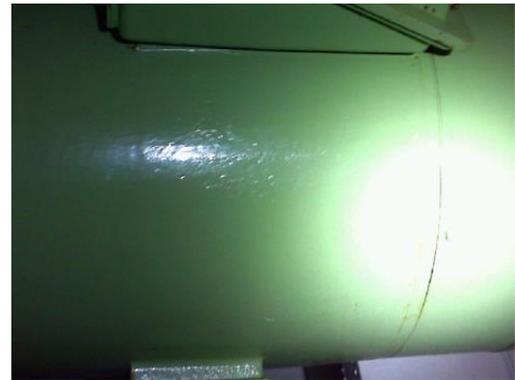
IR005334.IS2-Emergency fire Pump
12/3/2016 7:38:01 PM

Name	Avg	Min	Max	Emissivity
A0	50.5°C	49.3°C	51.8°C	0.95

Name	Temperature	Emissivity
Centerpoint	46.6°C	0.95
Hot	53.2°C	0.95
Cold	40.1°C	0.95

We did not find any abnormality with respect to Thermal Imaging under this section. All the Mooring Hydraulic pumps were run under no load. Predictive findings are restricted under this section

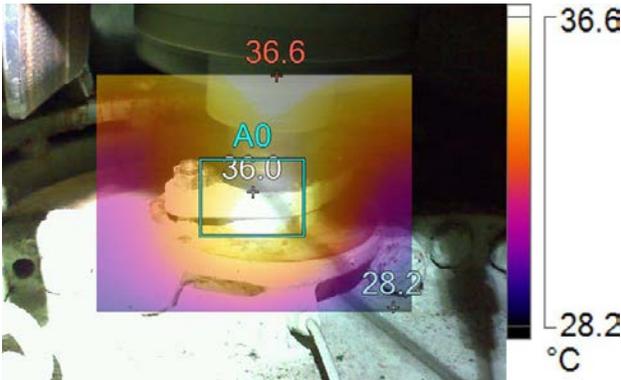
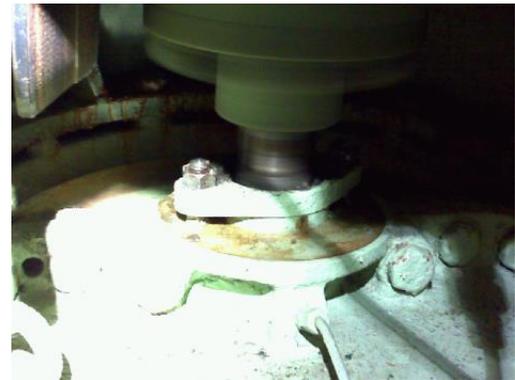
IR005335.IS2-Emergency fire Pump
12/3/2016 7:38:22 PM

Name	Avg	Min	Max	Emissivity
A0	35.6°C	34.0°C	36.5°C	0.95

Name	Temperature	Emissivity
Centerpoint	36.0°C	0.95
Hot	36.6°C	0.95
Cold	28.2°C	0.95

We did not find any abnormality with respect to Thermal Imaging under this section. All the Mooring Hydraulic pumps were run under no load. Predictive findings are restricted under this section

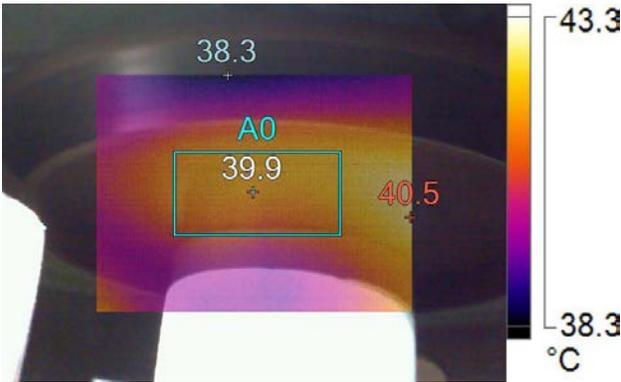
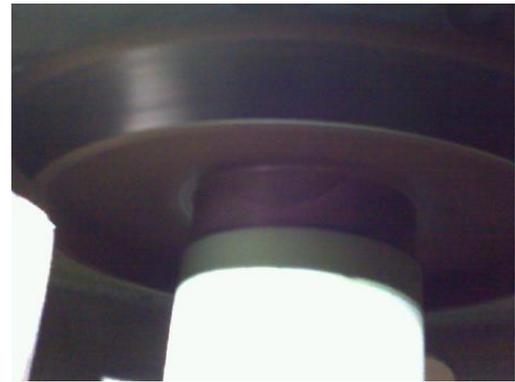
IR005336.IS2-Emergency fire Pump
12/3/2016 7:38:45 PM

Name	Avg	Min	Max	Emissivity
A0	39.8°C	39.2°C	40.3°C	0.95

Name	Temperature	Emissivity
Centerpoint	39.9°C	0.95
Hot	40.5°C	0.95
Cold	38.3°C	0.95

We did not find any abnormality with respect to Thermal Imaging under this section. All the Mooring Hydraulic pumps were run under no load. Predictive findings are restricted under this section

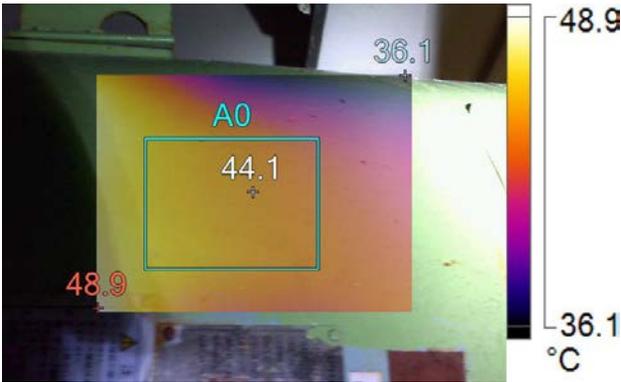
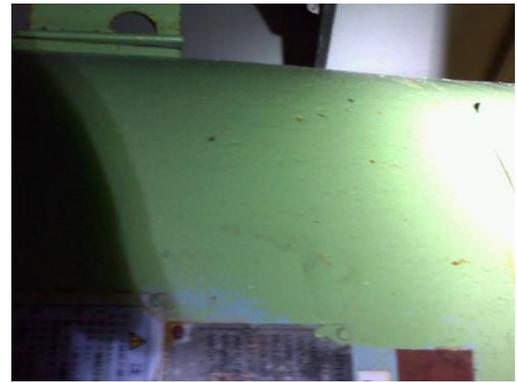
IR005337.IS2-Emergency fire Pump
12/3/2016 7:39:07 PM

Name	Avg	Min	Max	Emissivity
A0	44.7°C	41.7°C	47.1°C	0.95

Name	Temperature	Emissivity
Centerpoint	44.1°C	0.95
Hot	48.9°C	0.95
Cold	36.1°C	0.95

We did not find any abnormality with respect to Thermal Imaging under this section. All the Mooring Hydraulic pumps were run under no load. Predictive findings are restricted under this section

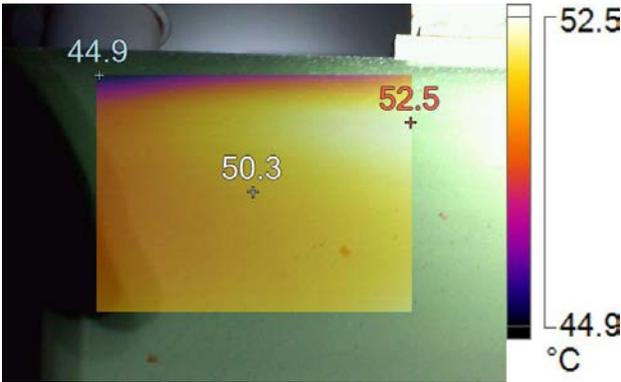
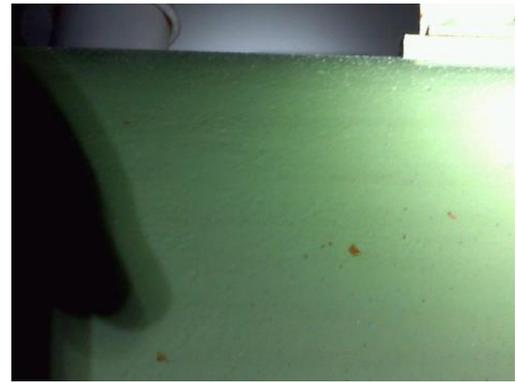
IR005338.IS2-Emergency fire Pump
12/3/2016 7:39:14 PM

Name	Temperature	Emissivity
Centerpoint	50.3°C	0.95
Hot	52.5°C	0.95
Cold	44.9°C	0.95

We did not find any abnormality with respect to Thermal Imaging under this section. All the Mooring Hydraulic pumps were run under no load. Predictive findings are restricted under this section

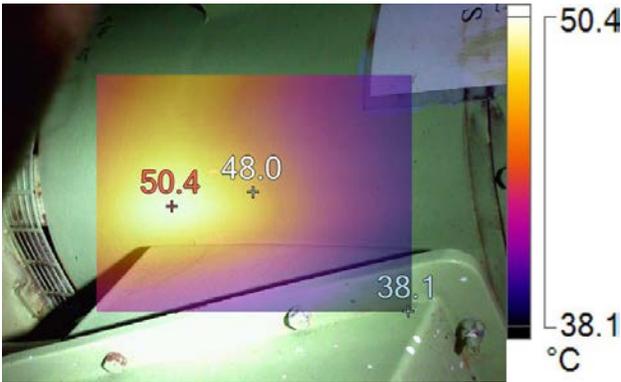
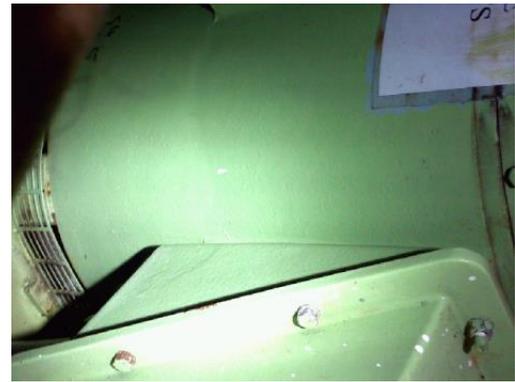
IR005339.IS2-Emergency fire Pump
12/3/2016 7:40:28 PM

Name	Temperature	Emissivity
Centerpoint	48.0°C	0.95
Hot	50.4°C	0.95
Cold	38.1°C	0.95

We did not find any abnormality with respect to Thermal Imaging under this section. All the Mooring Hydraulic pumps were run under no load. Predictive findings are restricted under this section

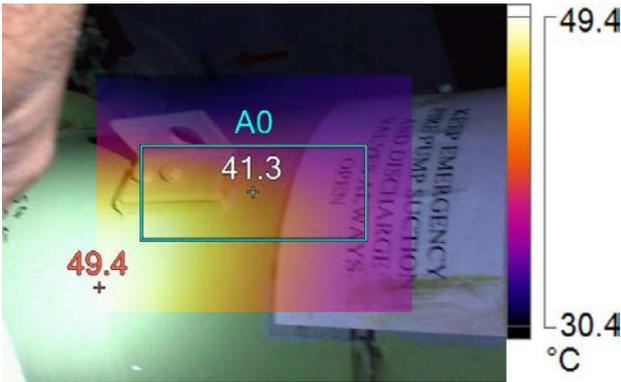
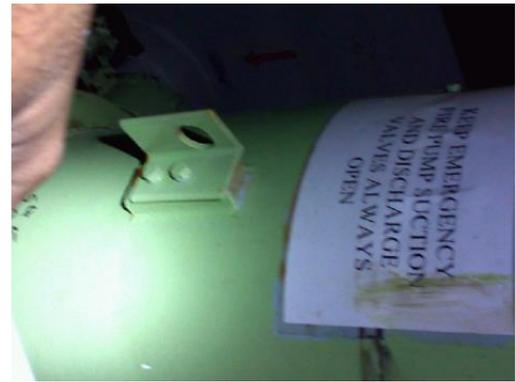
IR005340.IS2-Emergency fire Pump
12/3/2016 7:40:37 PM

Name	Avg	Min	Max	Emissivity
A0	40.7°C	35.7°C	48.2°C	0.95

Name	Temperature	Emissivity
Centerpoint	41.3°C	0.95
Hot	49.4°C	0.95

We did not find any abnormality with respect to Thermal Imaging under this section. All the Mooring Hydraulic pumps were run under no load. Predictive findings are restricted under this section

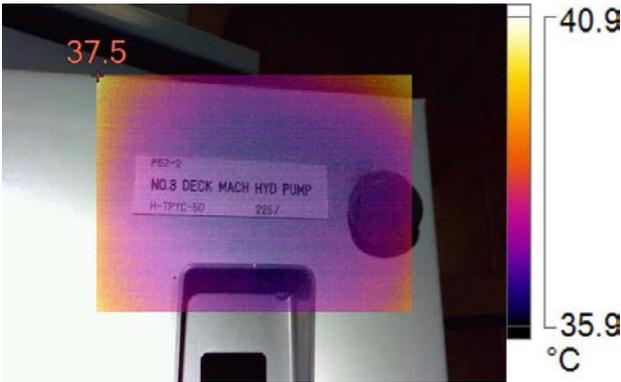
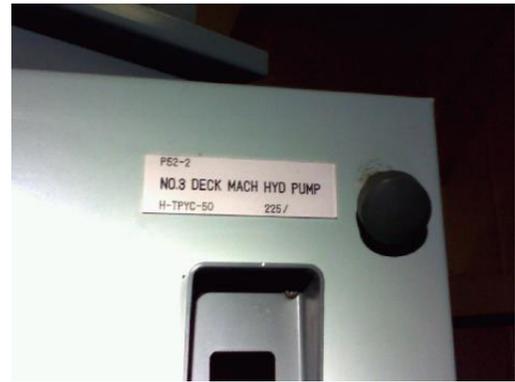
IR005341.IS2-No3 Deck Hydraulic Pump
12/3/2016 8:02:30 PM

Name	Temperature	Emissivity
Hot	37.5°C	0.95

We did not find any abnormality with respect to Thermal Imaging under this section. All the Mooring Hydraulic pumps were run under no load. Predictive findings are restricted under this section

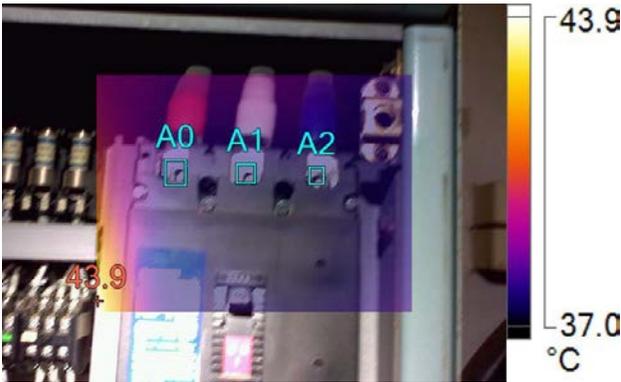
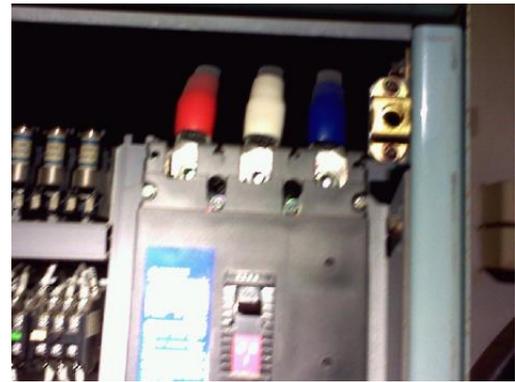
IR005342.IS2-No3 Deck Hydraulic Pump
12/3/2016 8:02:55 PM

Name	Avg	Min	Max	Emissivity
A0	37.8°C	37.4°C	38.1°C	0.95
A1	37.5°C	37.4°C	37.8°C	0.95
A2	37.5°C	37.4°C	37.8°C	0.95

Name	Temperature	Emissivity
Hot	43.9°C	0.95

We did not find any abnormality with respect to Thermal Imaging under this section. All the Mooring Hydraulic pumps were run under no load. Predictive findings are restricted under this section

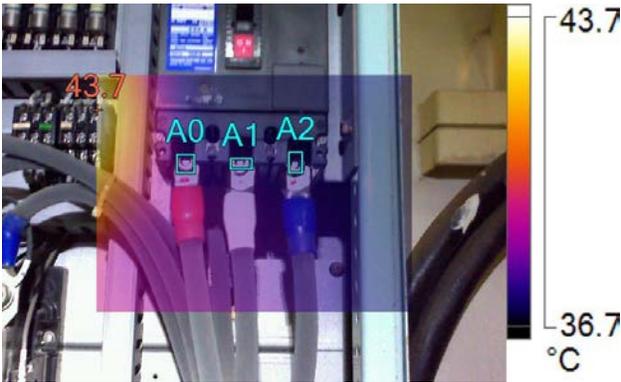
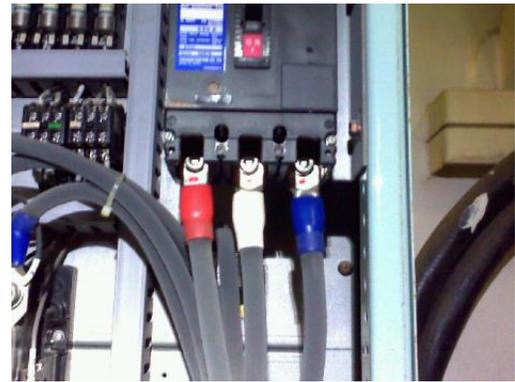
IR005343.IS2-No3 Deck Hydraulic Pump
12/3/2016 8:03:05 PM

Name	Avg	Min	Max	Emissivity
A0	38.0°C	37.7°C	38.3°C	0.95
A1	37.6°C	37.4°C	37.8°C	0.95
A2	37.4°C	37.1°C	37.6°C	0.95

Name	Temperature	Emissivity
Hot	43.7°C	0.95

We did not find any abnormality with respect to Thermal Imaging under this section. All the Mooring Hydraulic pumps were run under no load. Predictive findings are restricted under this section

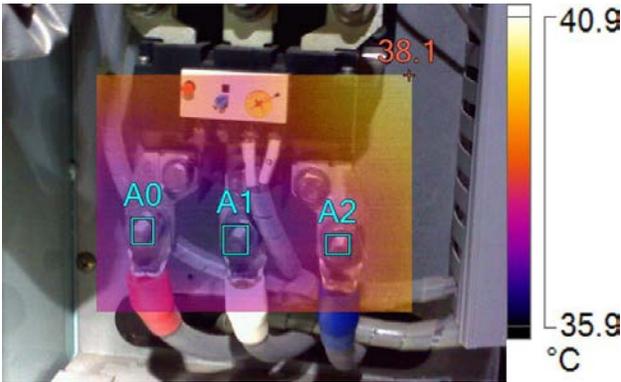
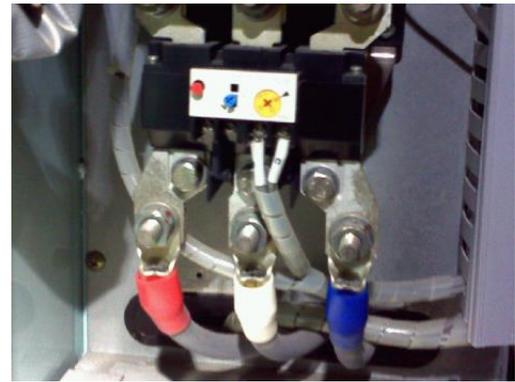
IR005345.IS2-No3 Deck Hydraulic Pump
12/3/2016 8:03:24 PM

Name	Avg	Min	Max	Emissivity
A0	36.3°C	36.2°C	36.5°C	0.95
A1	36.2°C	36.0°C	36.4°C	0.95
A2	36.8°C	36.6°C	37.0°C	0.95

Name	Temperature	Emissivity
Hot	38.1°C	0.95

We did not find any abnormality with respect to Thermal Imaging under this section. All the Mooring Hydraulic pumps were run under no load. Predictive findings are restricted under this section

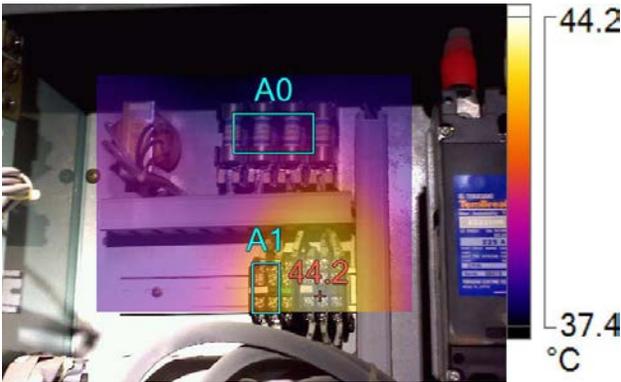
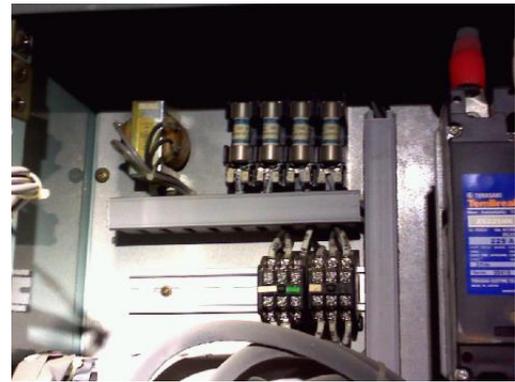
IR005346.IS2-No3 Deck Hydraulic Pump
12/3/2016 8:03:30 PM

Name	Avg	Min	Max	Emissivity
A0	38.9°C	38.0°C	39.9°C	0.95
A1	42.2°C	41.2°C	43.0°C	0.95

Name	Temperature	Emissivity
Hot	44.2°C	0.95

We did not find any abnormality with respect to Thermal Imaging under this section. All the Mooring Hydraulic pumps were run under no load. Predictive findings are restricted under this section

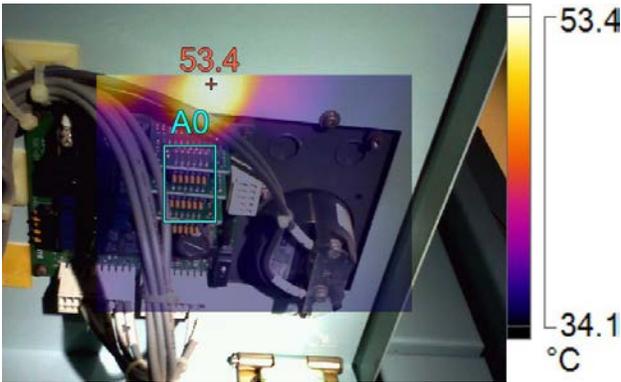
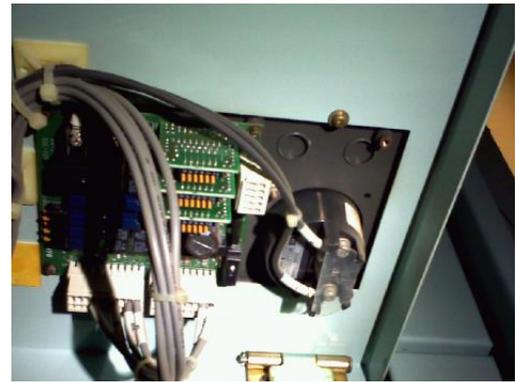
IR005347.IS2-No3 Deck Hydraulic Pump
12/3/2016 8:03:48 PM

Name	Avg	Min	Max	Emissivity
A0	36.2°C	34.9°C	39.2°C	0.95

Name	Temperature	Emissivity
Hot	53.4°C	0.95

We did not find any abnormality with respect to Thermal Imaging under this section. All the Mooring Hydraulic pumps were run under no load. Predictive findings are restricted under this section

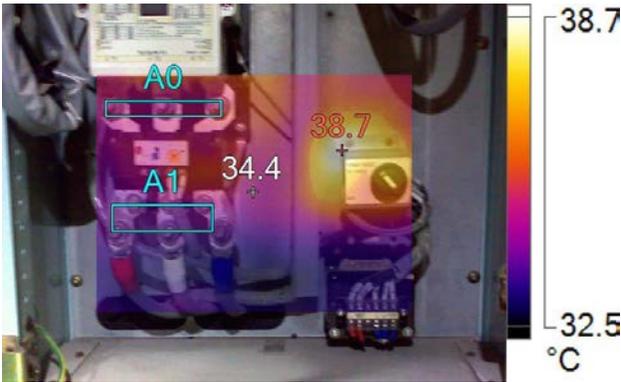
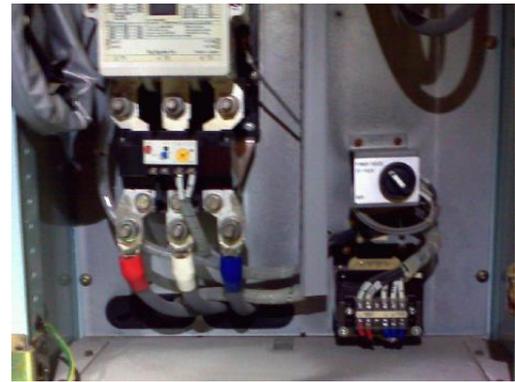
IR005348.IS2-No3 Deck Hydraulic Pump
12/3/2016 8:04:02 PM

Name	Avg	Min	Max	Emissivity
A0	34.4°C	34.1°C	34.9°C	0.95
A1	33.6°C	33.3°C	34.2°C	0.95

Name	Temperature	Emissivity
Centerpoint	34.4°C	0.95
Hot	38.7°C	0.95

We did not find any abnormality with respect to Thermal Imaging under this section. All the Mooring Hydraulic pumps were run under no load. Predictive findings are restricted under this section

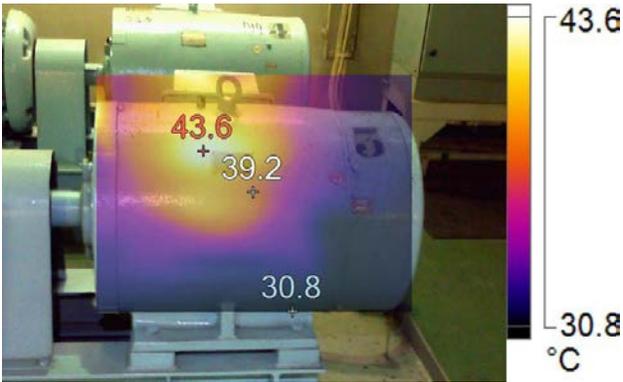
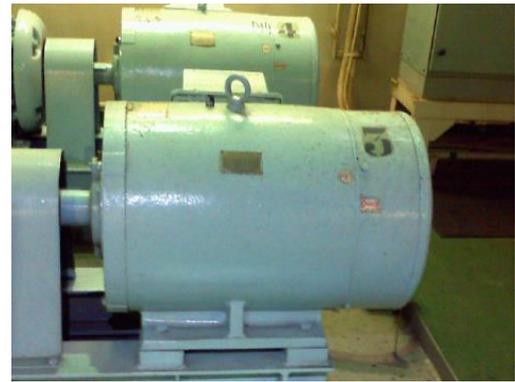
IR005350.IS2-No3 Deck Hydraulic Pump
12/3/2016 8:04:31 PM

Name	Temperature	Emissivity
Centerpoint	39.2°C	0.95
Hot	43.6°C	0.95
Cold	30.8°C	0.95

We did not find any abnormality with respect to Thermal Imaging under this section. All the Mooring Hydraulic pumps were run under no load. Predictive findings are restricted under this section

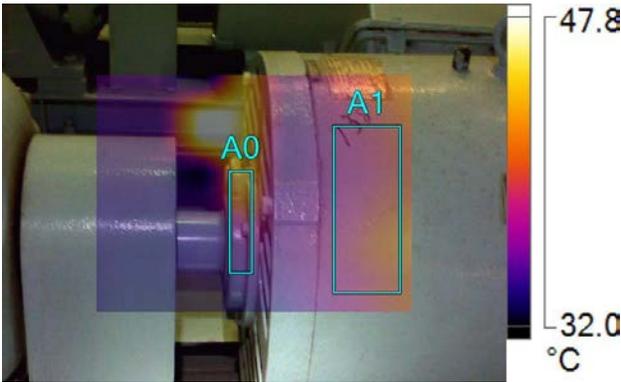
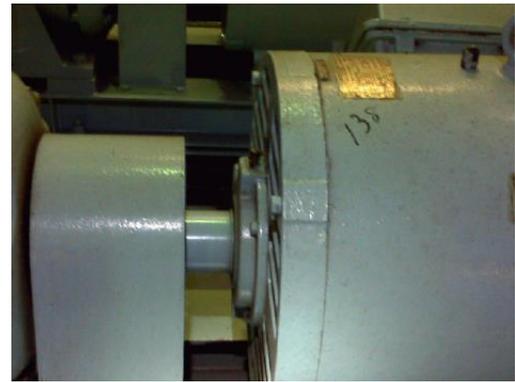
IR005351.IS2-No3 Deck Hydraulic Pump
12/3/2016 8:04:39 PM

Name	Avg	Min	Max	Emissivity
A0	38.9°C	34.9°C	44.0°C	0.95
A1	39.3°C	37.3°C	42.1°C	0.95

We did not find any abnormality with respect to Thermal Imaging under this section. All the Mooring Hydraulic pumps were run under no load. Predictive findings are restricted under this section

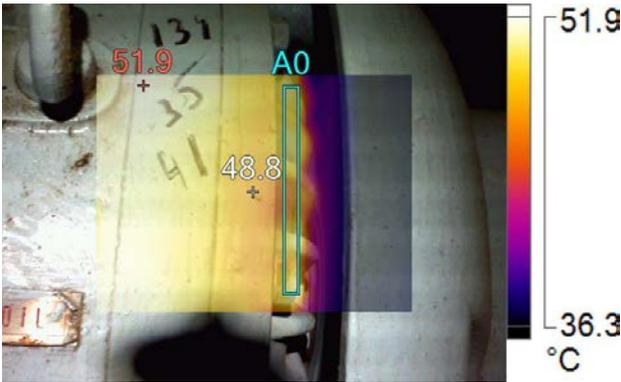
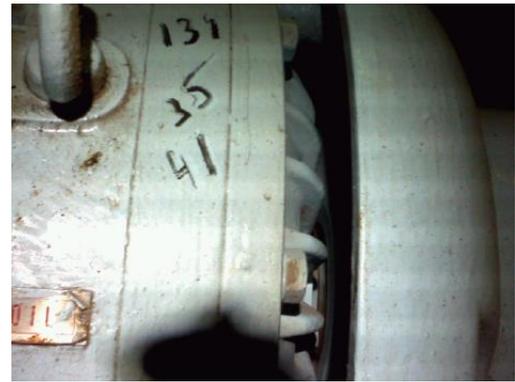
IR005352.IS2-No3 Deck Hydraulic Pump
12/3/2016 8:05:31 PM

Name	Avg	Min	Max	Emissivity
A0	49.8°C	47.5°C	51.6°C	0.95

Name	Temperature	Emissivity
Centerpoint	48.8°C	0.95
Hot	51.9°C	0.95

We did not find any abnormality with respect to Thermal Imaging under this section. All the Mooring Hydraulic pumps were run under no load. Predictive findings are restricted under this section

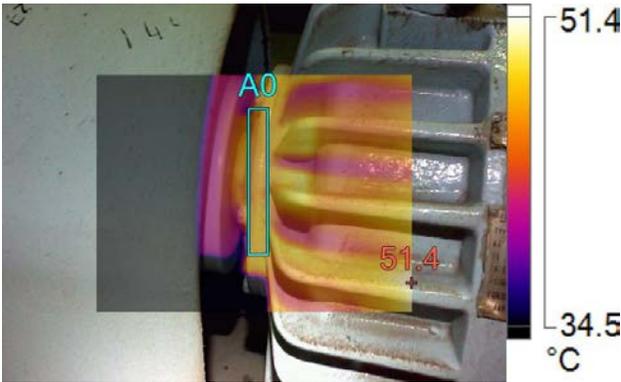
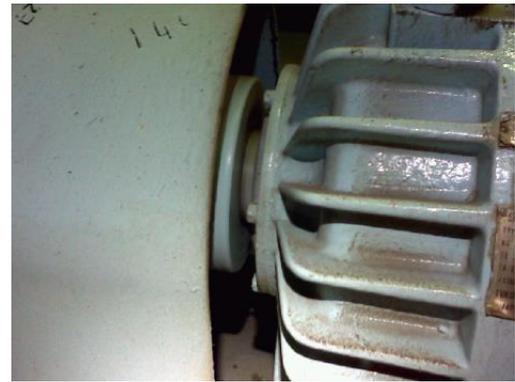
IR005353.IS2-No3 Deck Hydraulic Pump
12/3/2016 8:05:38 PM

Name	Avg	Min	Max	Emissivity
A0	48.7°C	43.9°C	49.6°C	0.95

Name	Temperature	Emissivity
Hot	51.4°C	0.95

We did not find any abnormality with respect to Thermal Imaging under this section. All the Mooring Hydraulic pumps were run under no load. Predictive findings are restricted under this section

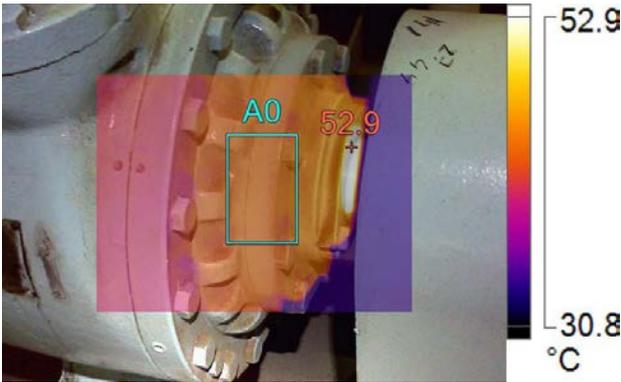
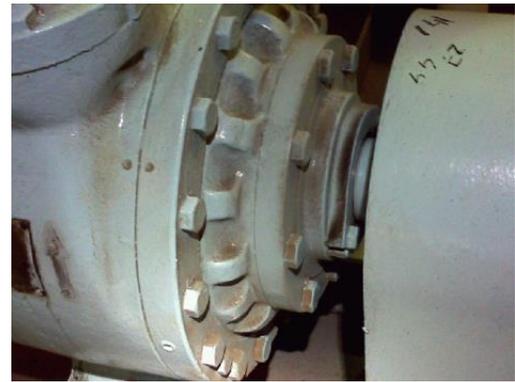
IR005354.IS2-No3 Deck Hydraulic Pump
12/3/2016 8:06:00 PM

Name	Avg	Min	Max	Emissivity
A0	41.4°C	40.3°C	42.4°C	0.95

Name	Temperature	Emissivity
Hot	52.9°C	0.95

We did not find any abnormality with respect to Thermal Imaging under this section. All the Mooring Hydraulic pumps were run under no load. Predictive findings are restricted under this section

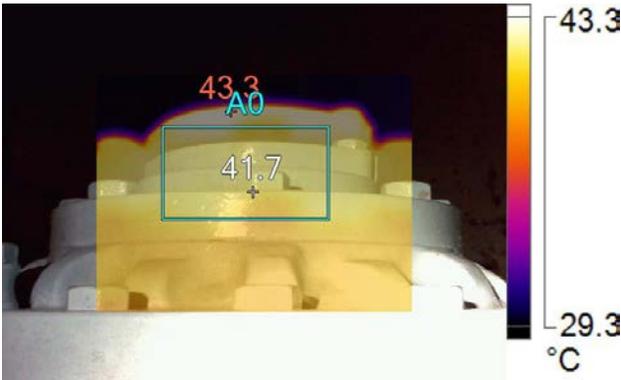
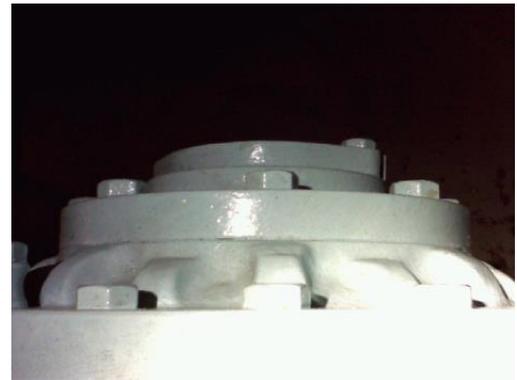
IR005355.IS2-No3 Deck Hydraulic Pump
12/3/2016 8:06:12 PM

Name	Avg	Min	Max	Emissivity
A0	42.0°C	40.3°C	43.0°C	0.95

Name	Temperature	Emissivity
Centerpoint	41.7°C	0.95
Hot	43.3°C	0.95

We did not find any abnormality with respect to Thermal Imaging under this section. All the Mooring Hydraulic pumps were run under no load. Predictive findings are restricted under this section

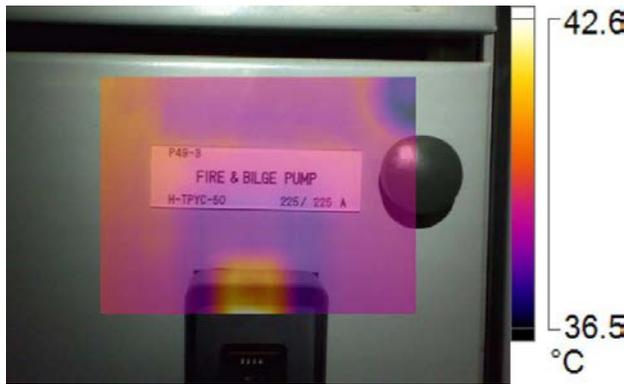
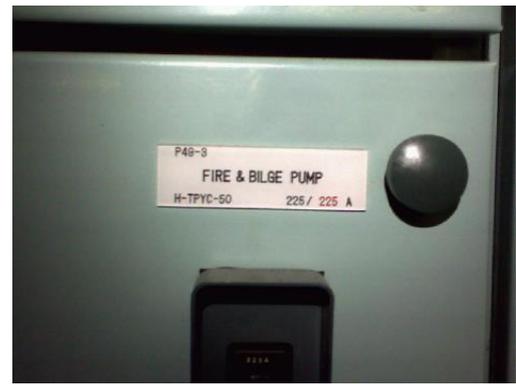
IR005356.IS2-Fire & Bilge Pump
12/3/2016 8:54:13 PM

We did not find any abnormality with respect to Thermal Imaging under this section. All the Mooring Hydraulic pumps were run under no load. Predictive findings are restricted under this section

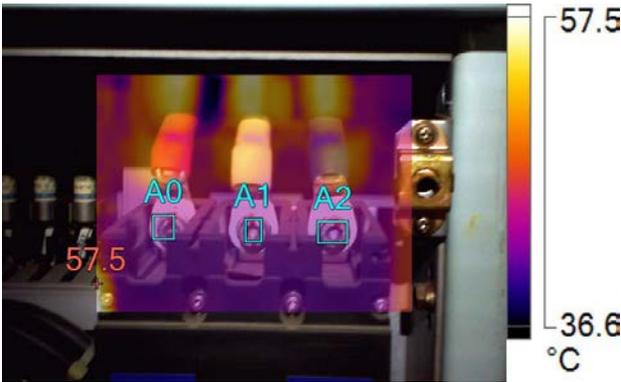
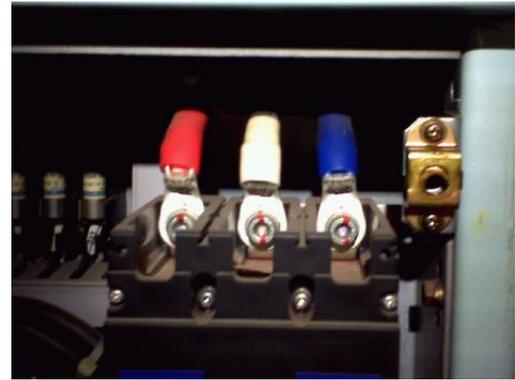
IR005357.IS2-Fire & Bilge Pump

Name	Avg	Min	Max	Emissivity
A0	40.9°C	40.4°C	41.5°C	0.95
A1	40.7°C	40.3°C	41.1°C	0.95
A2	40.7°C	40.2°C	41.2°C	0.95

Name	Temperature	Emissivity
Hot	57.5°C	0.95

We did not find any abnormality with respect to Thermal Imaging under this section. All the Mooring Hydraulic pumps were run under no load. Predictive findings are restricted under this section

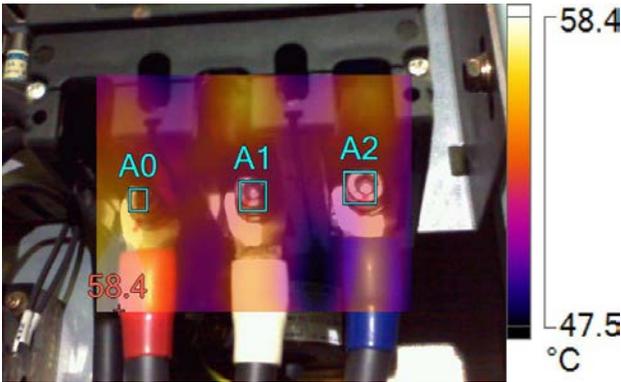
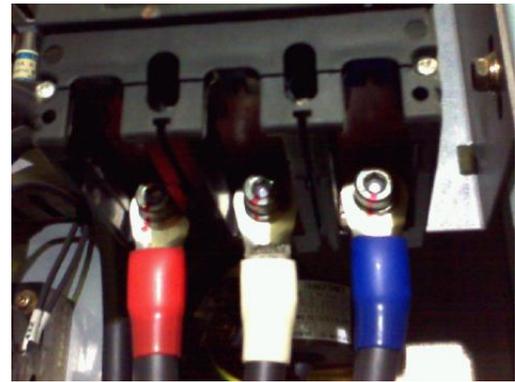
IR005358.IS2-Fire & Bilge Pump

Name	Avg	Min	Max	Emissivity
A0	53.4°C	52.5°C	54.4°C	0.95
A1	52.0°C	51.6°C	52.6°C	0.95
A2	51.9°C	51.1°C	52.3°C	0.95

Name	Temperature	Emissivity
Hot	58.4°C	0.95

We did not find any abnormality with respect to Thermal Imaging under this section. All the Mooring Hydraulic pumps were run under no load. Predictive findings are restricted under this section
