SVL SINGAPORE SERVICES

M.T.-----

Thermal Imaging

Steering, Deck Hyd & Emergency Fire pump

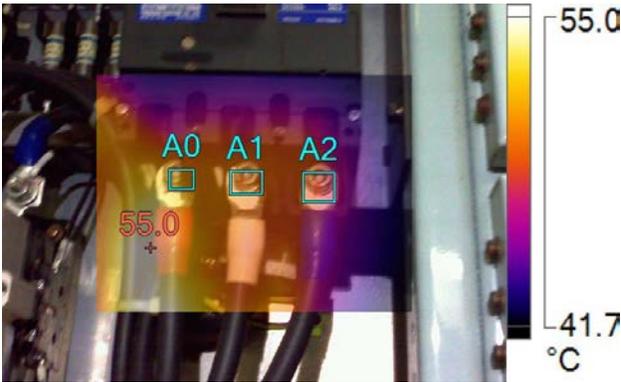
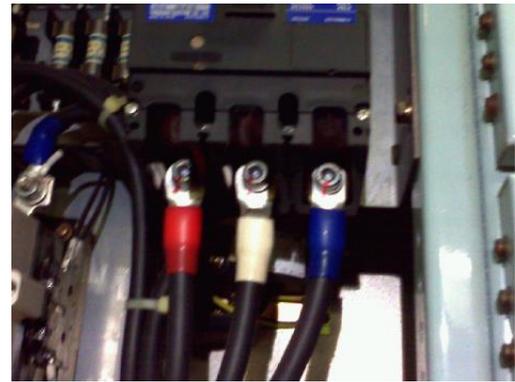
IR005359.IS2-Fire & Bilge Pump

Name	Avg	Min	Max	Emissivity
A0	52.1°C	51.2°C	53.4°C	0.95
A1	51.1°C	50.6°C	51.5°C	0.95
A2	49.7°C	48.5°C	50.5°C	0.95

Name	Temperature	Emissivity
Hot	55.0°C	0.95

We did not find any abnormality with respect to Thermal Imaging under this section. All the Mooring Hydraulic pumps were run under no load. Predictive findings are restricted under this section

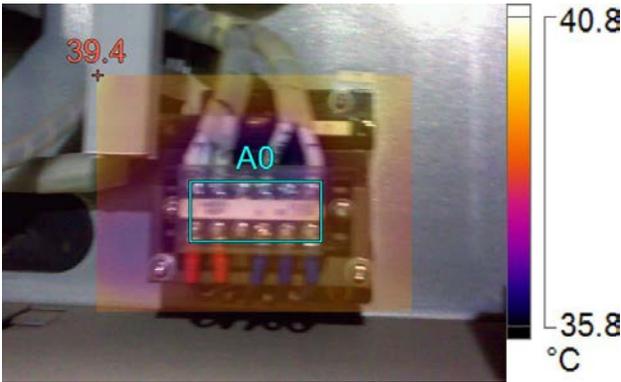
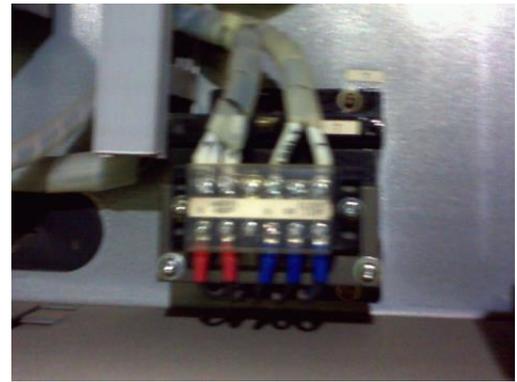
IR005360.IS2-Fire & Bilge Pump

Name	Avg	Min	Max	Emissivity
A0	37.1°C	36.1°C	38.2°C	0.95

Name	Temperature	Emissivity
Hot	39.4°C	0.95

We did not find any abnormality with respect to Thermal Imaging under this section. All the Mooring Hydraulic pumps were run under no load. Predictive findings are restricted under this section

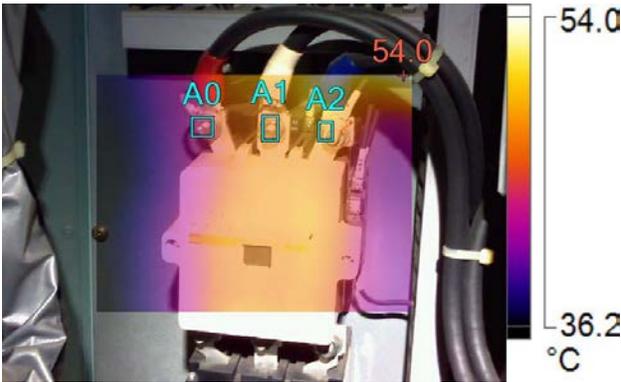
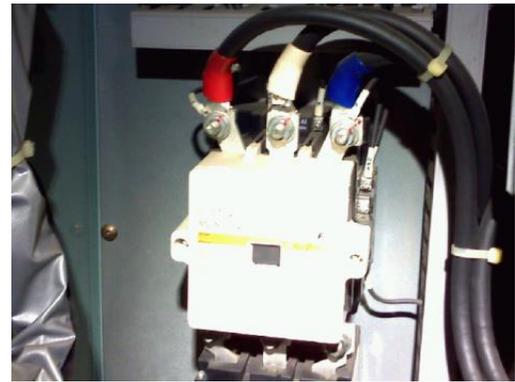
IR005361.IS2-Fire & Bilge Pump

Name	Avg	Min	Max	Emissivity
A0	45.8°C	44.6°C	47.1°C	0.95
A1	48.9°C	48.7°C	49.2°C	0.95
A2	49.9°C	49.2°C	50.5°C	0.95

Name	Temperature	Emissivity
Hot	54.0°C	0.95

We did not find any abnormality with respect to Thermal Imaging under this section. All the Mooring Hydraulic pumps were run under no load. Predictive findings are restricted under this section

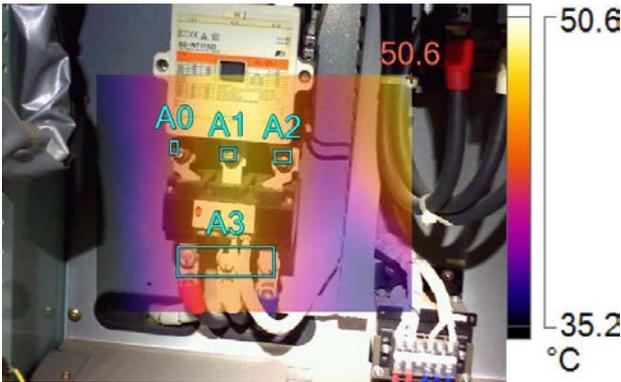
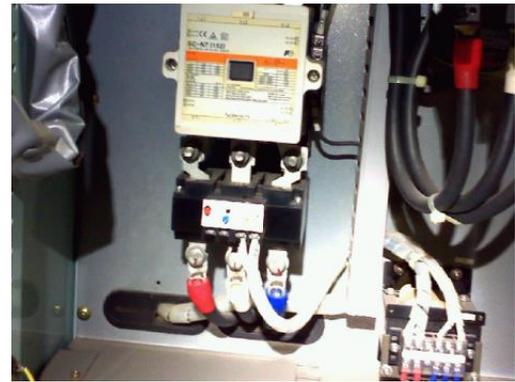
IR005362.IS2-Fire & Bilge Pump

Name	Avg	Min	Max	Emissivity
A0	44.3°C	43.6°C	44.9°C	0.95
A1	48.6°C	48.2°C	48.9°C	0.95
A2	46.3°C	45.3°C	47.1°C	0.95
A3	45.6°C	42.5°C	47.6°C	0.95

Name	Temperature	Emissivity
Hot	50.6°C	0.95

We did not find any abnormality with respect to Thermal Imaging under this section. All the Mooring Hydraulic pumps were run under no load. Predictive findings are restricted under this section

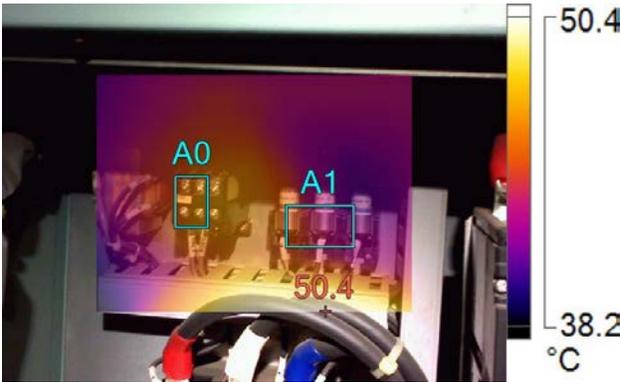
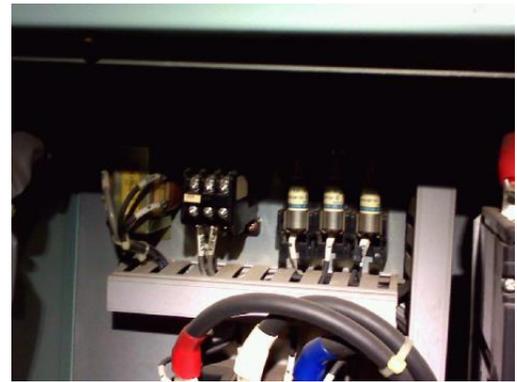
IR005363.IS2-Fire & Bilge Pump

Name	Avg	Min	Max	Emissivity
A0	44.8°C	43.6°C	45.5°C	0.95
A1	42.3°C	40.4°C	43.9°C	0.95

Name	Temperature	Emissivity
Hot	50.4°C	0.95

We did not find any abnormality with respect to Thermal Imaging under this section. All the Mooring Hydraulic pumps were run under no load. Predictive findings are restricted under this section

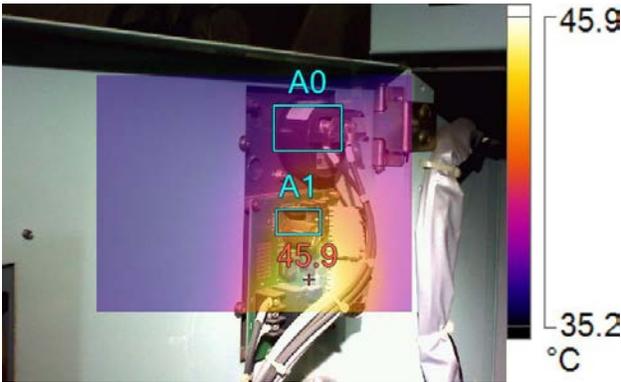
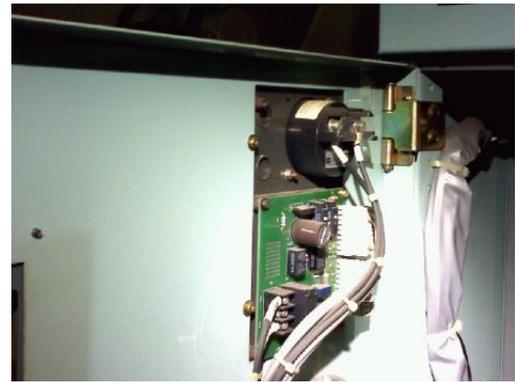
IR005364.IS2-Fire & Bilge Pump

Name	Avg	Min	Max	Emissivity
A0	38.5°C	37.5°C	39.5°C	0.95
A1	41.8°C	40.0°C	43.2°C	0.95

Name	Temperature	Emissivity
Hot	45.9°C	0.95

We did not find any abnormality with respect to Thermal Imaging under this section. All the Mooring Hydraulic pumps were run under no load. Predictive findings are restricted under this section

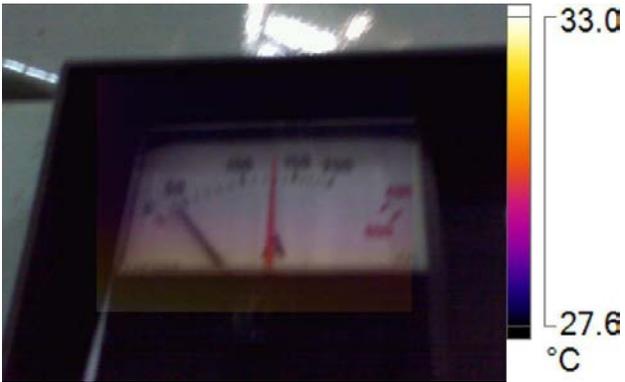
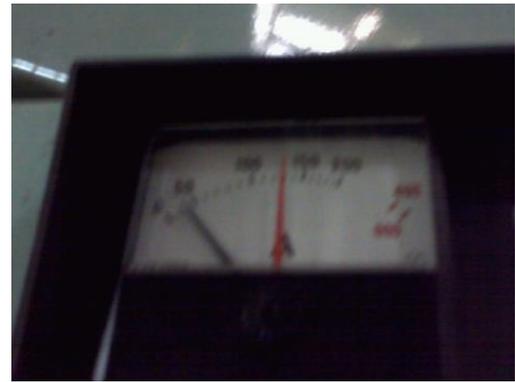
IR005735.IS2- No1 Deck Hyd pump

All the checks Deck Hydraulic pumps were carried out when run with no load

We did not find any abnormality with respect to Thermal Imaging under this section. All the Mooring Hydraulic pumps were run under no load. Predictive findings are restricted under this section

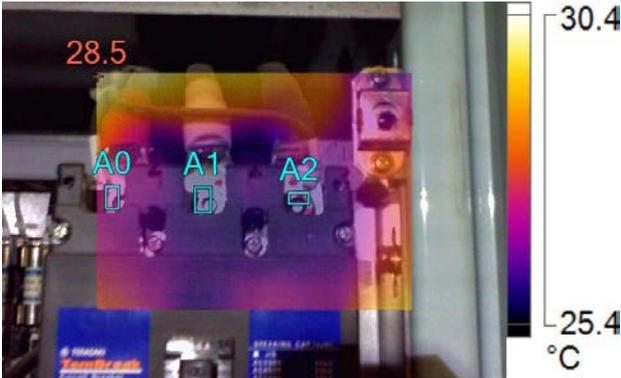
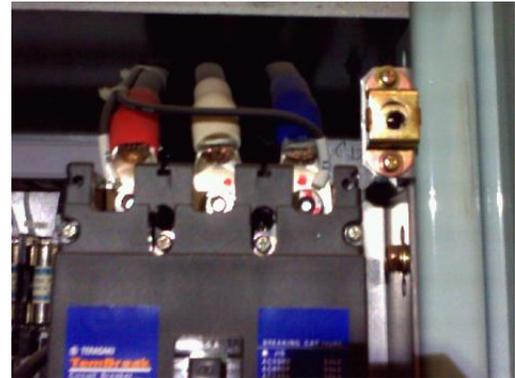
IR005736.IS2- No1 Deck Hyd pump

We did not find any abnormality with respect to Thermal Imaging under this section. All the Mooring Hydraulic pumps were run under no load. Predictive findings are restricted under this section

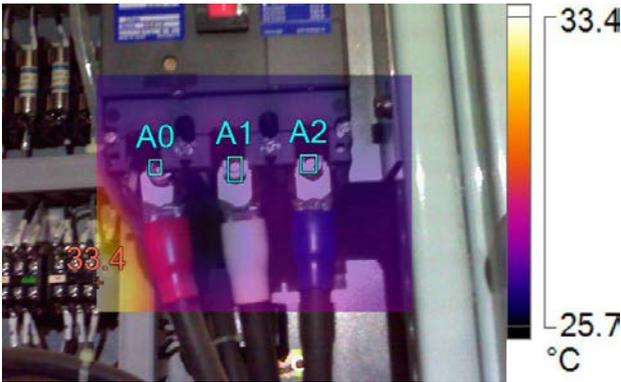
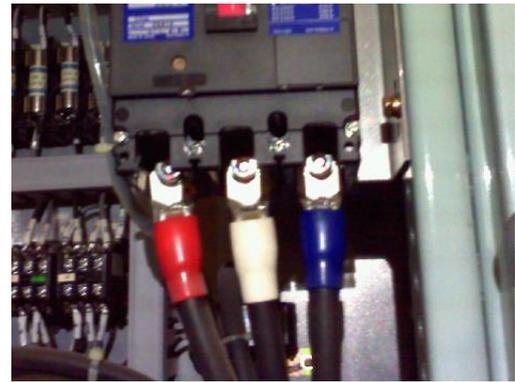
IR005737.IS2- No1 Deck Hyd pump

We did not find any abnormality with respect to Thermal Imaging under this section. All the Mooring Hydraulic pumps were run under no load. Predictive findings are restricted under this section

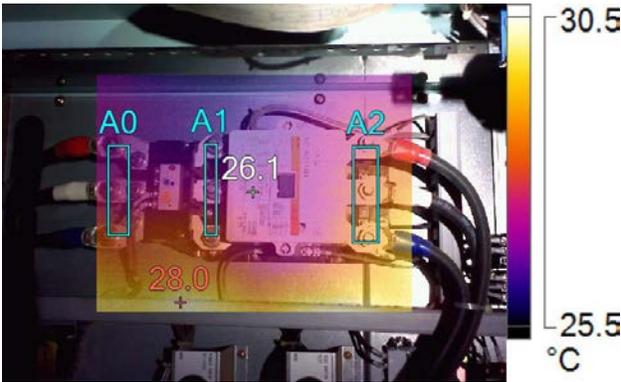
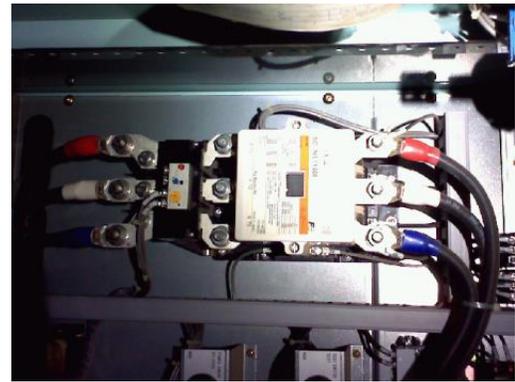
IR005738.IS2- No1 Deck Hyd pump

We did not find any abnormality with respect to Thermal Imaging under this section. All the Mooring Hydraulic pumps were run under no load. Predictive findings are restricted under this section

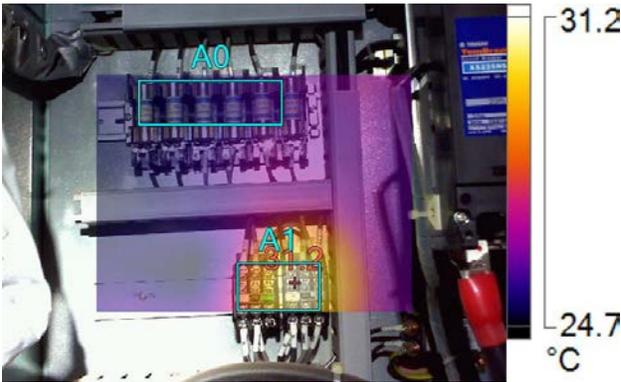
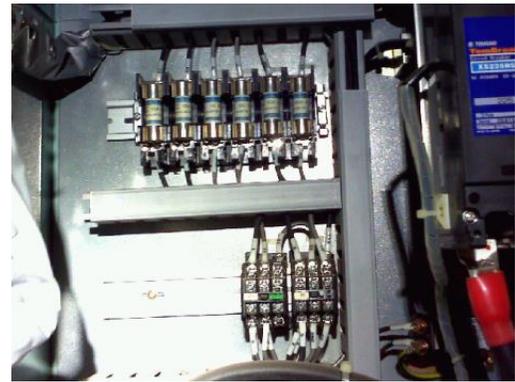
IR005739.IS2- No1 Deck Hyd pump

We did not find any abnormality with respect to Thermal Imaging under this section. All the Mooring Hydraulic pumps were run under no load. Predictive findings are restricted under this section

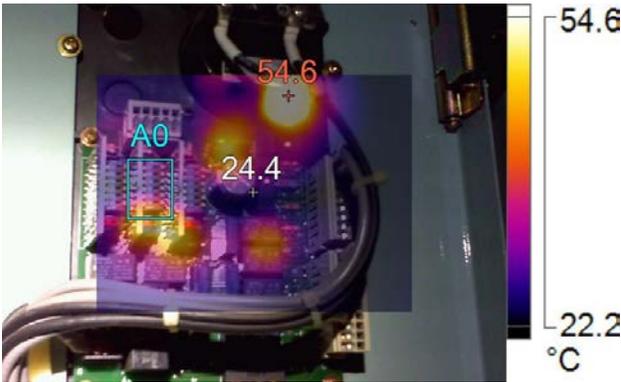
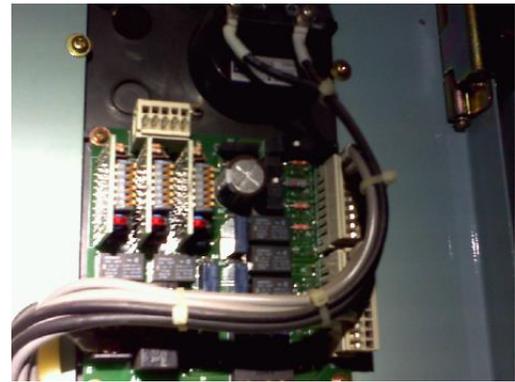
IR005740.IS2- No1 Deck Hyd pump

We did not find any abnormality with respect to Thermal Imaging under this section. All the Mooring Hydraulic pumps were run under no load. Predictive findings are restricted under this section

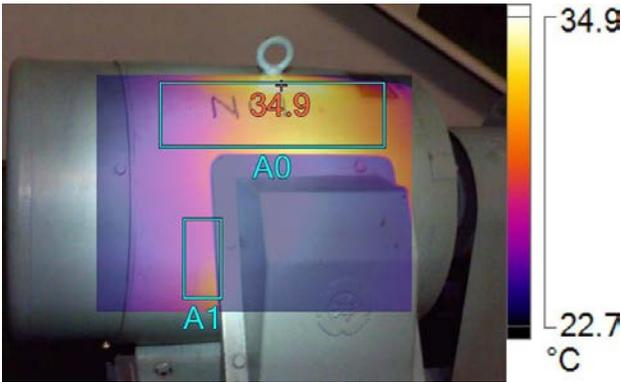
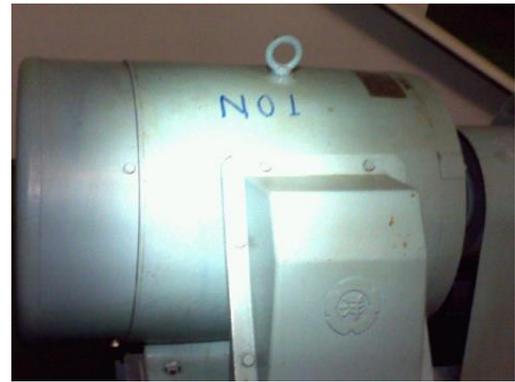
IR005741.IS2- No1 Deck Hyd pump

We did not find any abnormality with respect to Thermal Imaging under this section. All the Mooring Hydraulic pumps were run under no load. Predictive findings are restricted under this section

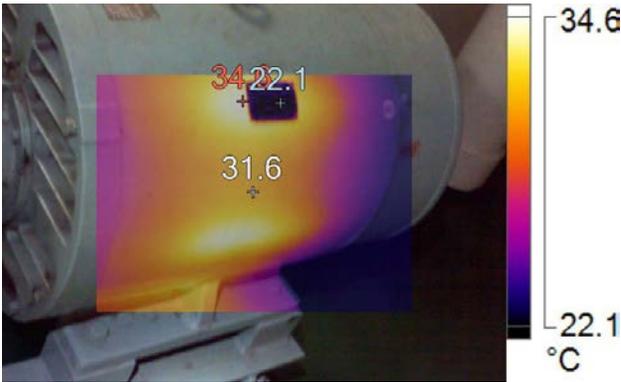
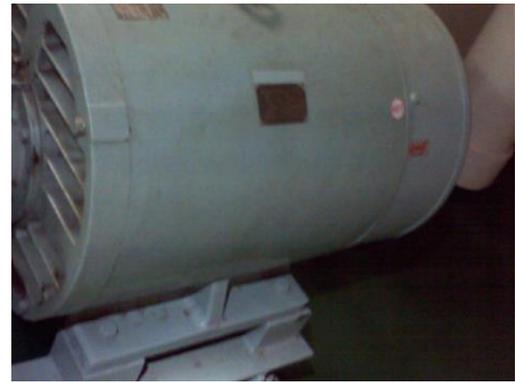
IR005742.IS2- No1 Deck Hyd pump

We did not find any abnormality with respect to Thermal Imaging under this section. All the Mooring Hydraulic pumps were run under no load. Predictive findings are restricted under this section

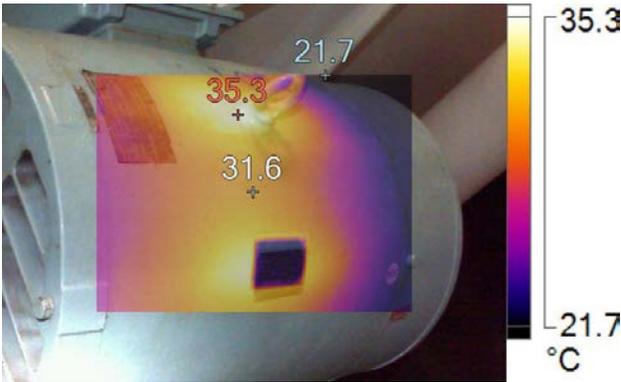
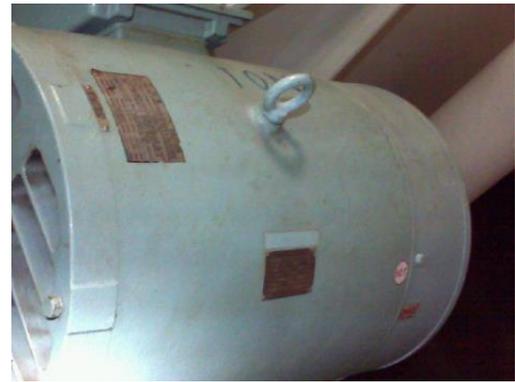
IR005743.IS2- No1 Deck Hyd pump

We did not find any abnormality with respect to Thermal Imaging under this section. All the Mooring Hydraulic pumps were run under no load. Predictive findings are restricted under this section

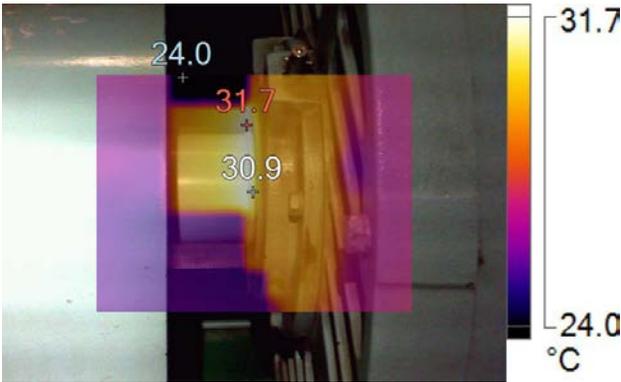
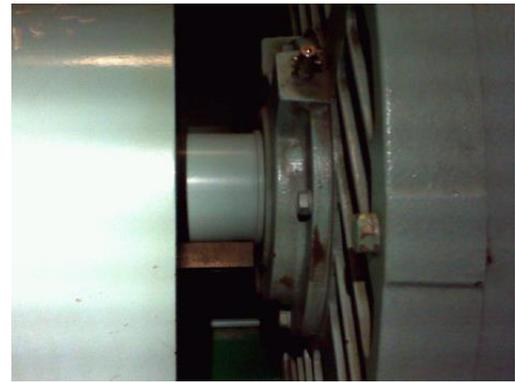
IR005744.IS2- No1 Deck Hyd pump

We did not find any abnormality with respect to Thermal Imaging under this section. All the Mooring Hydraulic pumps were run under no load. Predictive findings are restricted under this section

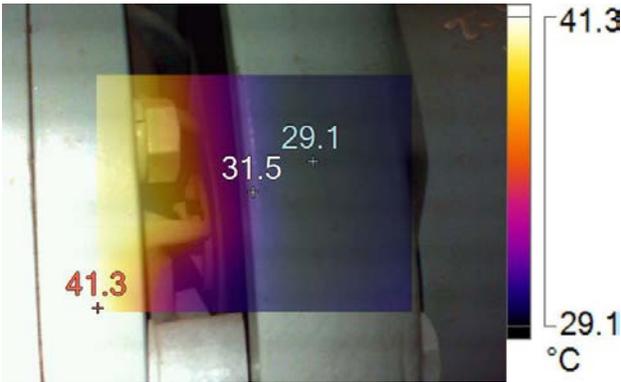
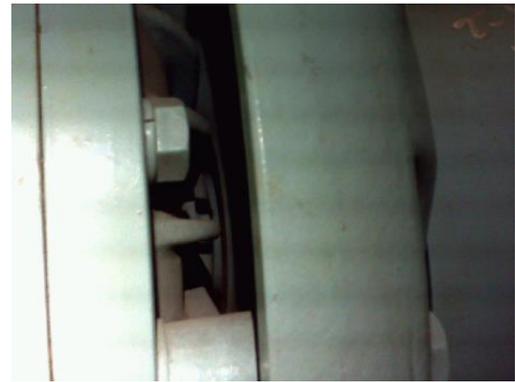
IR005745.IS2- No1 Deck Hyd pump

We did not find any abnormality with respect to Thermal Imaging under this section. All the Mooring Hydraulic pumps were run under no load. Predictive findings are restricted under this section

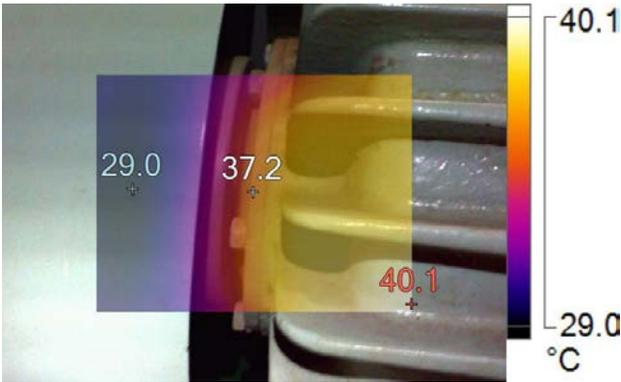
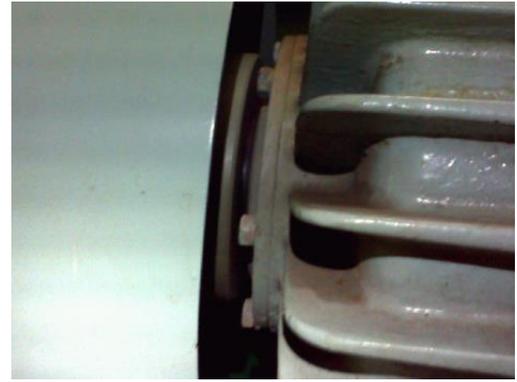
IR005746.IS2- No1 Deck Hyd pump

We did not find any abnormality with respect to Thermal Imaging under this section. All the Mooring Hydraulic pumps were run under no load. Predictive findings are restricted under this section

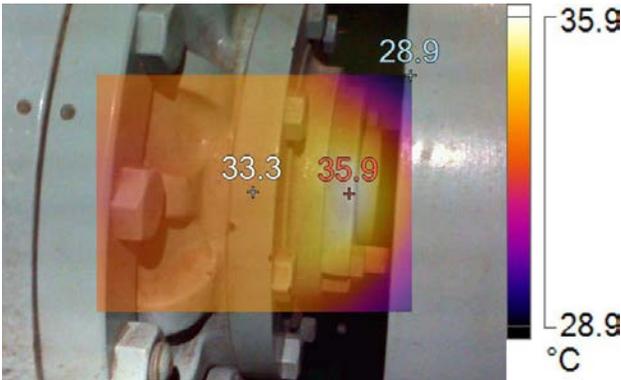
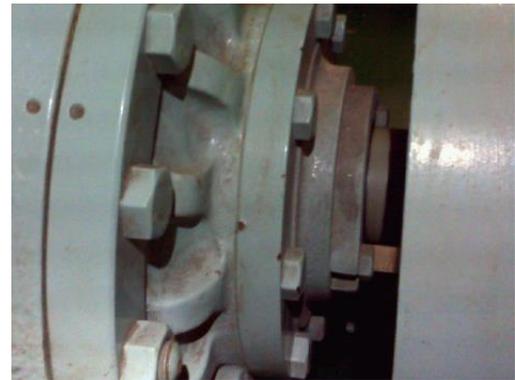
IR005747.IS2- No1 Deck Hyd pump

We did not find any abnormality with respect to Thermal Imaging under this section. All the Mooring Hydraulic pumps were run under no load. Predictive findings are restricted under this section

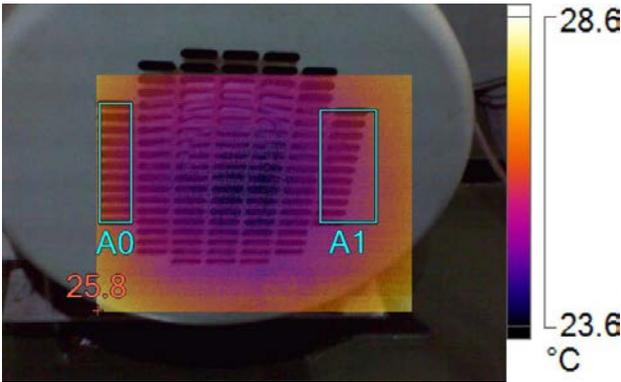
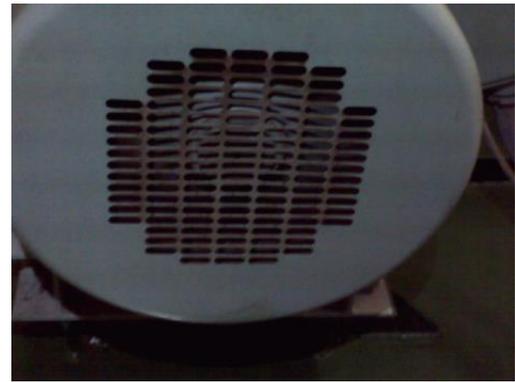
IR005748.IS2- No1 Deck Hyd pump

We did not find any abnormality with respect to Thermal Imaging under this section. All the Mooring Hydraulic pumps were run under no load. Predictive findings are restricted under this section

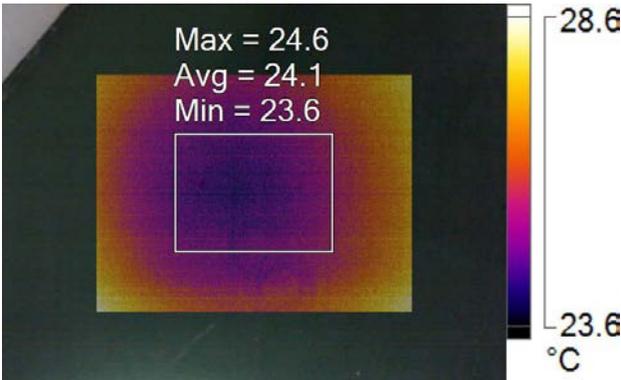
IR005749.IS2-Room Temperature
12/5/2016 9:35:44 AM

We did not find any abnormality with respect to Thermal Imaging under this section. All the Mooring Hydraulic pumps were run under no load. Predictive findings are restricted under this section

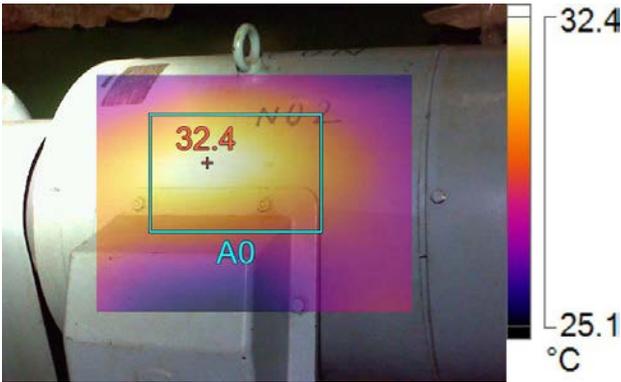
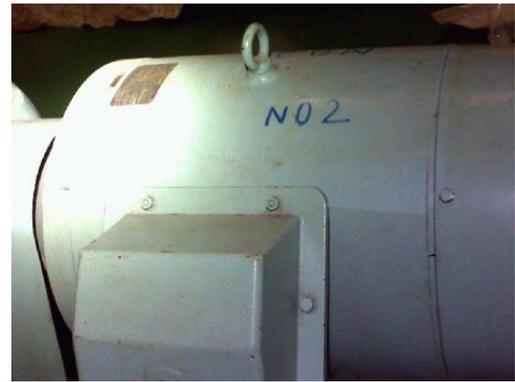
IR005750.IS2- No2 Deck Hyd pump

We did not find any abnormality with respect to Thermal Imaging under this section. All the Mooring Hydraulic pumps were run under no load. Predictive findings are restricted under this section

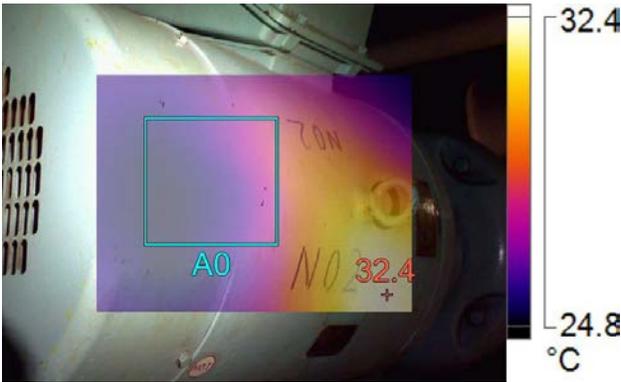
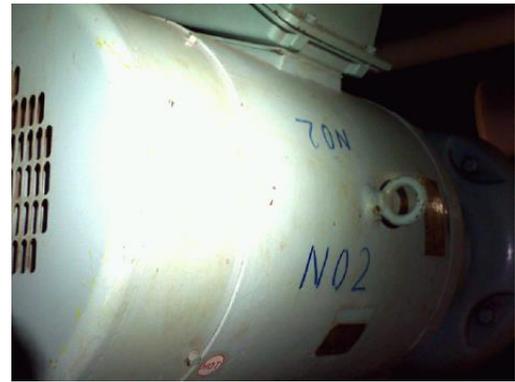
IR005751.IS2- No2 Deck Hyd pump
12/5/2016 9:36:26 AM

We did not find any abnormality with respect to Thermal Imaging under this section. All the Mooring Hydraulic pumps were run under no load. Predictive findings are restricted under this section

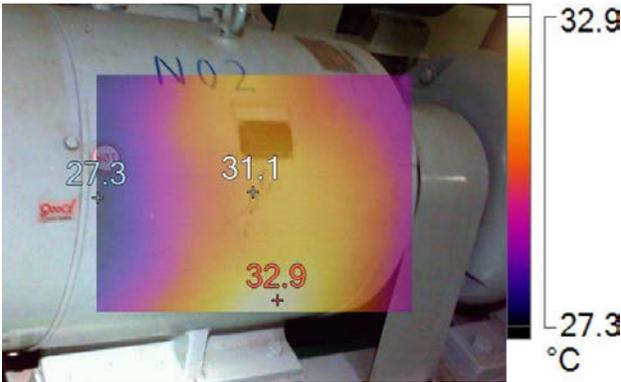
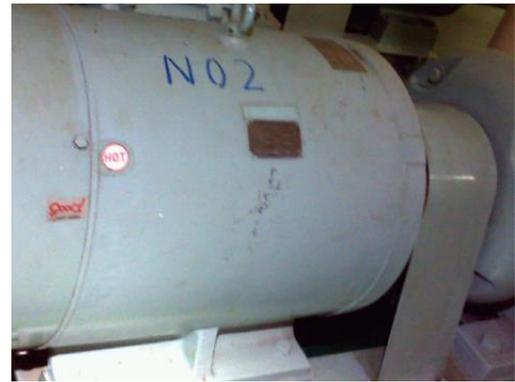
IR005752.IS2- No2 Deck Hyd pump
12/5/2016 9:36:31 AM

We did not find any abnormality with respect to Thermal Imaging under this section. All the Mooring Hydraulic pumps were run under no load. Predictive findings are restricted under this section

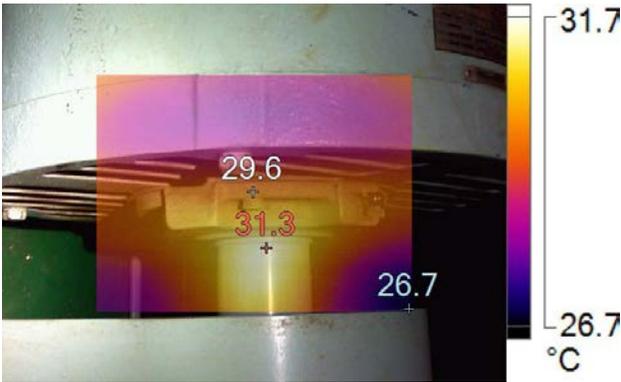
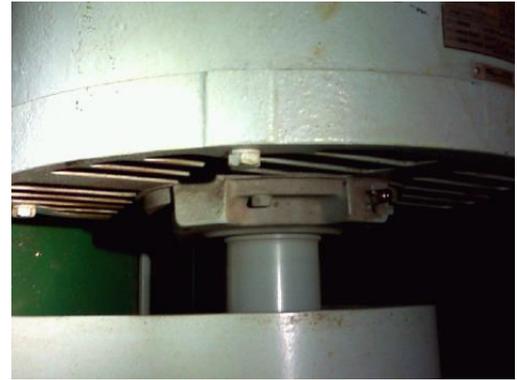
IR005753.IS2- No2 Deck Hyd pump
12/5/2016 9:36:40 AM

We did not find any abnormality with respect to Thermal Imaging under this section. All the Mooring Hydraulic pumps were run under no load. Predictive findings are restricted under this section

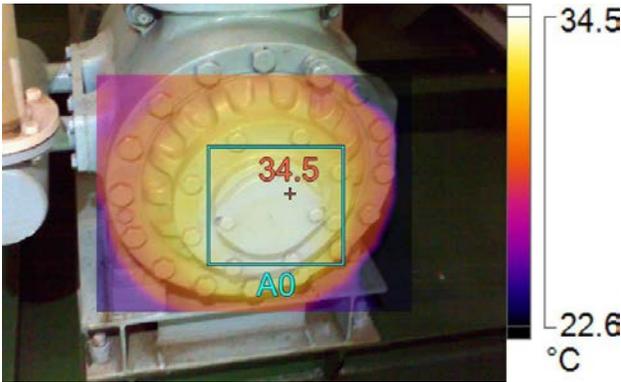
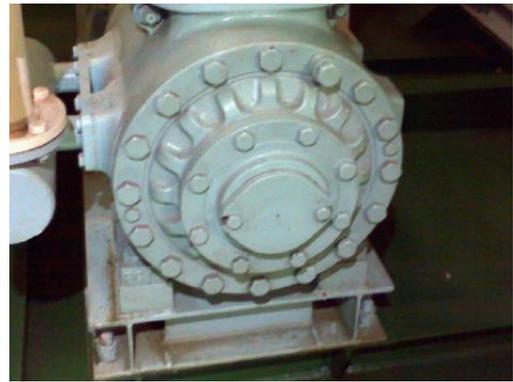
IR005756.IS2- No2 Deck Hyd pump
12/5/2016 9:37:44 AM

We did not find any abnormality with respect to Thermal Imaging under this section. All the Mooring Hydraulic pumps were run under no load. Predictive findings are restricted under this section

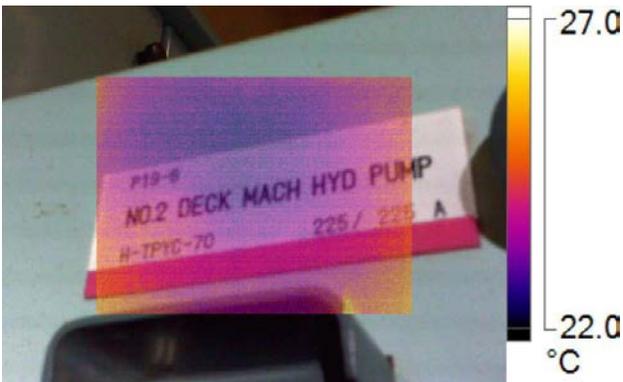
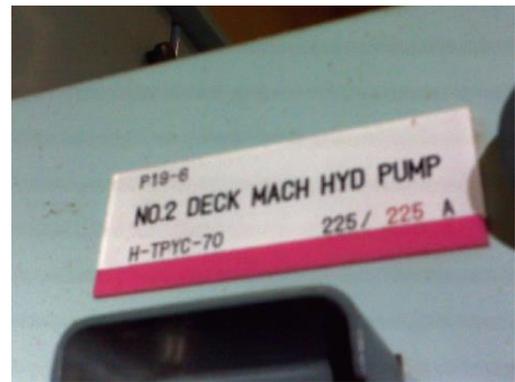
IR005757.IS2- No2 Deck Hyd pump
12/5/2016 9:38:20 AM

We did not find any abnormality with respect to Thermal Imaging under this section. All the Mooring Hydraulic pumps were run under no load. Predictive findings are restricted under this section

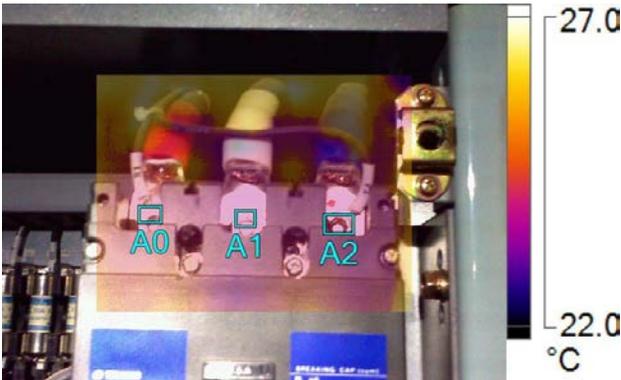
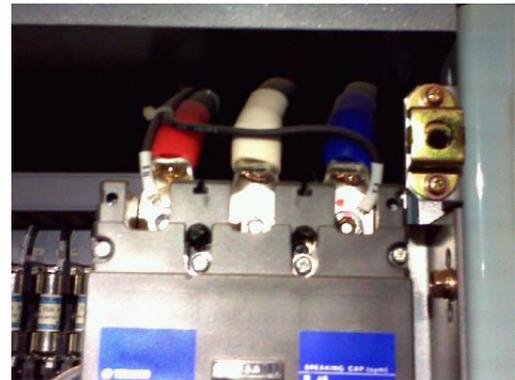
IR005758.IS2- No2 Deck Hyd pump
12/5/2016 9:38:32 AM

We did not find any abnormality with respect to Thermal Imaging under this section. All the Mooring Hydraulic pumps were run under no load. Predictive findings are restricted under this section

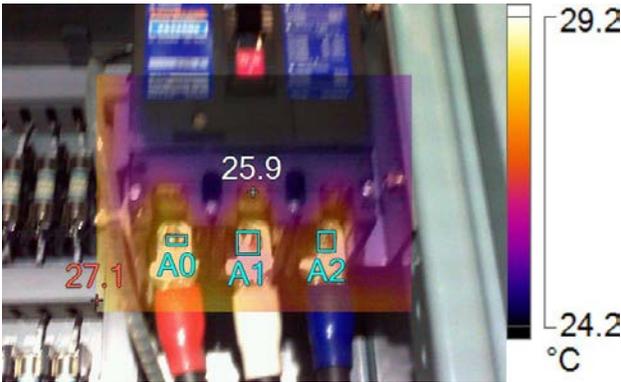
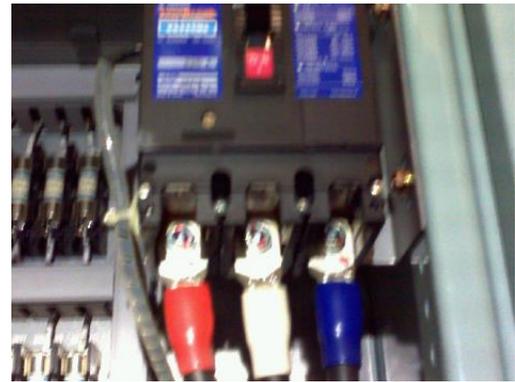
IR005759.IS2- No2 Deck Hyd pump
12/5/2016 9:38:46 AM

We did not find any abnormality with respect to Thermal Imaging under this section. All the Mooring Hydraulic pumps were run under no load. Predictive findings are restricted under this section

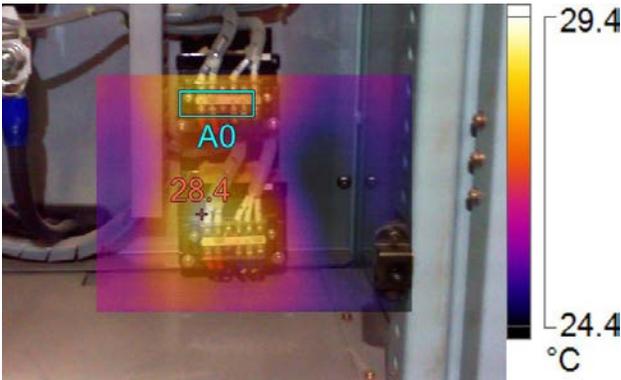
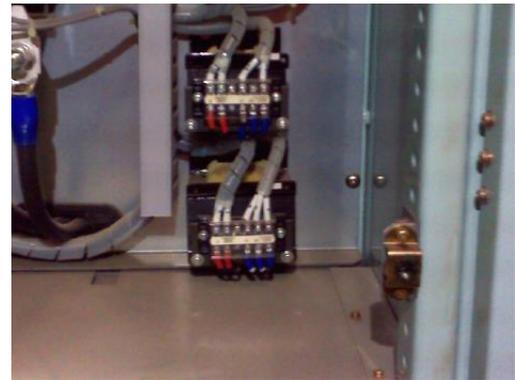
IR005760.IS2- No2 Deck Hyd pump
12/5/2016 9:38:55 AM

We did not find any abnormality with respect to Thermal Imaging under this section. All the Mooring Hydraulic pumps were run under no load. Predictive findings are restricted under this section

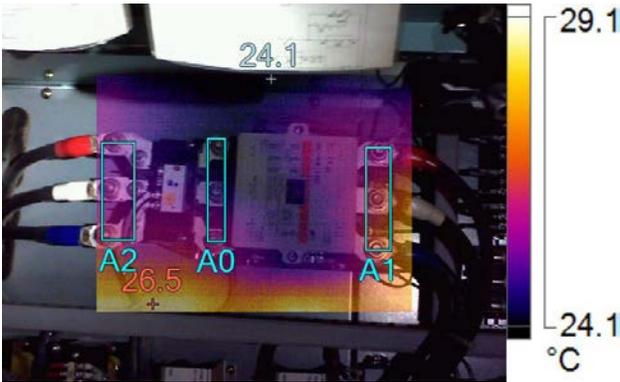
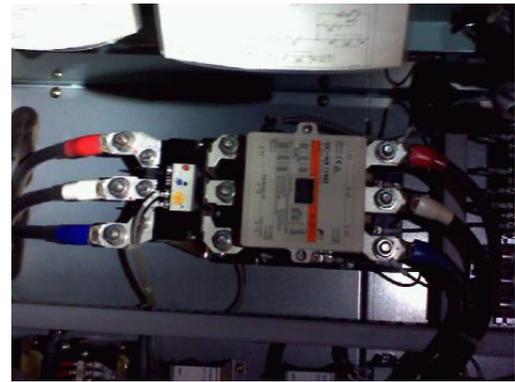
IR005761.IS2- No2 Deck Hyd pump
12/5/2016 9:39:02 AM

We did not find any abnormality with respect to Thermal Imaging under this section. All the Mooring Hydraulic pumps were run under no load. Predictive findings are restricted under this section

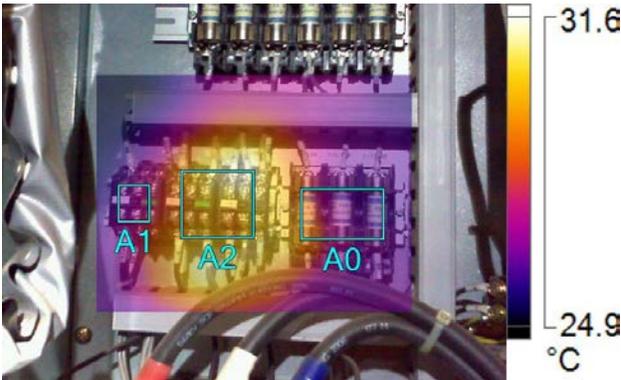
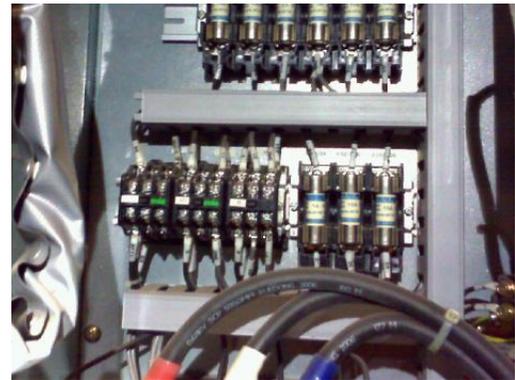
IR005762.IS2- No2 Deck Hyd pump
12/5/2016 9:39:09 AM

We did not find any abnormality with respect to Thermal Imaging under this section. All the Mooring Hydraulic pumps were run under no load. Predictive findings are restricted under this section

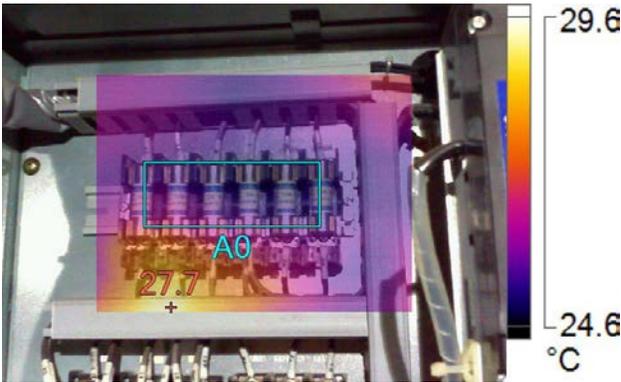
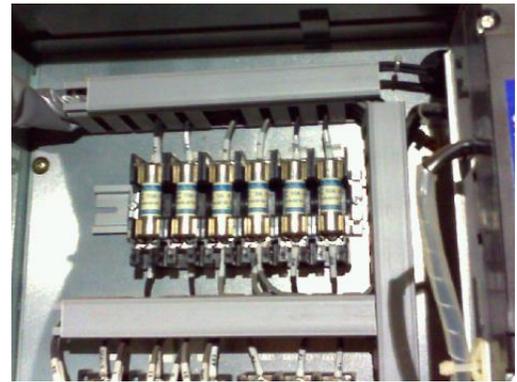
IR005763.IS2- No2 Deck Hyd pump
12/5/2016 9:39:15 AM

We did not find any abnormality with respect to Thermal Imaging under this section. All the Mooring Hydraulic pumps were run under no load. Predictive findings are restricted under this section
