**UNIFIED INTERPRETATIONS TO SOLAS CHAPTER II-2, THE FSS CODE
AND RELATED FIRE TEST PROCEDURES**

Guidelines on insulation of high temperature surfaces

Submitted by the Republic of Korea

ONBOARD INVESTIGATION RESULT

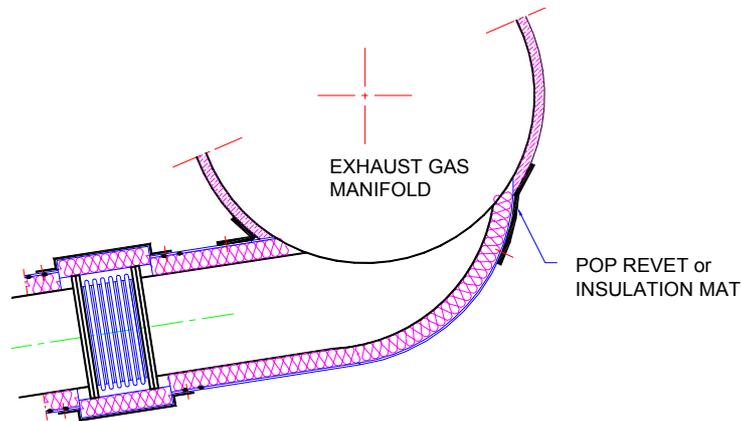
Figure A2-3 Insulation practice of discontinuous part

The measured temperatures around exhaust gas piping on older ships were of similar in pattern to that of new ships. Like new ships, areas around exhaust gas piping before and after turbo charger and exhaust gas piping between cylinder and exhaust gas manifold were found as hot surfaces. Figure 13 shows that an inappropriate replacement of insulation has resulted in hot surface after maintenance work of exhaust gas compensator (expansion joint). In general, when the insulation is arranged in horizontal direction there is no problem, but when installed in vertical direction, the insulation materials tend to compress down resulting in hot surfaces.

In order to avoid the discontinuity of insulation of the exhaust gas piping (i.e. the exhaust gas piping before and after turbo charger and the exhaust gas piping between cylinder and exhaust gas manifold), special finishing material (e.g. pot rivet or finish insulation mat) should be used as shown in figure A2-3.
